CONSTRUCTION CERTIFICATE No. J/74556/01

Issued under the Environmental Planning and Assessment Act 1979 Sections 6.4 and 6.7

Address: Ivanhoe Estate comprising Ivanhoe Place, Wilcannia Way, Nyngan Way, Narromine Way and Cobar Way, part of 2-4 Lyonpark Road and portions of Shrimptons Creek adjacent to the centre line of the creek, Macquarie Park

Description: Stage 1 development application for the redevelopment of the Ivanhoe Estate, including:

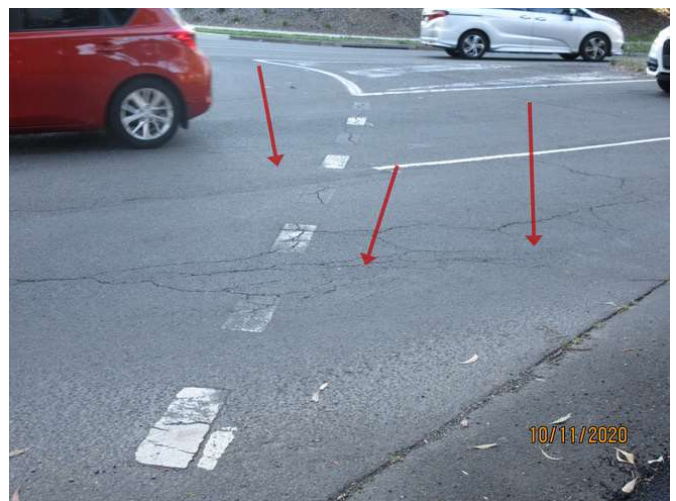
029_Note cracking damage

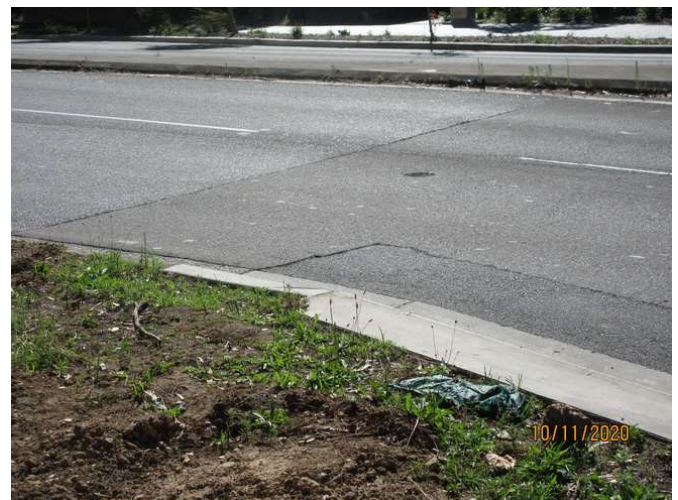
045_Note cracking damage

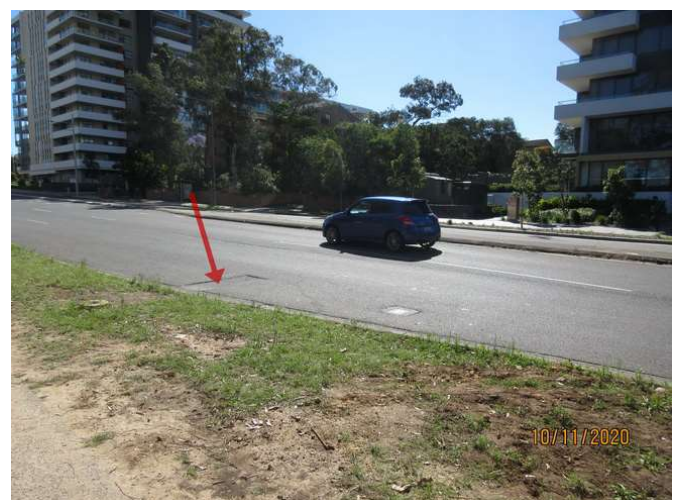
047_Note cracking damage_Note exposed soil ground along footpath

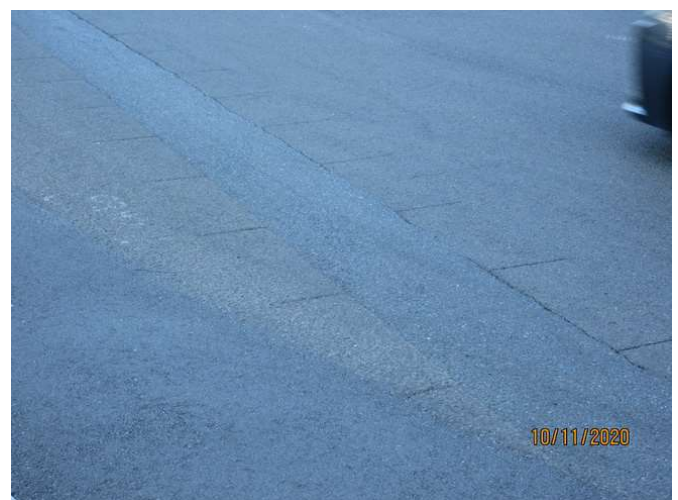
167_Note cracking damage

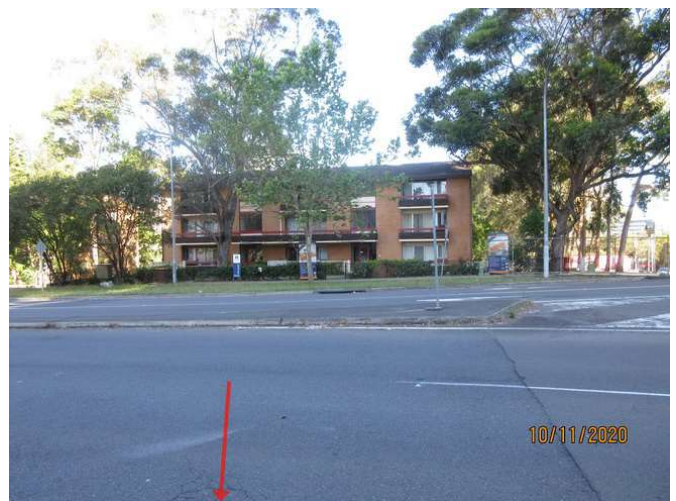
180_Note cracking damage

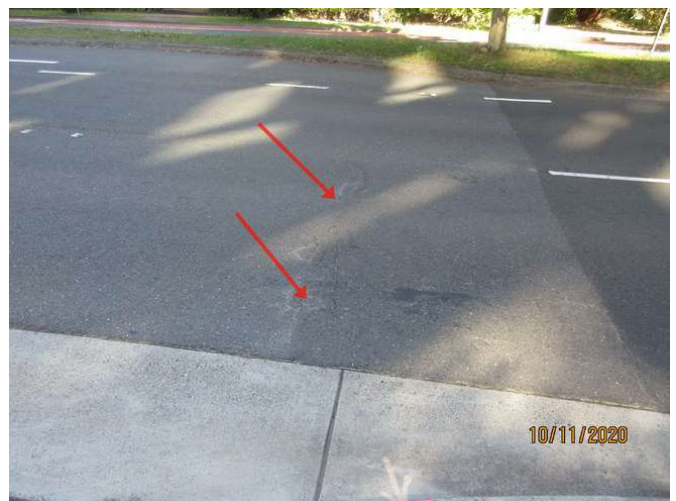
210_Note cracking damage

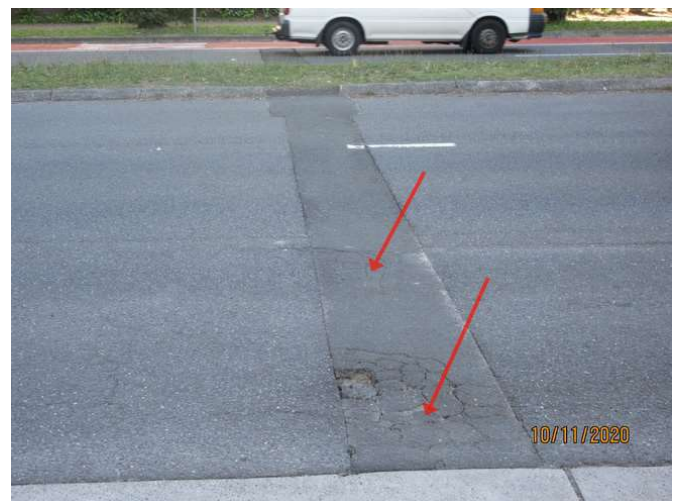
215_Note cracking damage

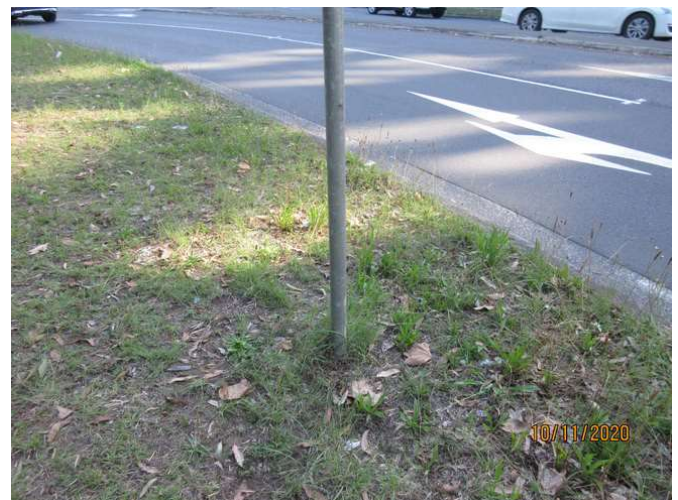
267_Note impact damage

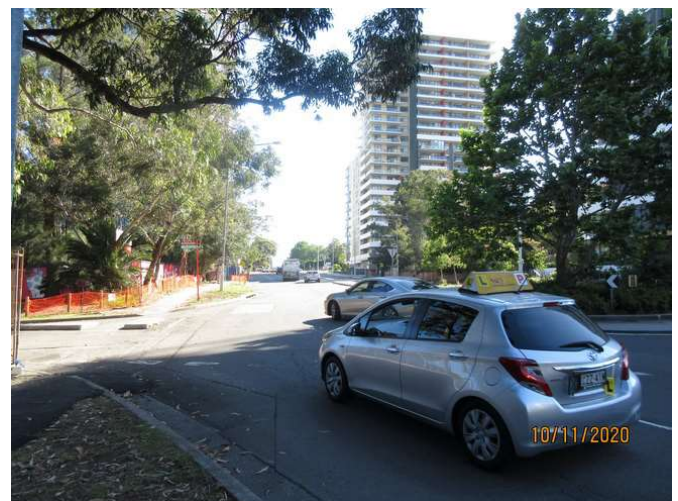
275_Note cracking to kerb stone

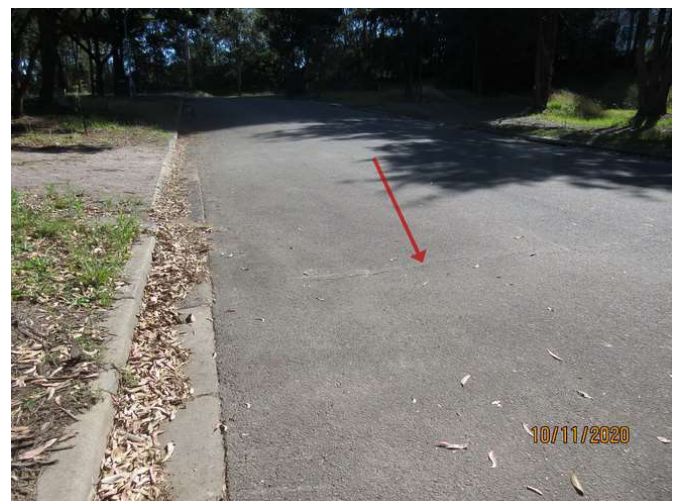
006_Note slight surface cracking and scratch damage

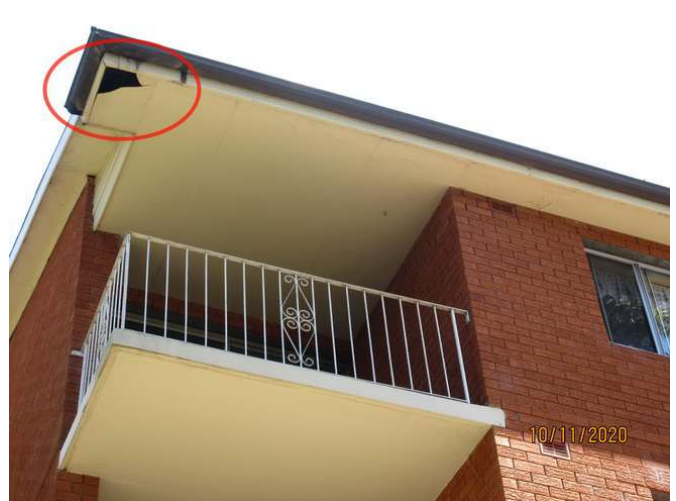
No 1-3_006_Note damaged eave line soffit board

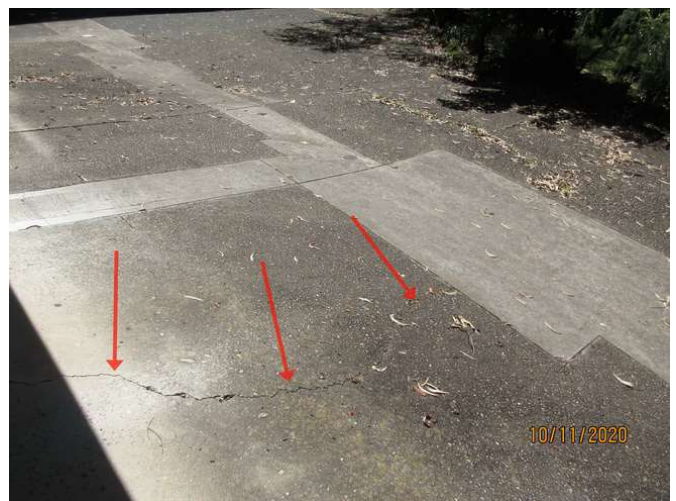
No 1-3_054_Note the cracking damage

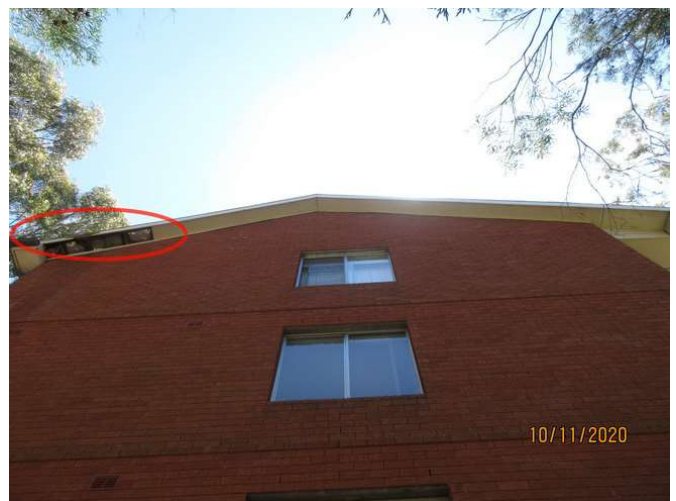
No 1-3_065_Note the cracking damage

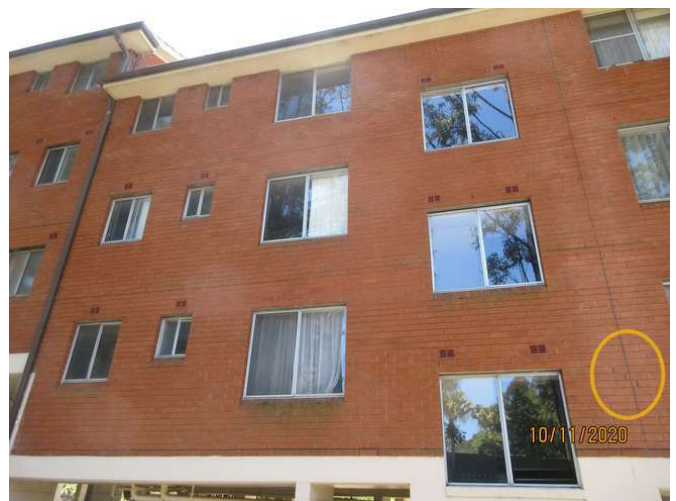
No 1-3_078_Note the cracking damage

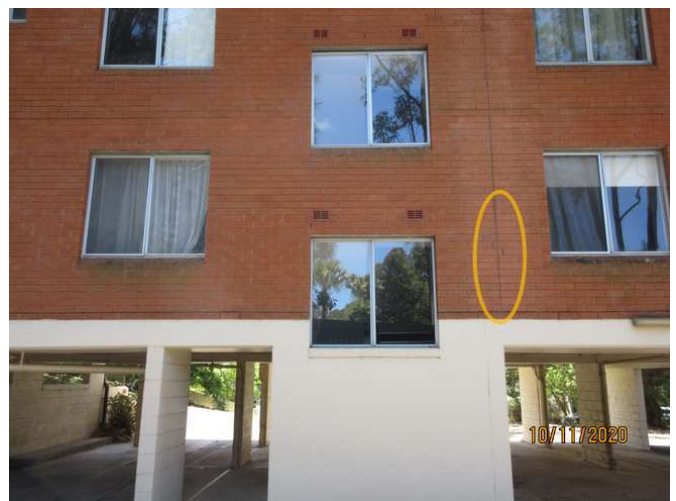
No 1-3_084_Note the cracking damage

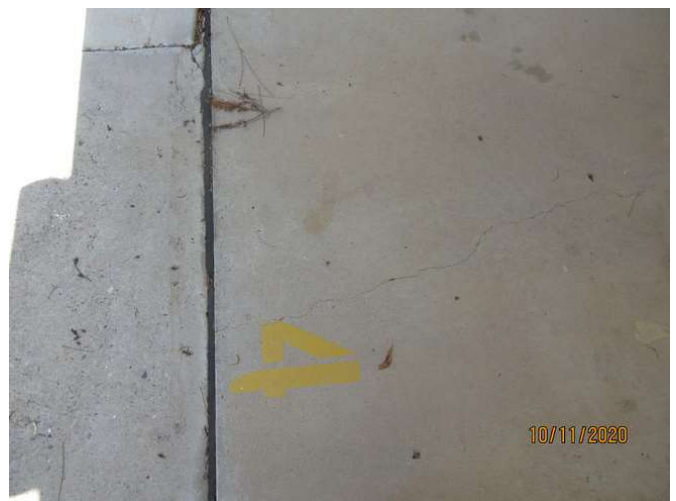
No 1-3_167_Note the cracking damage

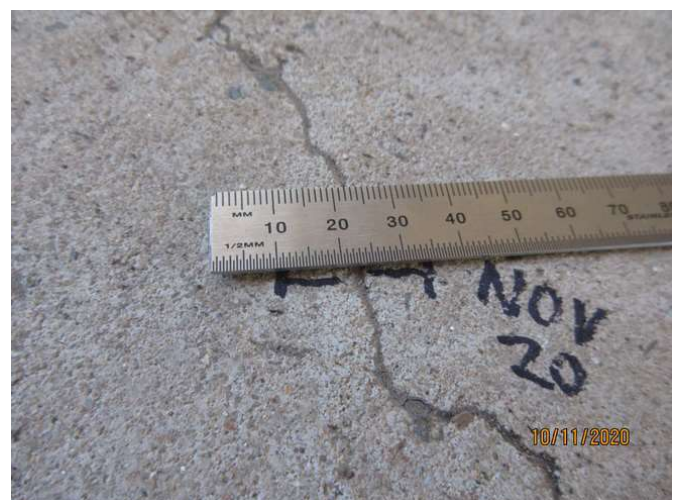
No 1-3_264_Note an estimated 1.5mm cracking width at representative location

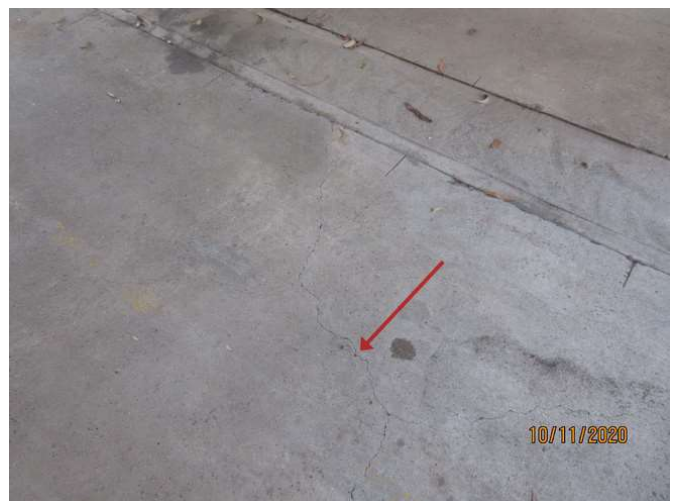
No 1-3_269_Note the cracking damage

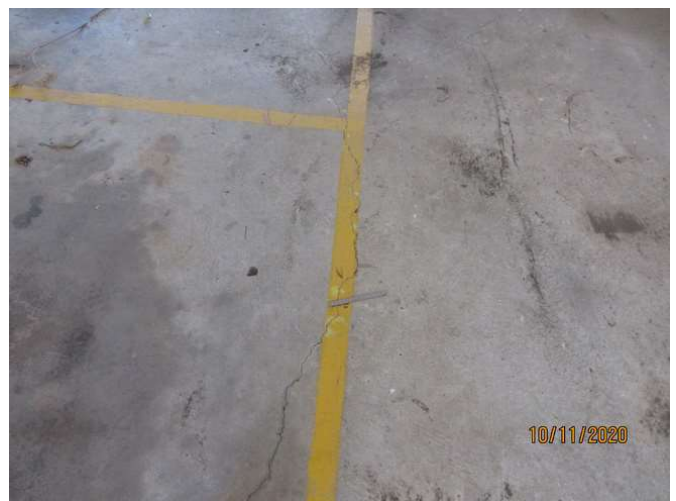
No 1-3_317_Note an estimated 2.0mm cracking width at representative location

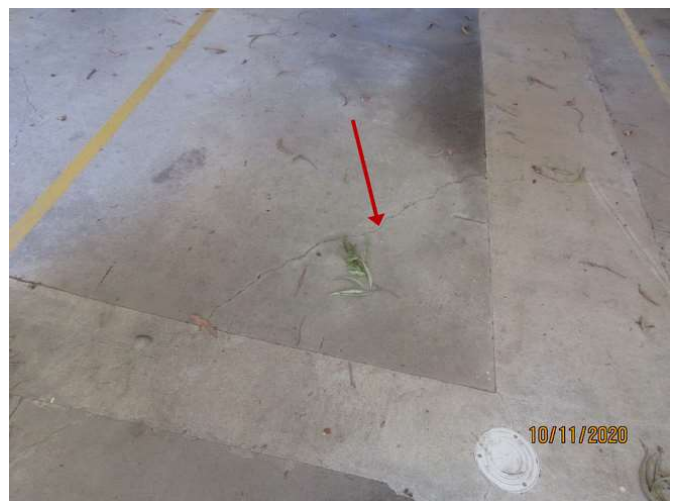
No 1-3_335_Note the cracking damage

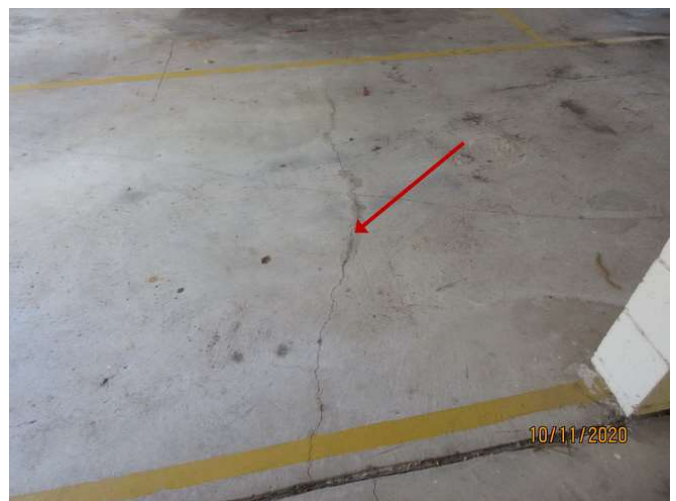
No 1-3_341_Note the cracking damage

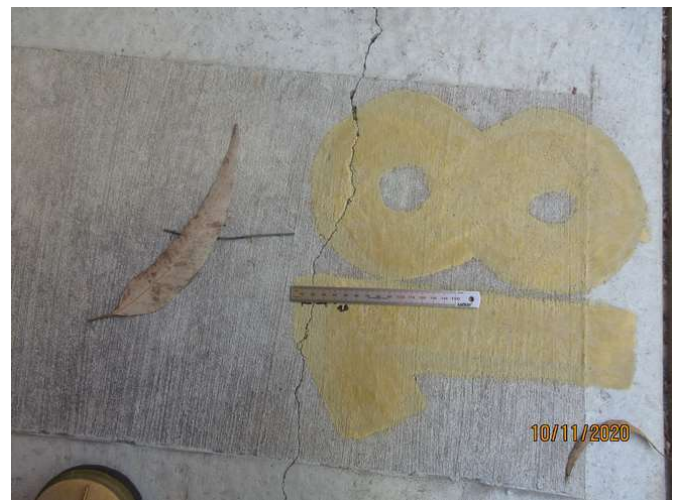
No 1-3_411_Note the cracking damage

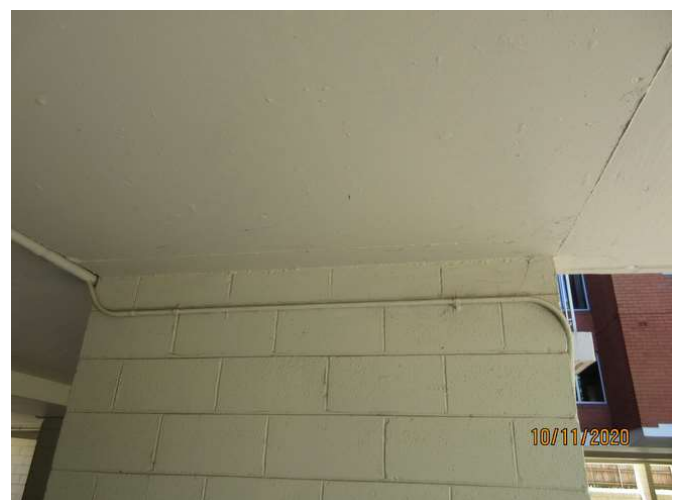
No 1-3_413_Note an estimated 0.5mm cracking width at representative location

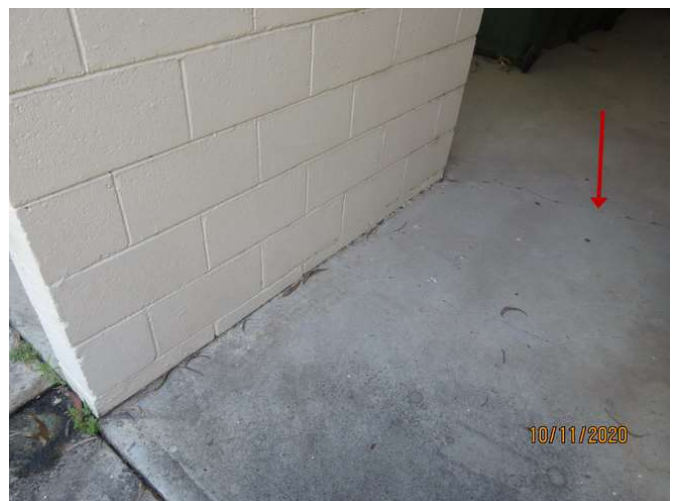
No 1-3_420_Note the cracking damage

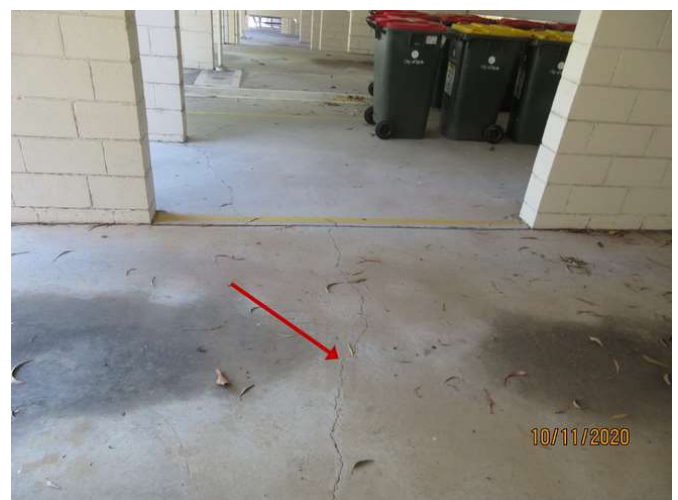
No 1-3_449_Note the cracking damage

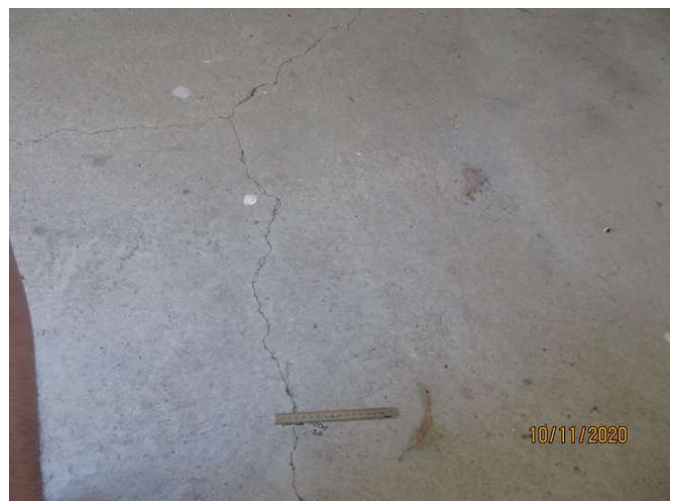
No 1-3_473_Note the cracking damage

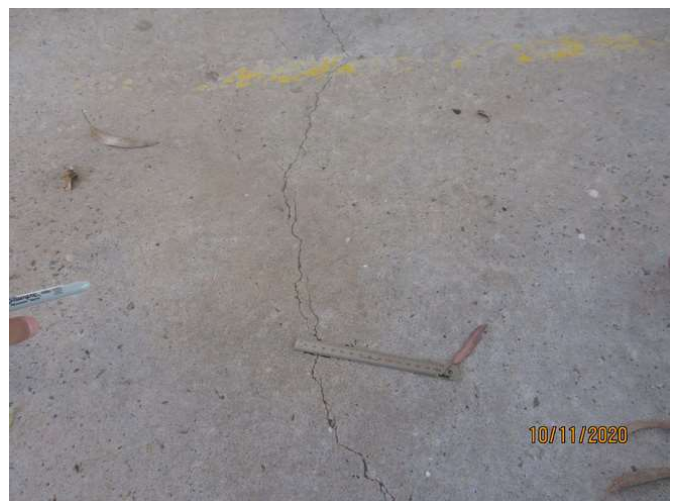
No 1-3_491_Note the cracking damage

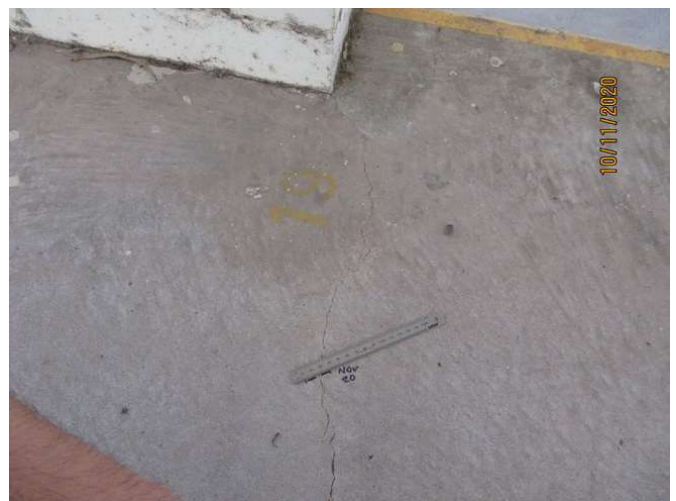
No 1-3_515_Note the cracking damage

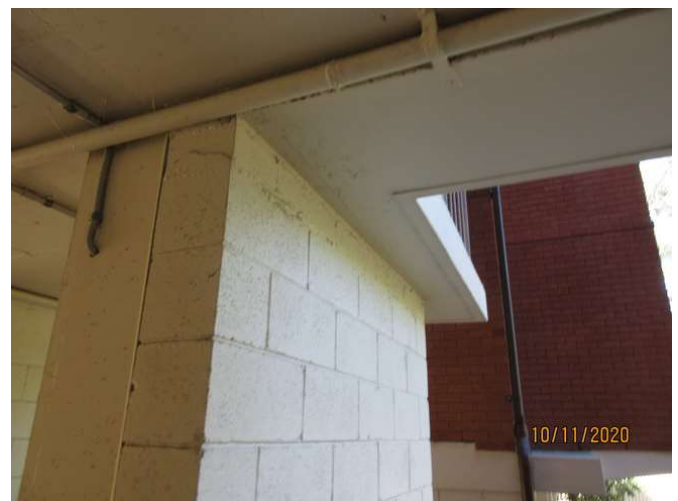
No 1-3_533_Note the cracking damage

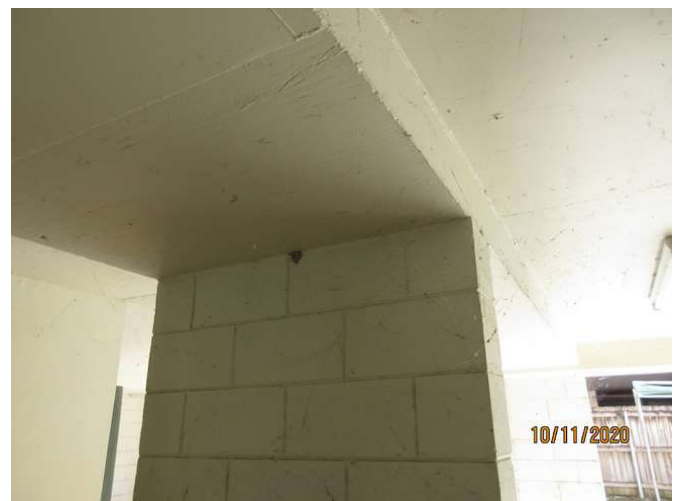
No 1-3_545_Note an estimated 0.75mm cracking width at representative location

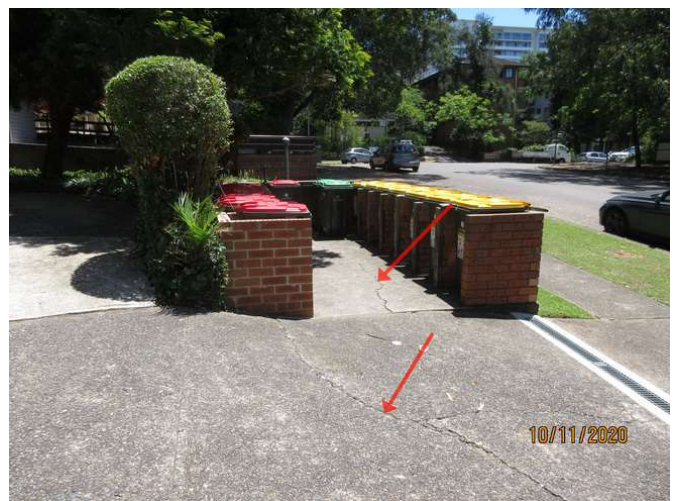
No1_005_Note evident cracking to concrete driveway

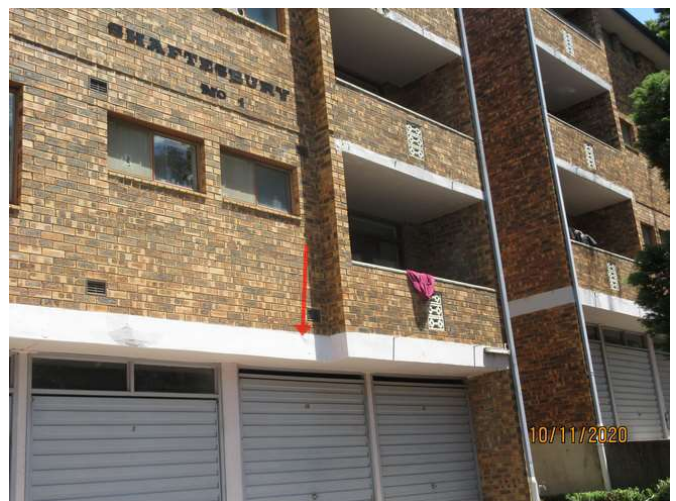
No1_011_Note slight concrete spalling

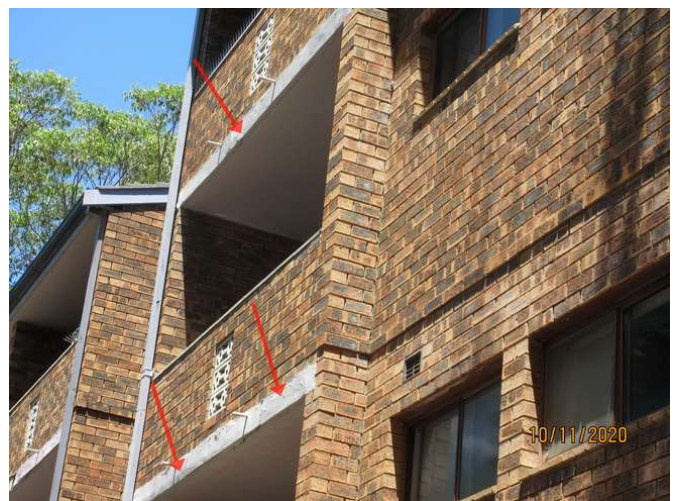
No1_018_Note slight concrete spalling

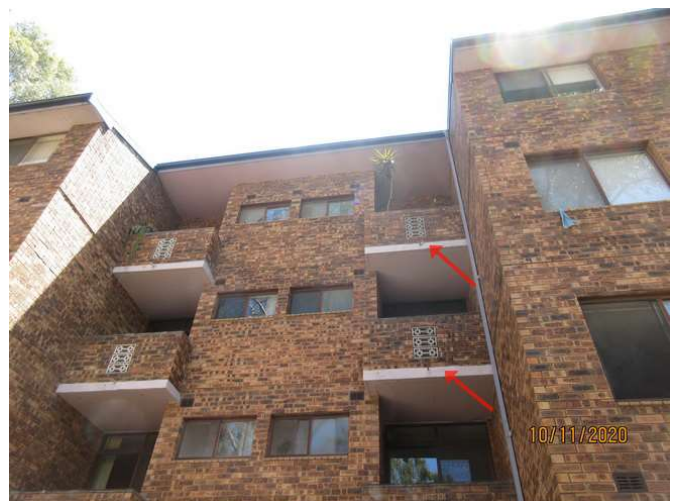
No1_024_Note slight concrete spalling

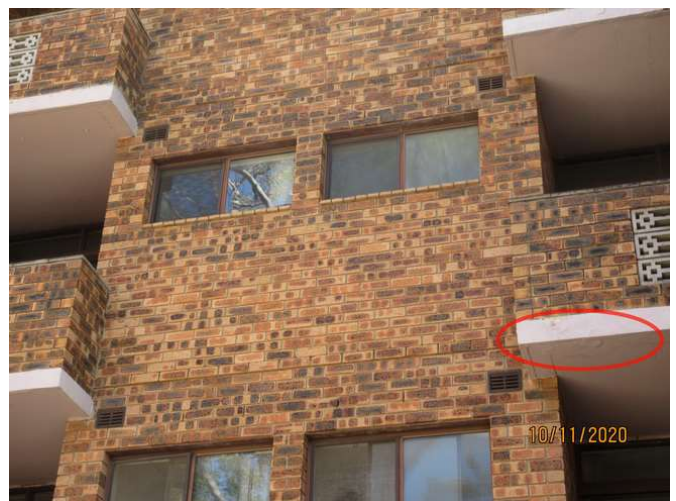
No1_035_Note slight concrete spalling

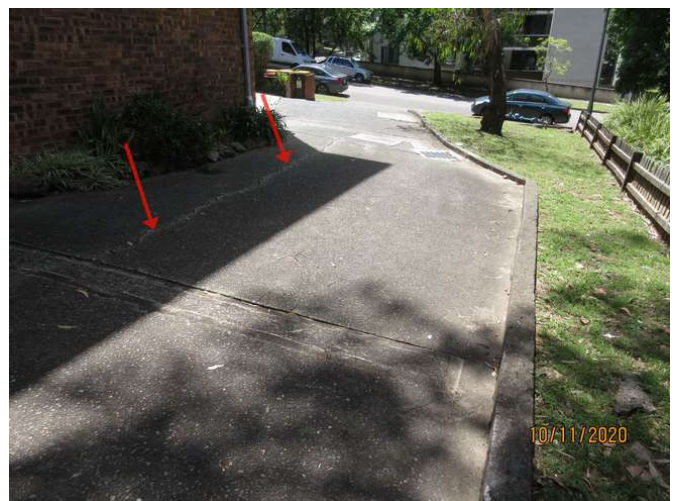
No1_047_Note evident cracking to concrete driveway

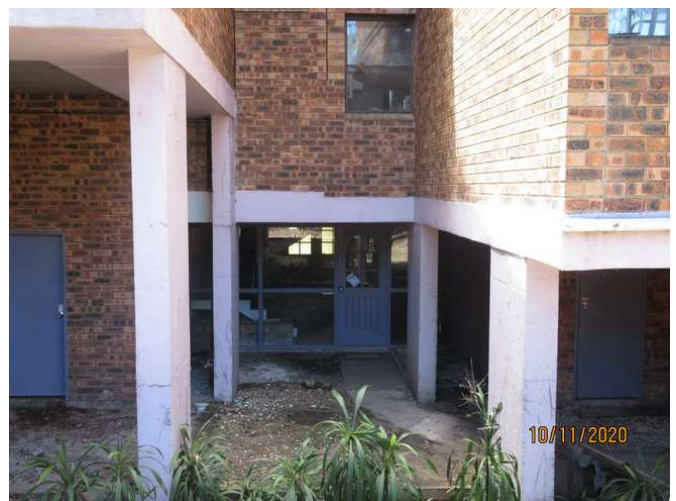
No1_065_Note slight concrete spalling

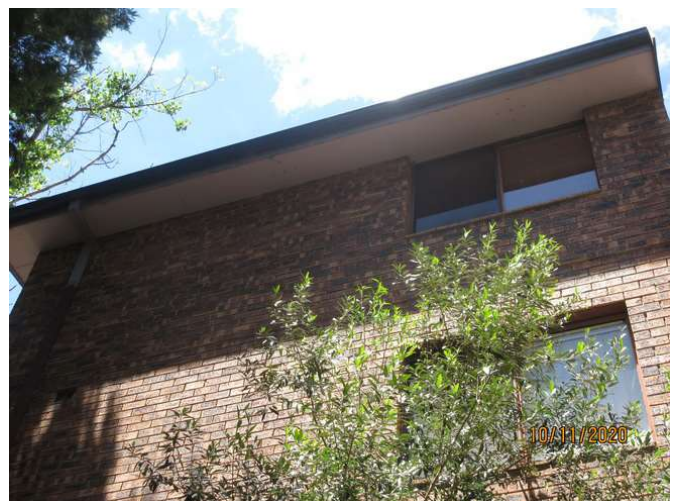
No1_089_Note slight concrete spalling

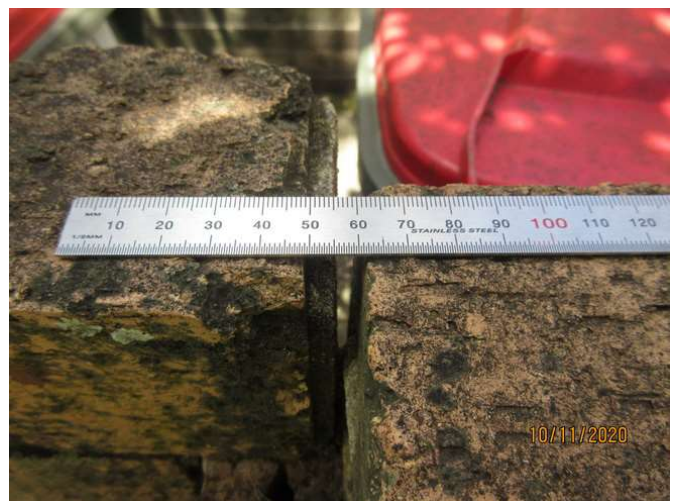
No 3_006_Note an estimated 13.0mm cracking width on top

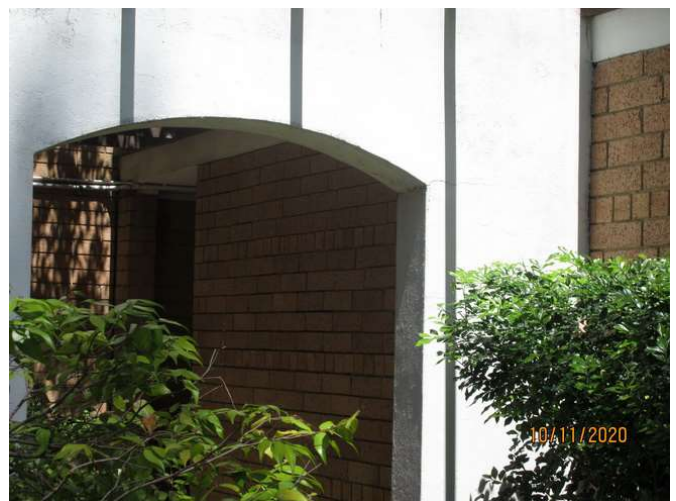
No 3_041_Note the cracking damage

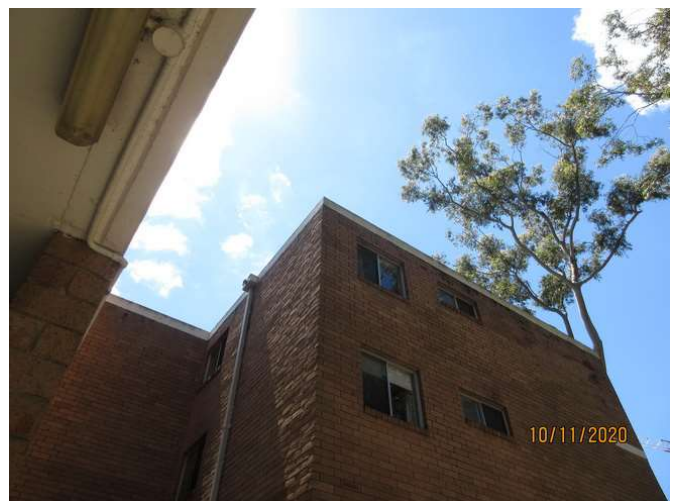
No 3_065_Note the cracking damage

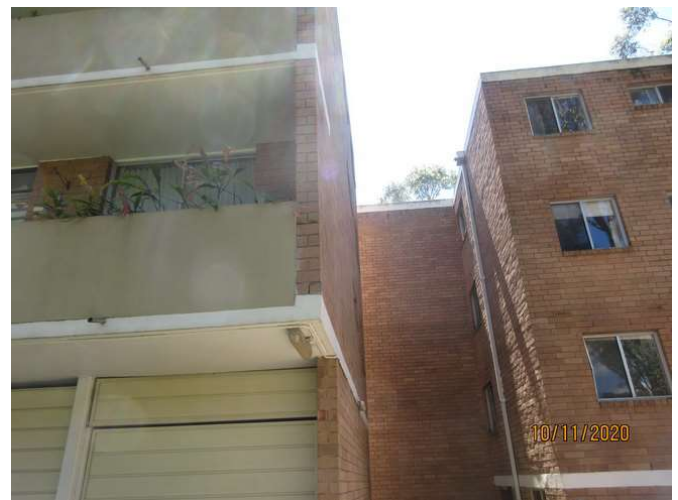
No 3_099_Note the cracking damage

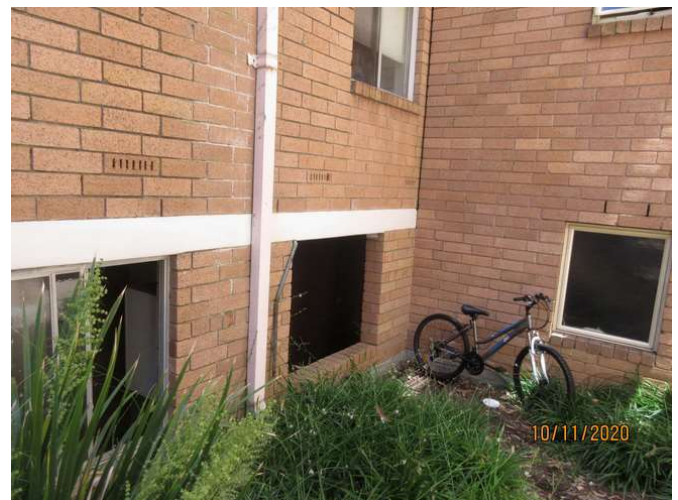
No 3_135_Note the cracking damage

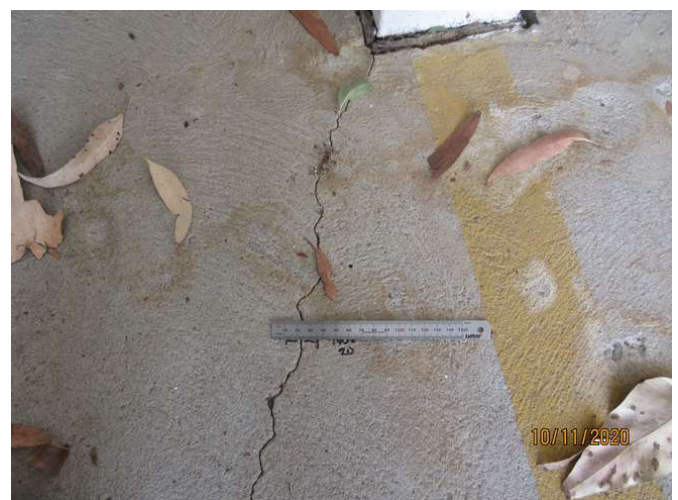
No 5_161_Note an estimated 1.5mm cracking width at representative location

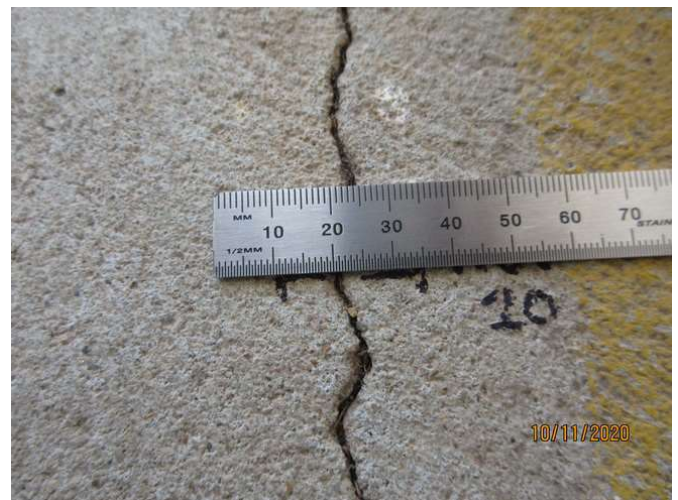
No 5_226_Note an estimated 1.0mm cracking width at representative location

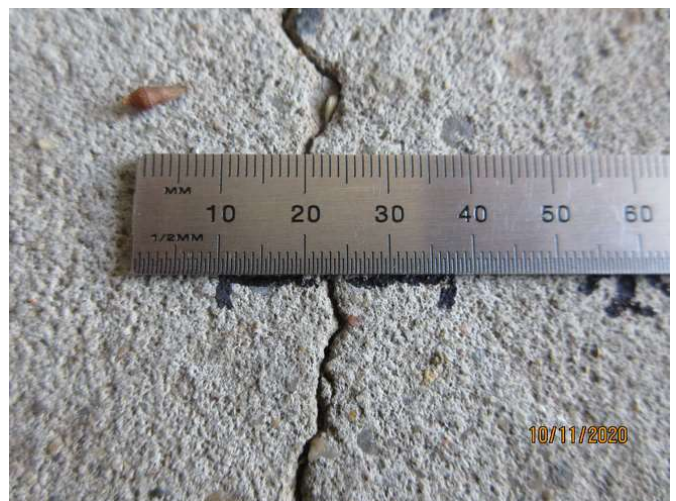
No 5_240_Note an estimated 1.5mm cracking width at representative location

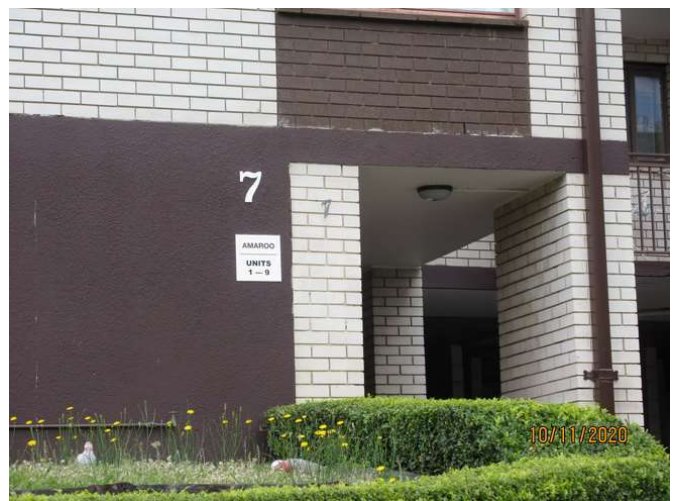
No 7_011_Note cracking damage

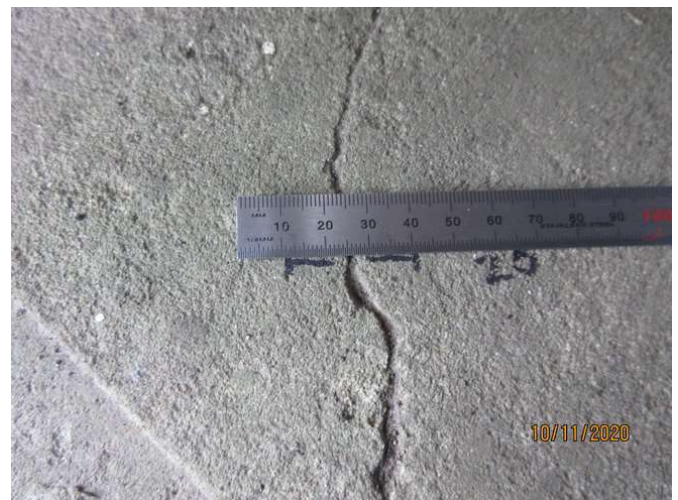
No 7_244_Note an estimated 1.0mm cracking width at representative location
