## **Site Audit Report**

**Ivanhoe Estate  
145 Herring Road  
Macquarie Park, NSW 2113**

**Final Report**

Report Reference: 600184\_0301-2126

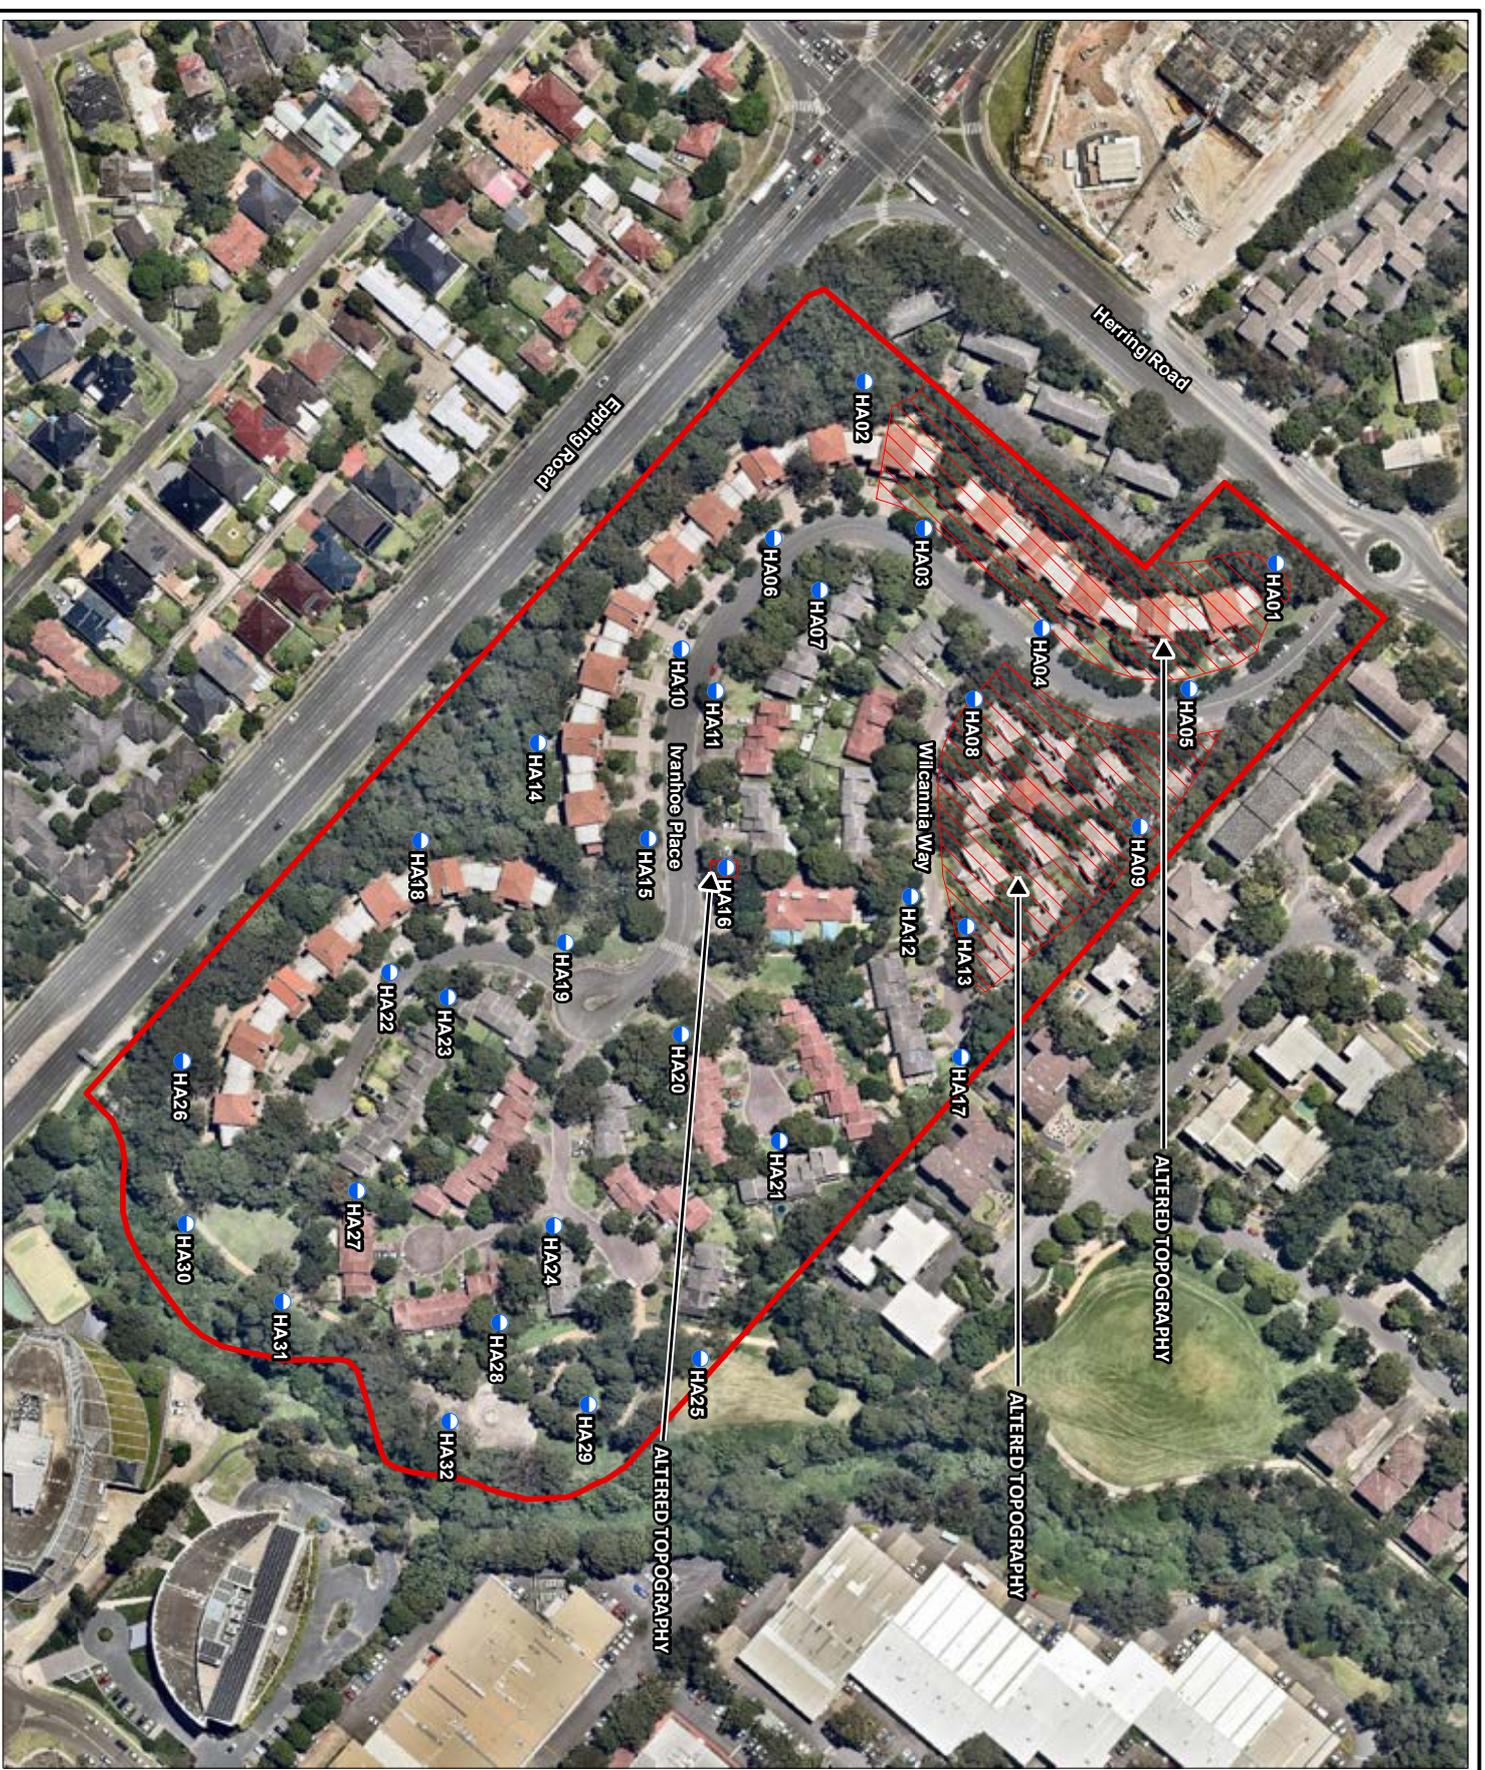
**Appendix C:**  
**JBS&G Detailed Site Investigation Location Plans**

**Legend:**  
 Approximate Site Boundary  
 Areas of Environmental Concern  
 Sample Location

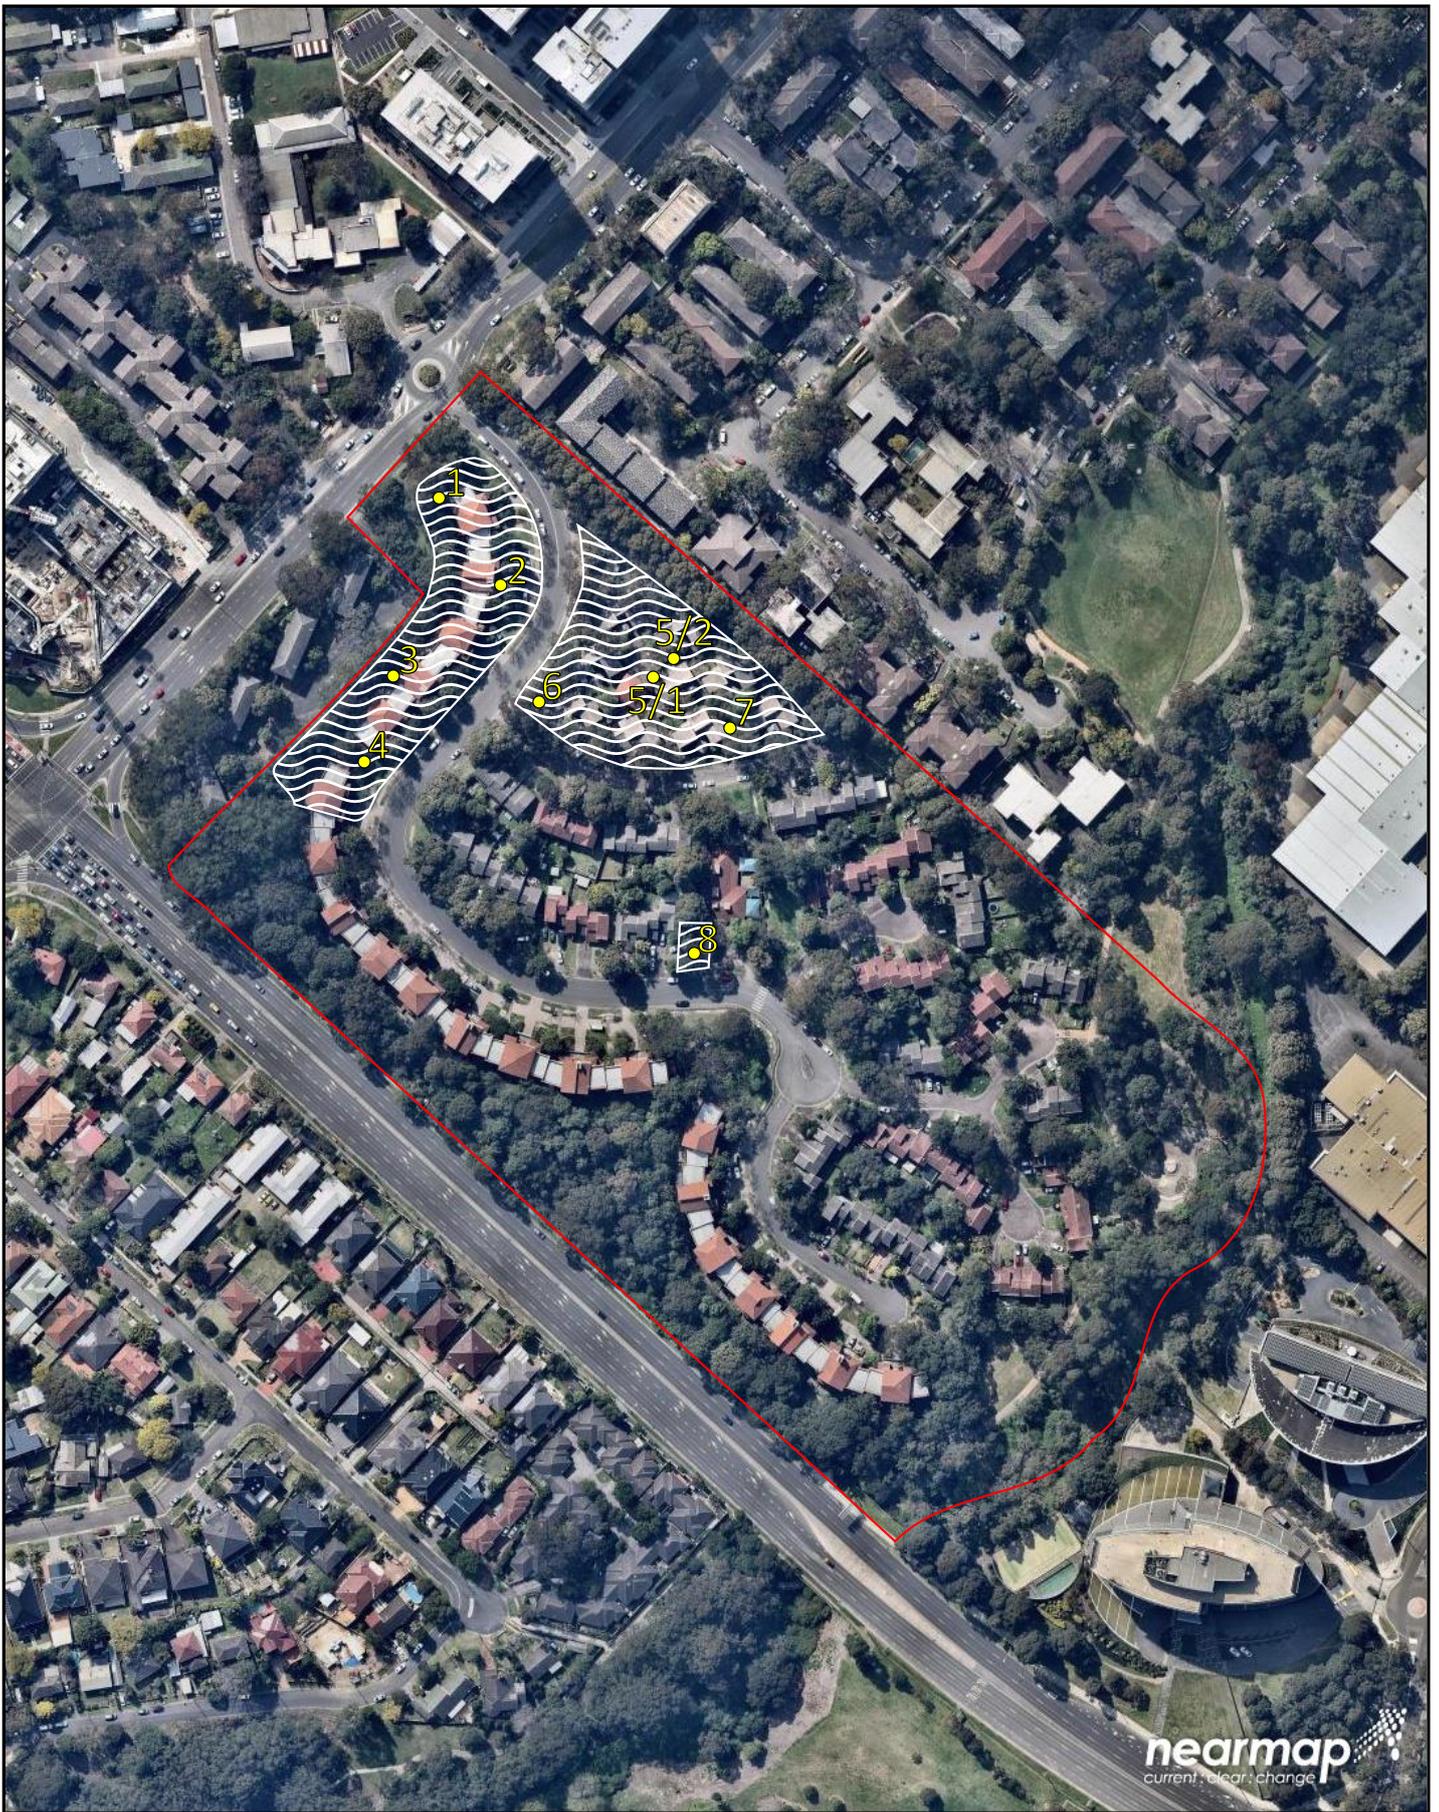
**Appendix E:  
DLA (DLA, 2017a) Supplementary Site Investigation  
Location Plans**

- Site Boundary
- Sample Locations (approximate)
- Altered Topography Areas

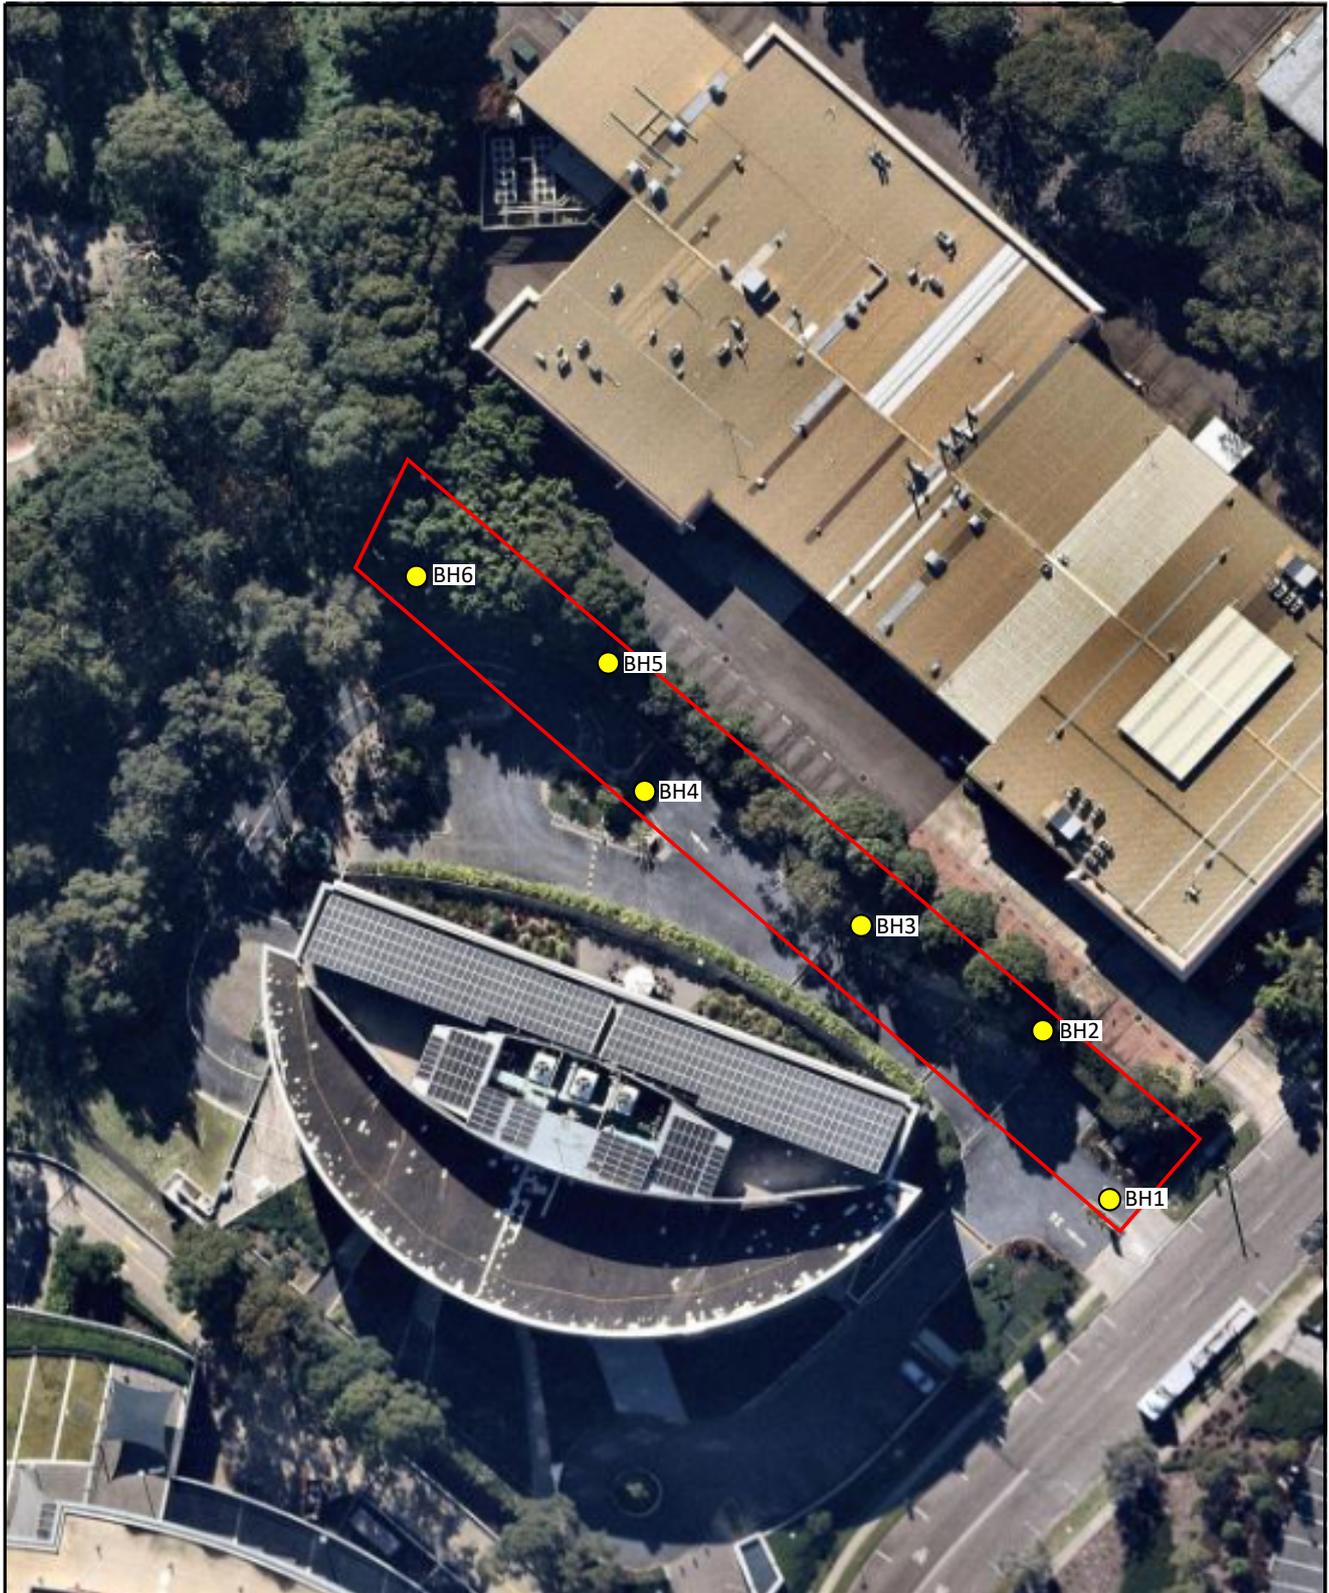
**Appendix G:  
DLA (DLA, 2017b) Supplementary Site Investigation Sample  
Location Plan**

- Approximate Site Boundary
- Sample Locations (approximate)
