GEOTECHNICAL SITE CLASSIFICATION

LOT 202

FIVE FARMS ESTATE STAGE 2, CLYDE NORTH

Report Reference: G4589.2

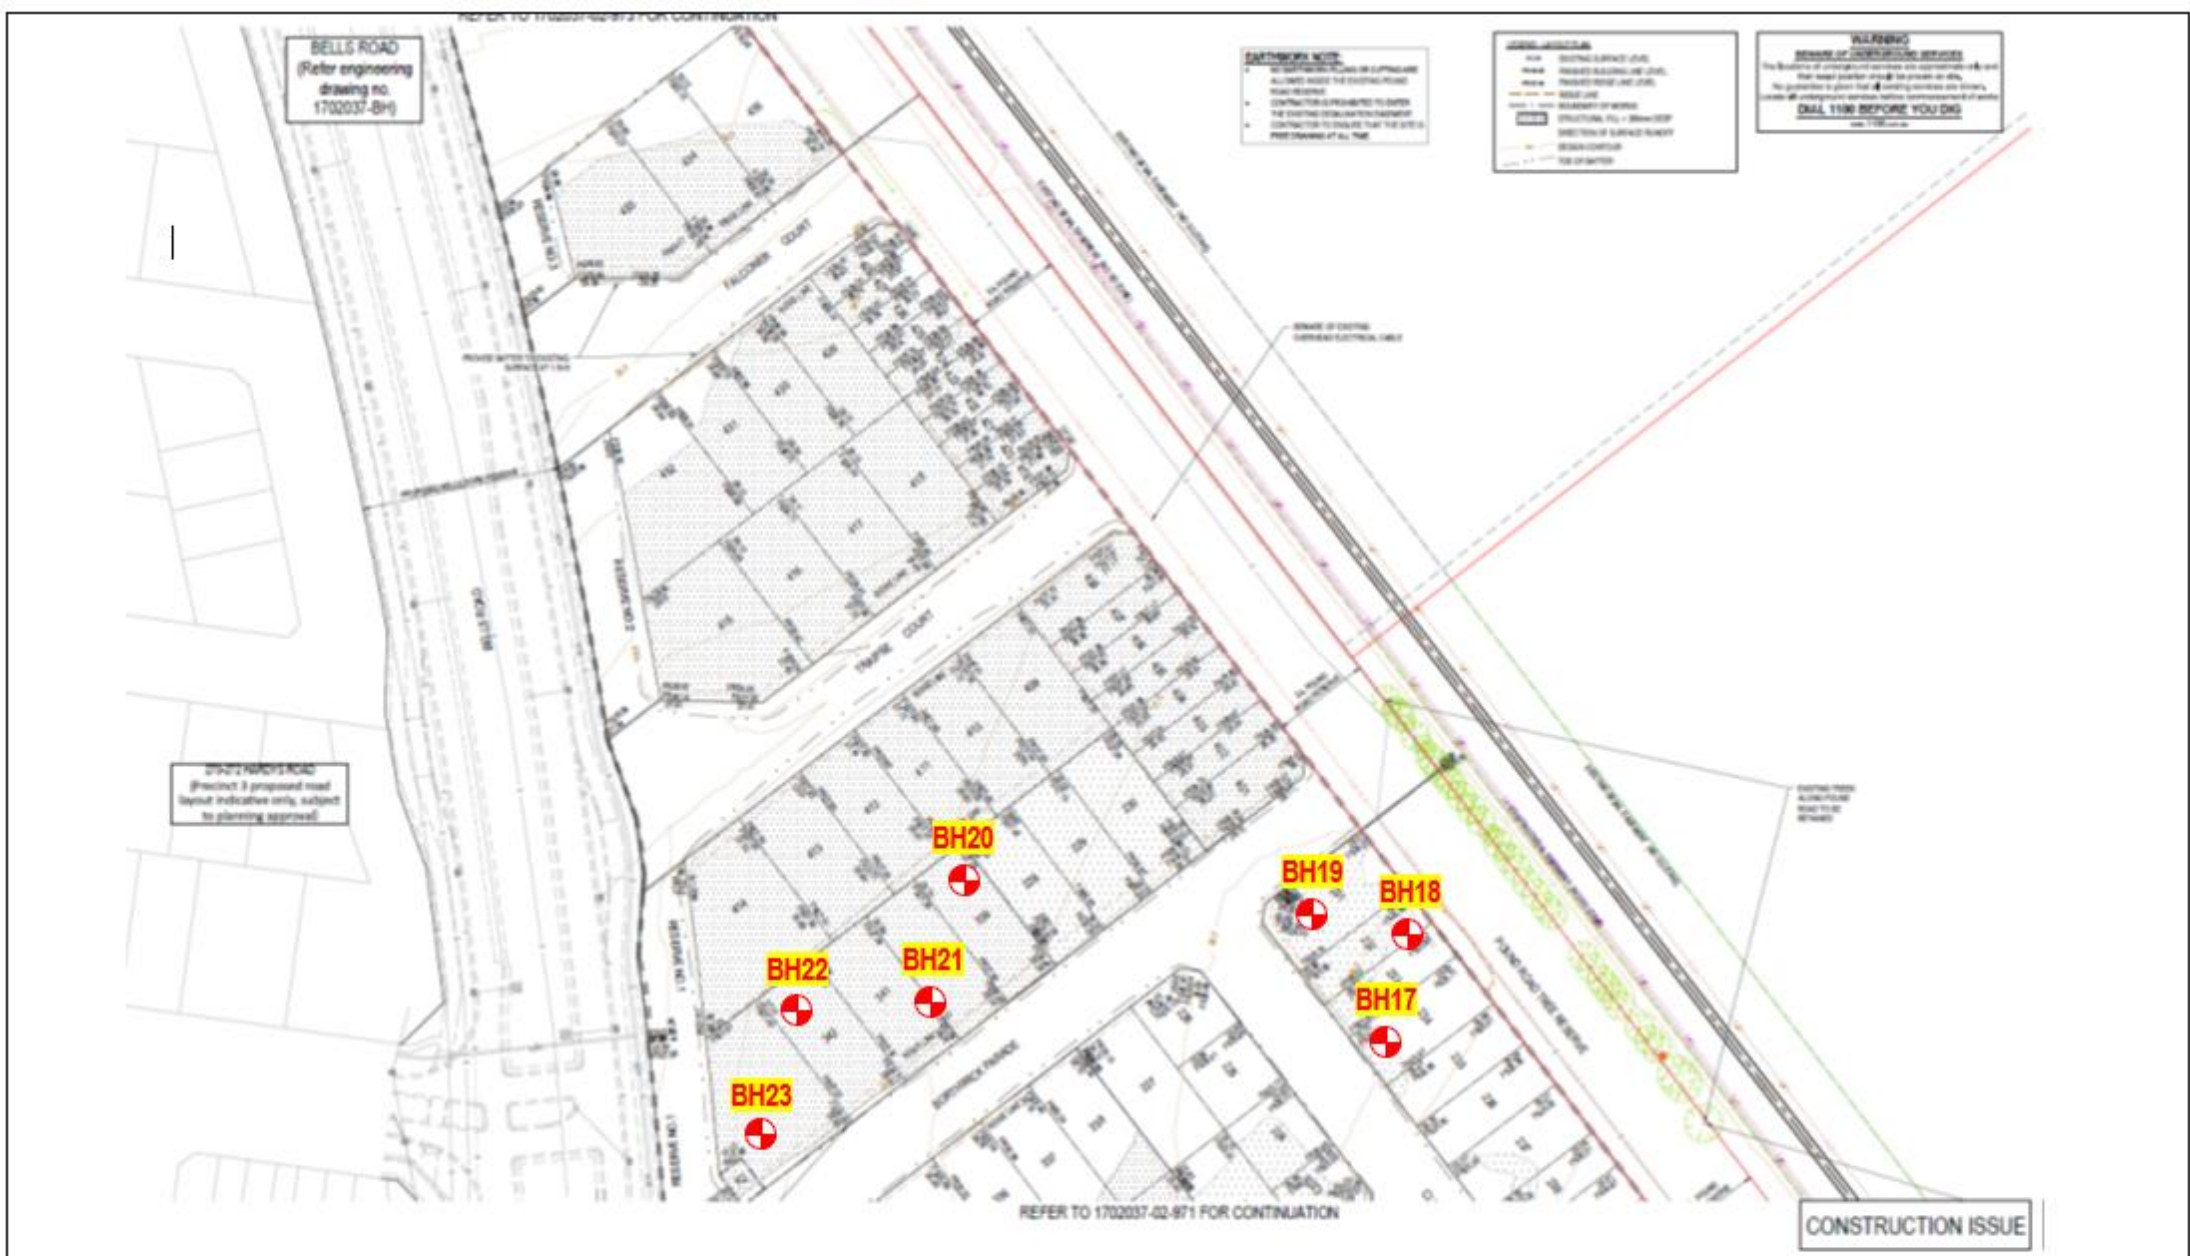
Rev	Drawn	Date	Checked	Scale
0	Figure 1 of 2: Borehole Locations	14.04.22	GS	NTS

**STAGE 2 & 3 BOREHOLE LOCATIONS
FIVE FARMS ESTATE, CLYDE NORTH**

Borehole locations are shown on the site plan in **Appendix A**. Engineering borehole log sheets for this allotment and surrounding allotments are presented in **Appendix B**. Laboratory test reports are presented in **Appendix C**.

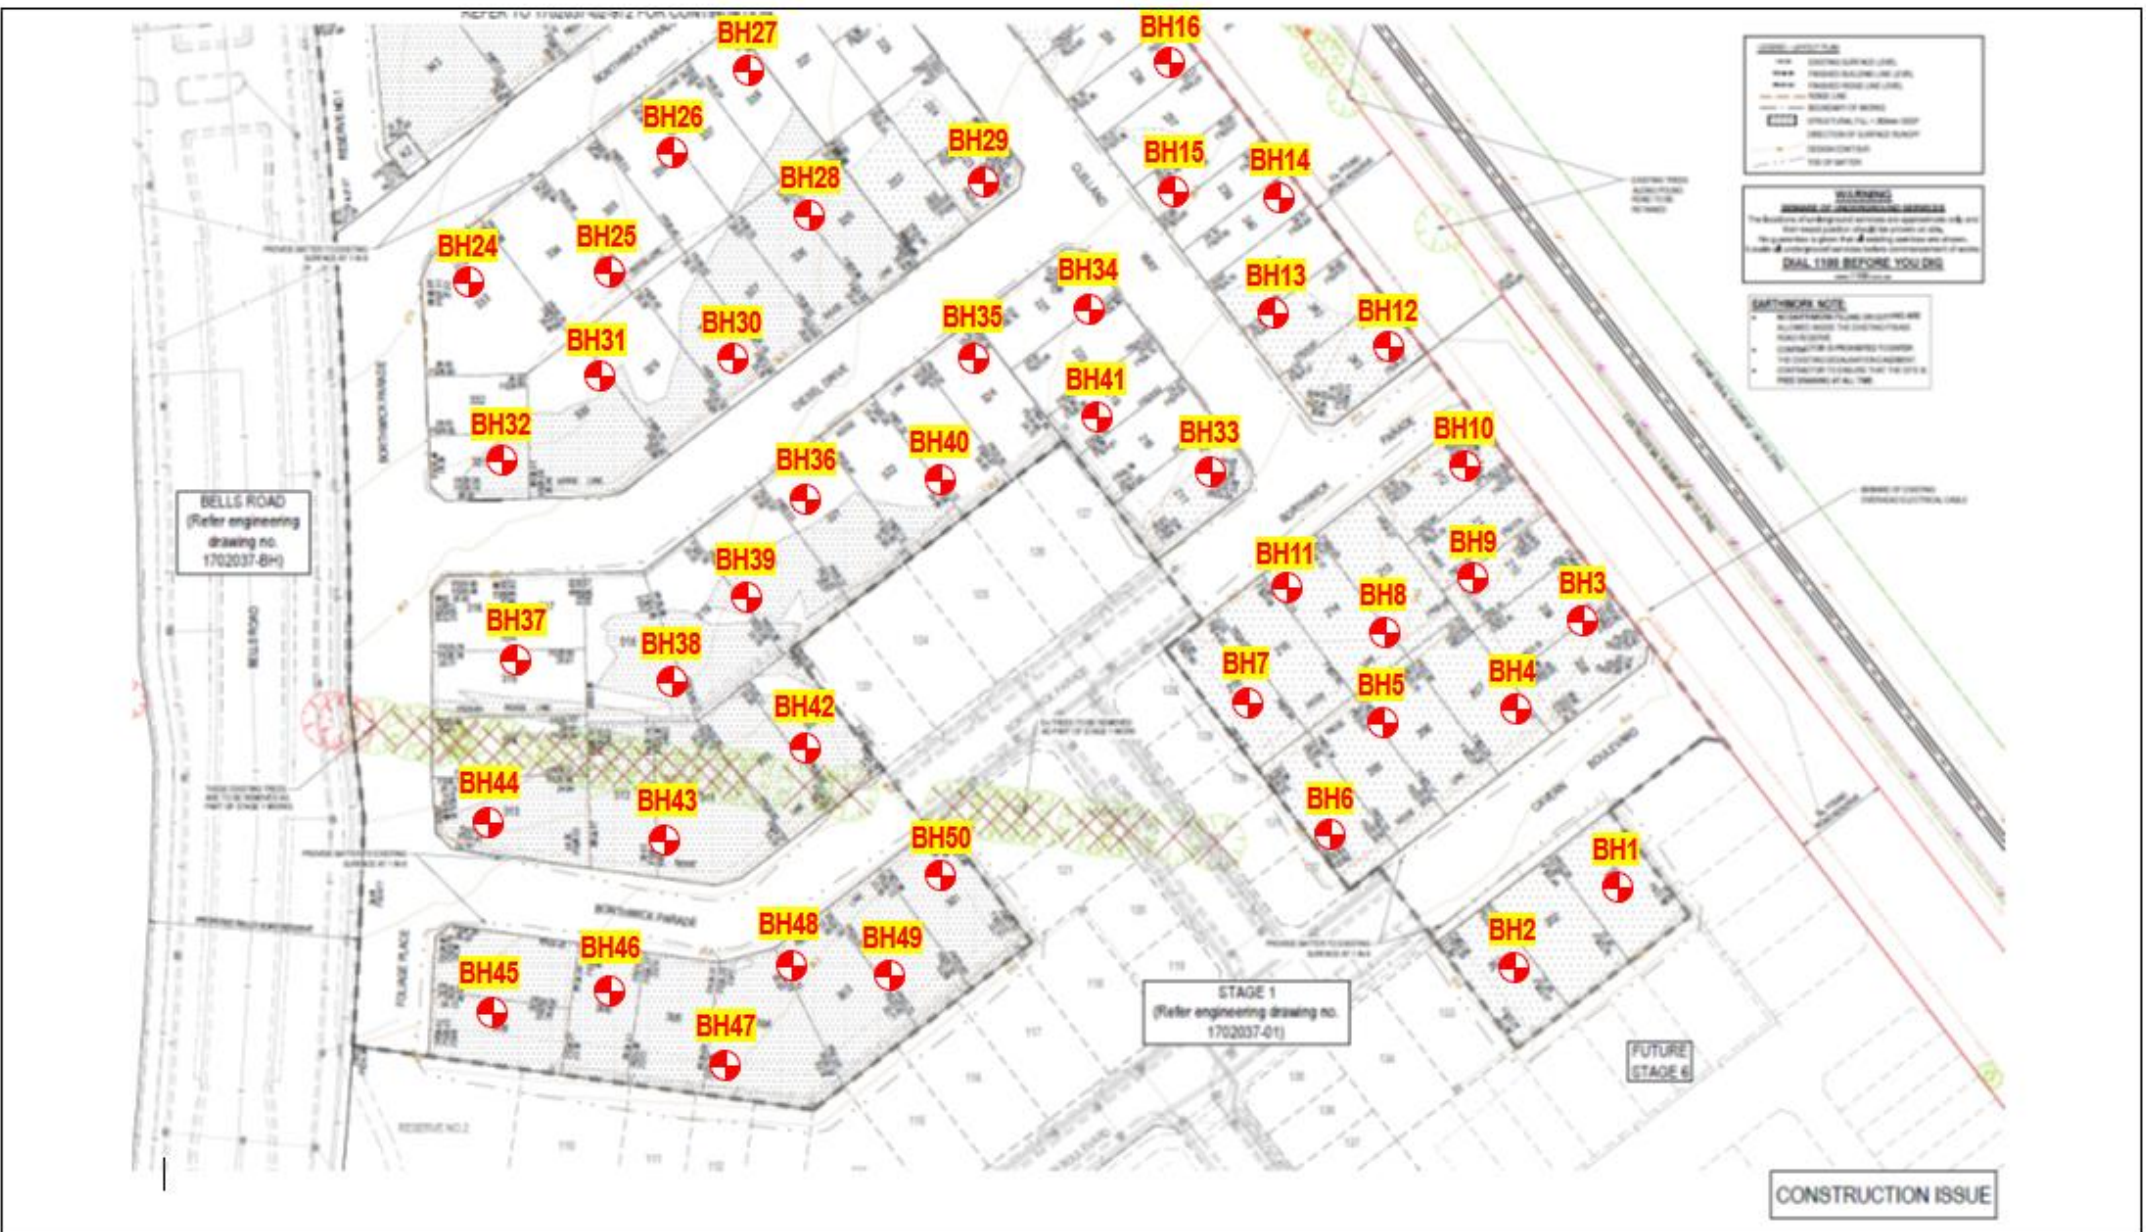
**STAGE 2 & 3 BOREHOLE LOCATIONS
FIVE FARMS ESTATE, CLYDE NORTH**
