SURVEILLANCE

AND INSPECTION REPORT

Project Name: Mambourin Estate Stage 15

Date: 30th of June 2022

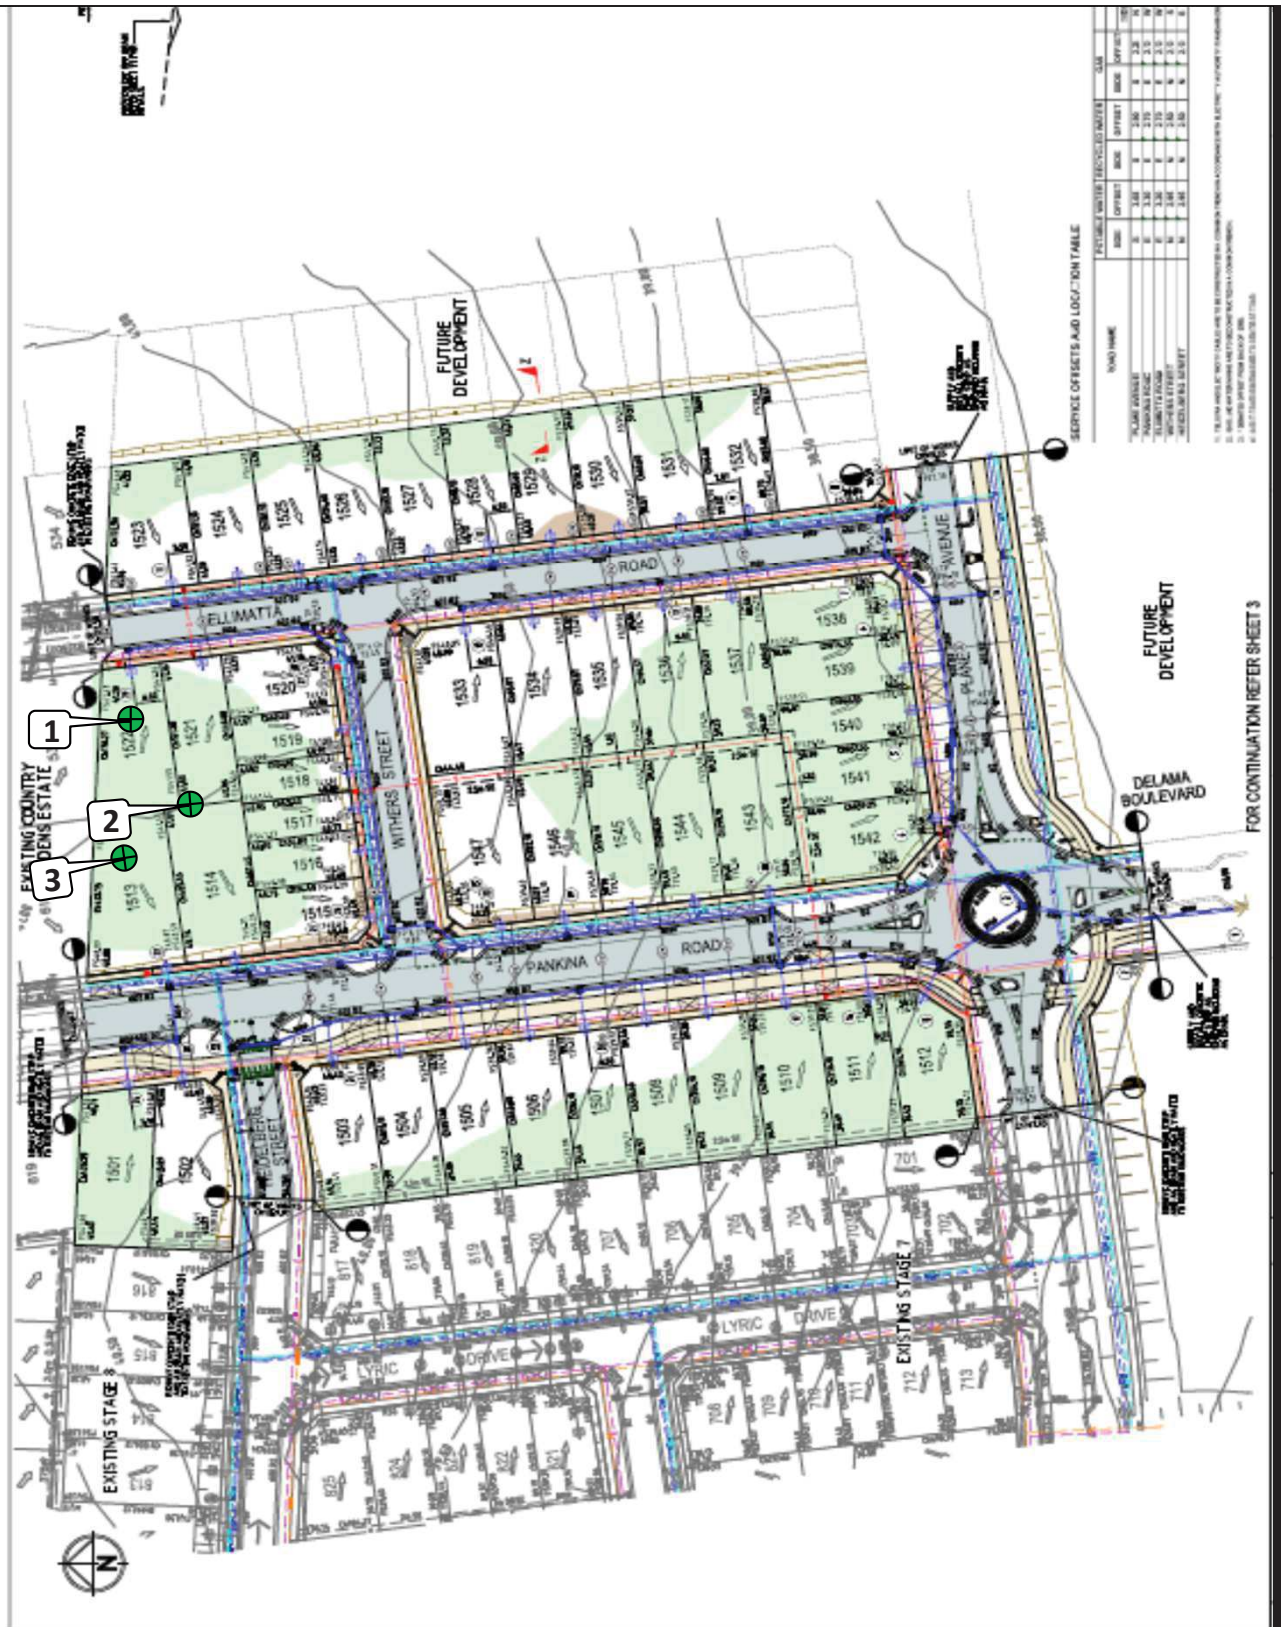
Sketch indicating compaction test locations

LOCATION: SYMON BROS - Mambourin Stage 15

NOTES: Clayey Fill Ex. Onsite
