**Frasers Property**  
**Level 1 Inspection and Testing Report, Stage 1, Mambourin Estate**  
**754-MELGE221991AD**

# Level 1 Inspection and Testing Report, Stage 1, Mambourin Estate

Prepared for  
Frasers Property

Our Ref: 754-MELGE221991AD Rev 1

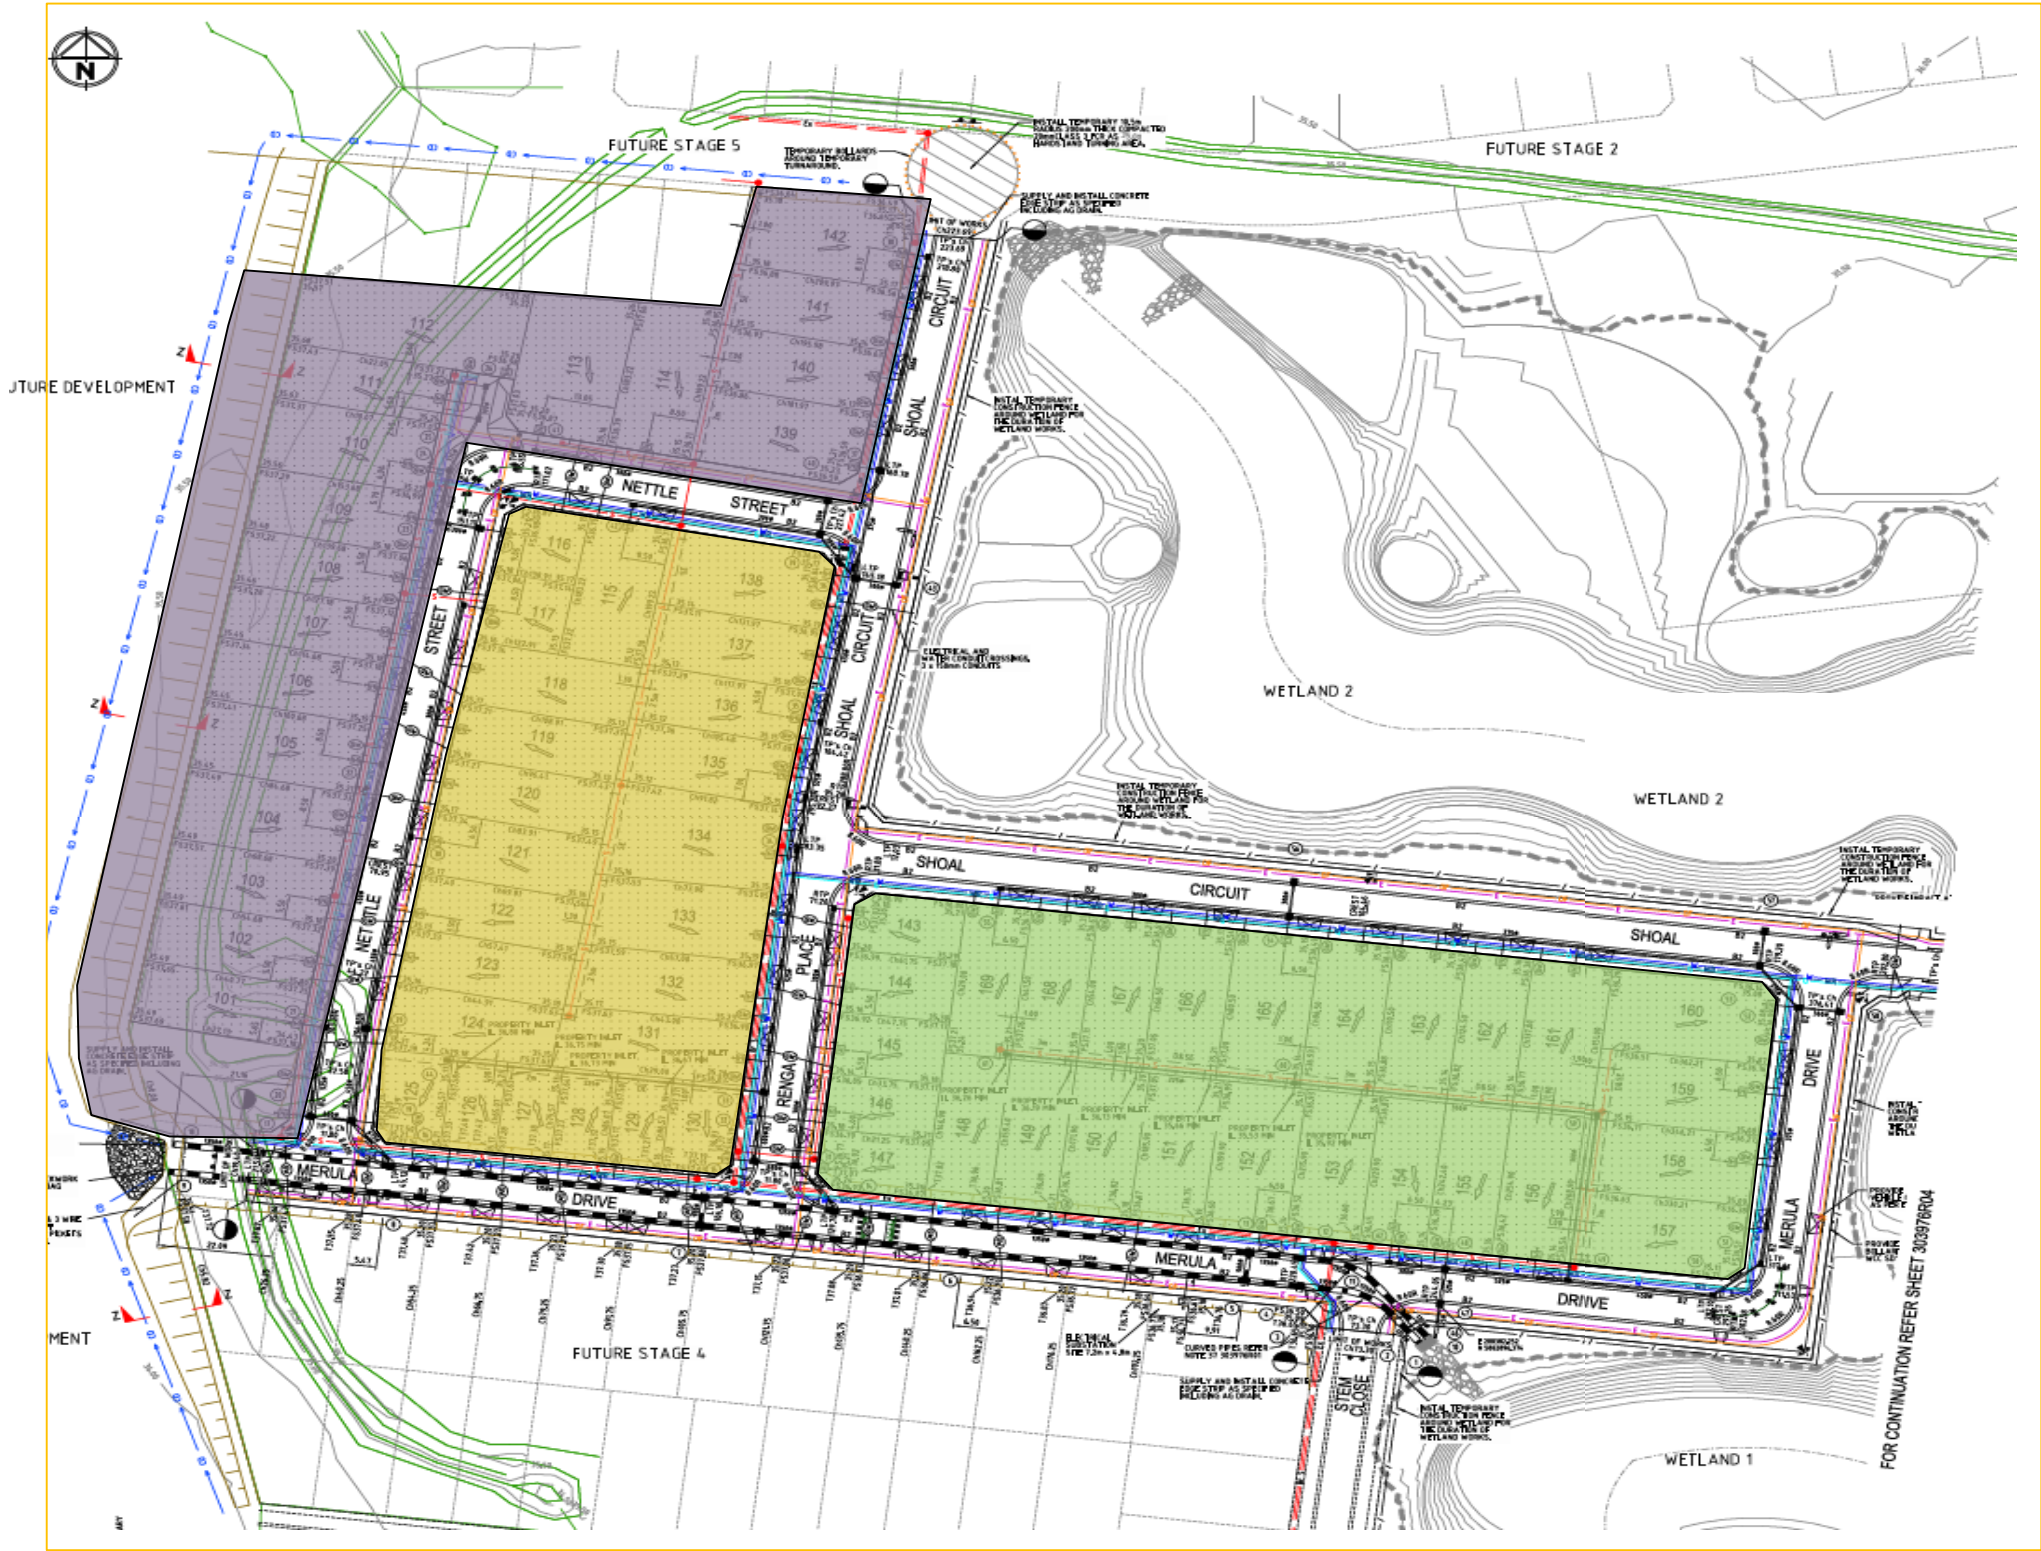
| project no: | 754-MELGE 221991 AD | figure no: 1 |

- Eastern Pad
- Central Pad
- Western Pad (incl. batters to west)

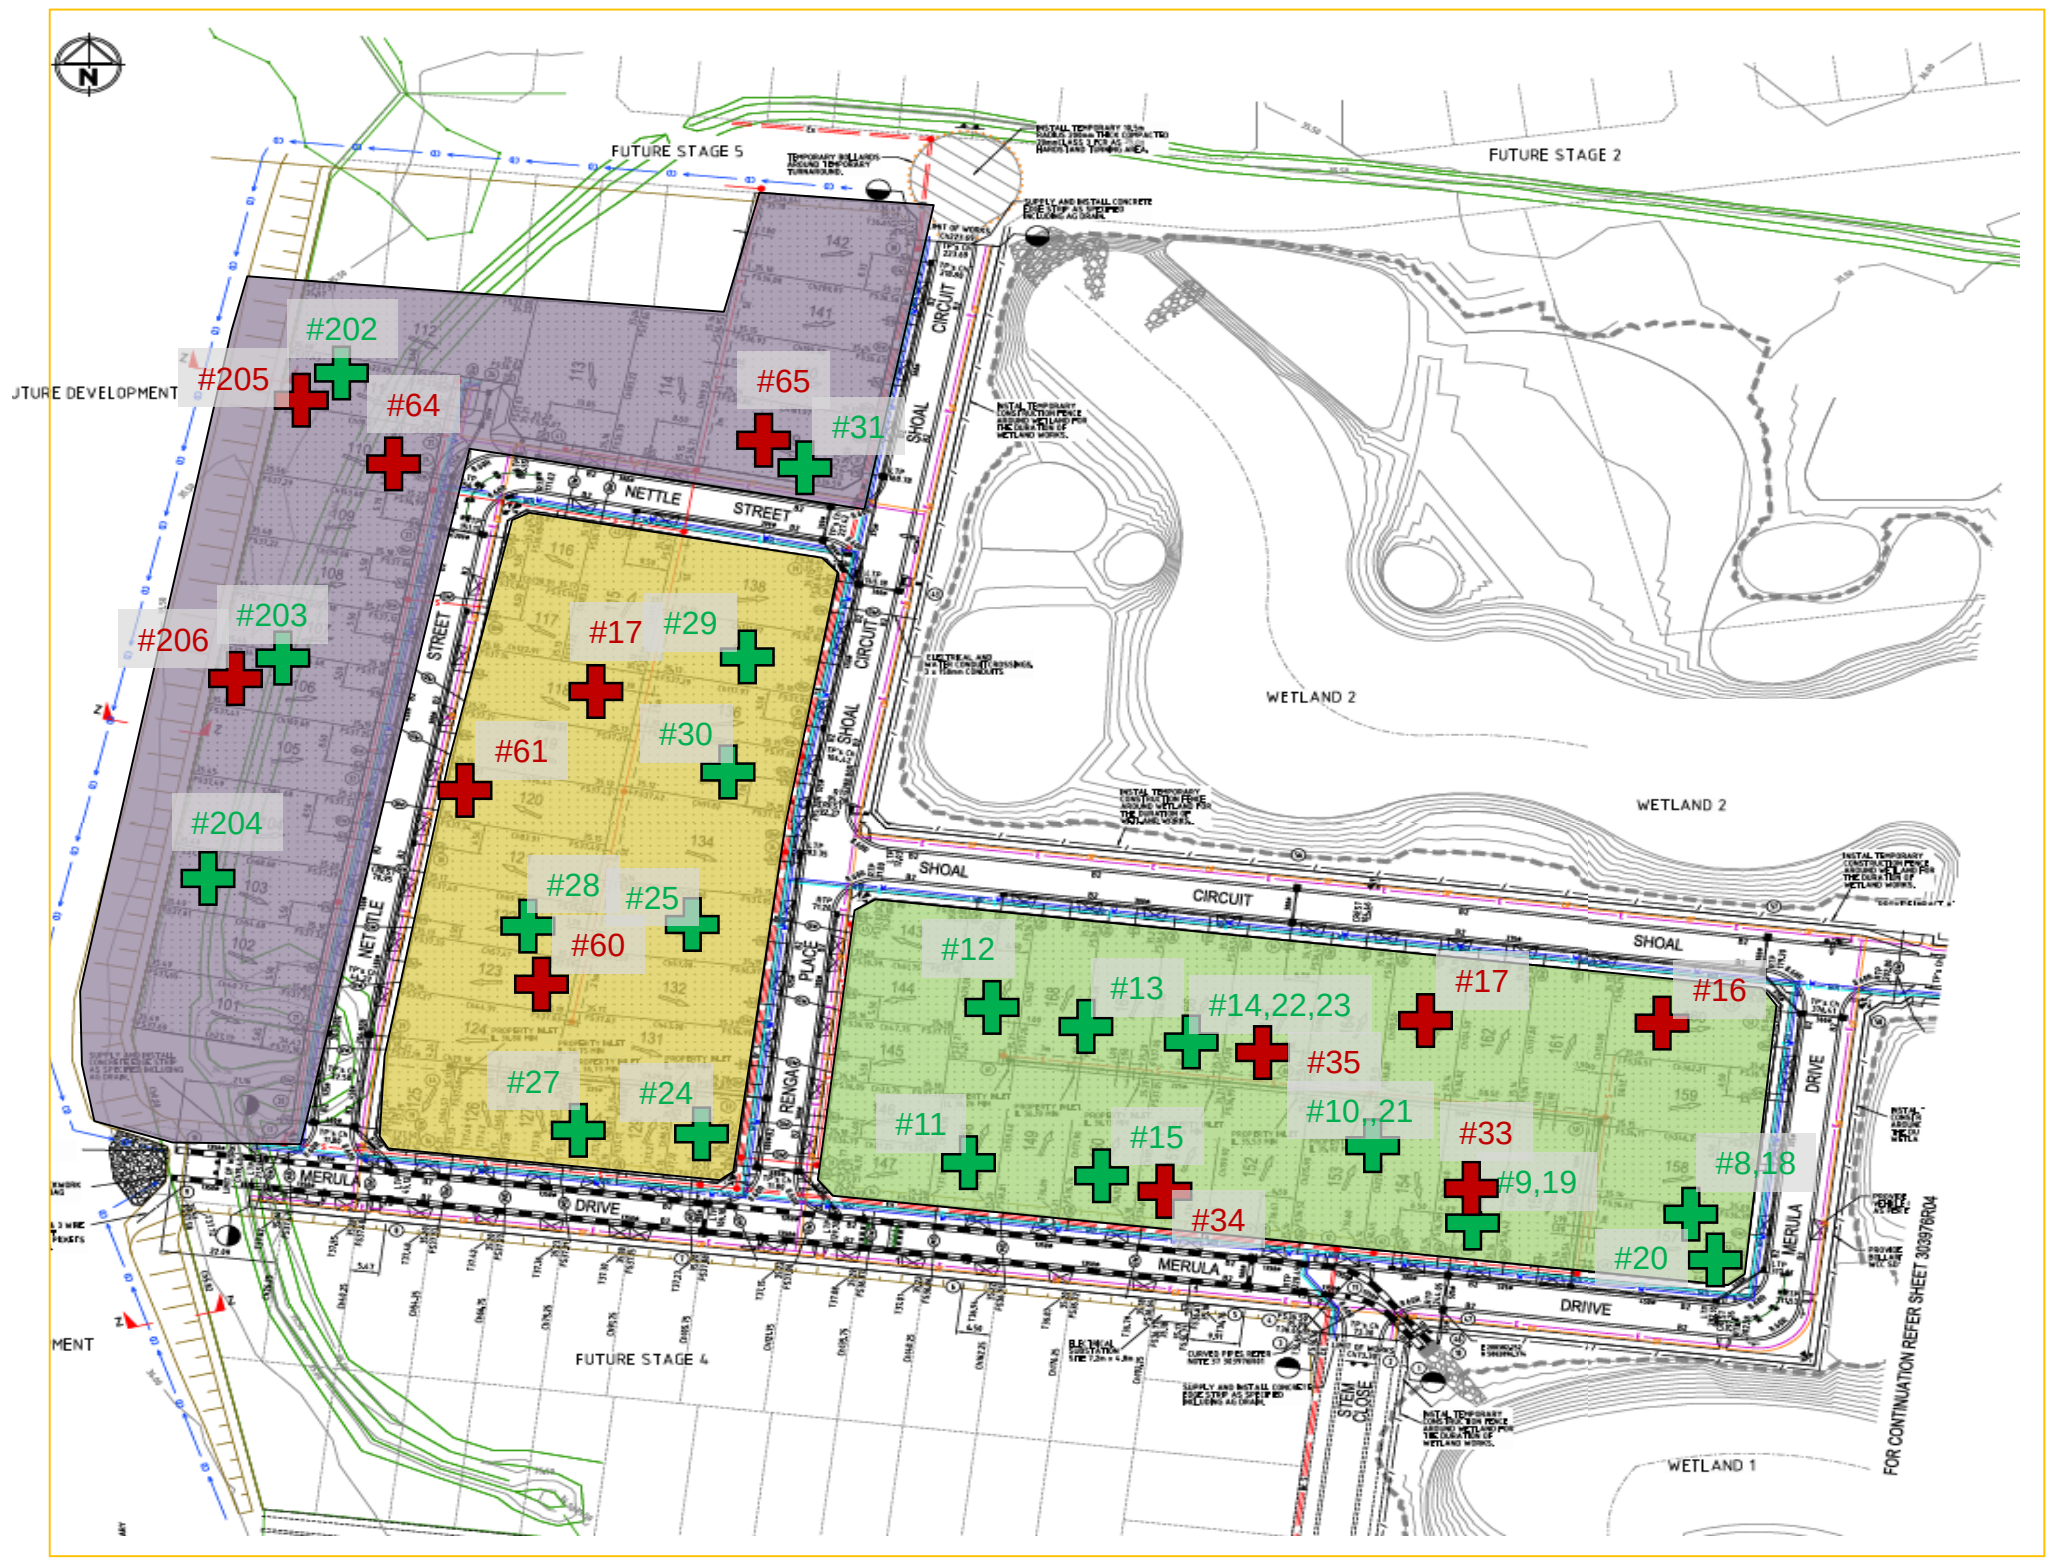
| project no: | 754-MELGE 221991 AD | figure no: 2 |

A total of 133 density tests were performed during the earthworks in the locations as presented in Figures 2 and 3. Of the 133 tests, 17 did not meet the specified criteria. These areas were subsequently re-worked and re-tested. Once re-tested, the 17 test results met the specified dry density ratio criteria of 95% Standard compactive effort and moisture variation of  $\pm 3\%$  of the Optimum Moisture Content (OMC).

- Eastern Pad
- Southern Pad
- Western Pad (incl. batters to west)
