**Frasers Property**  
**Level 1 Inspection and Testing Report, Stage 3, Mambourin Estate**  
**754-MELGE221991AG**

21 April 2020

# Level 1 Inspection and Testing Report, Stage 3, Mambourin Estate

Prepared for  
Frasers Property

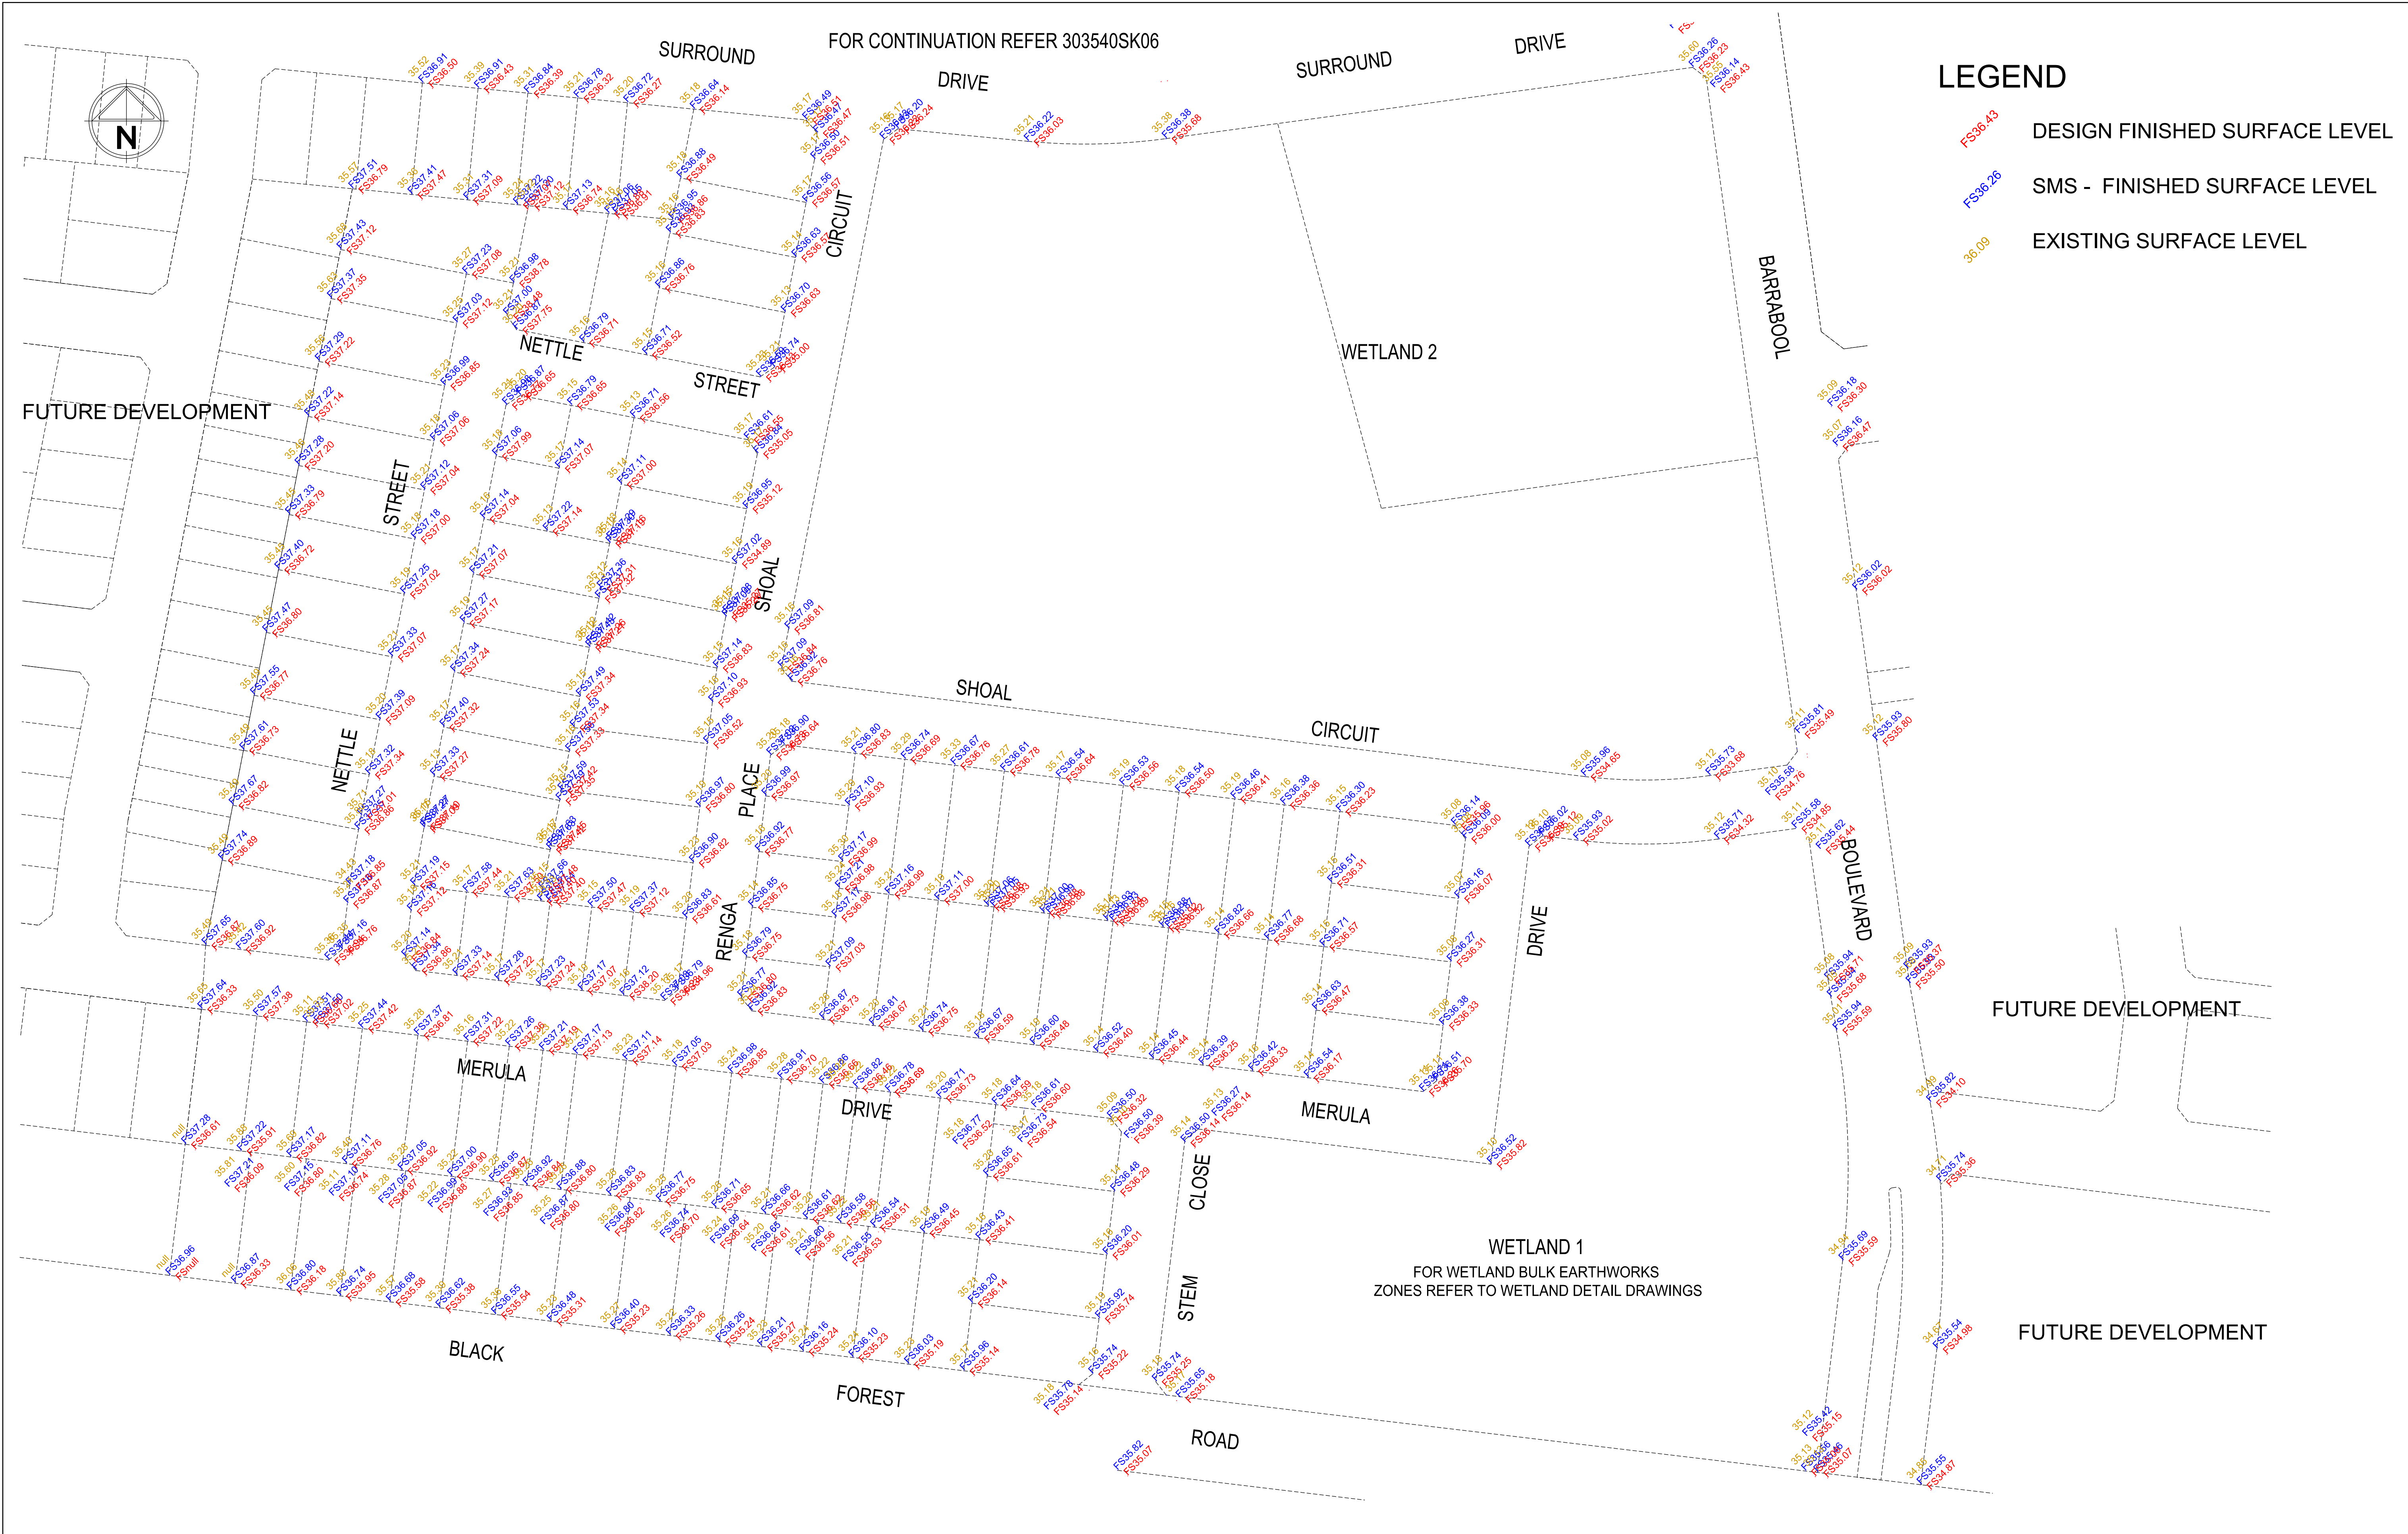
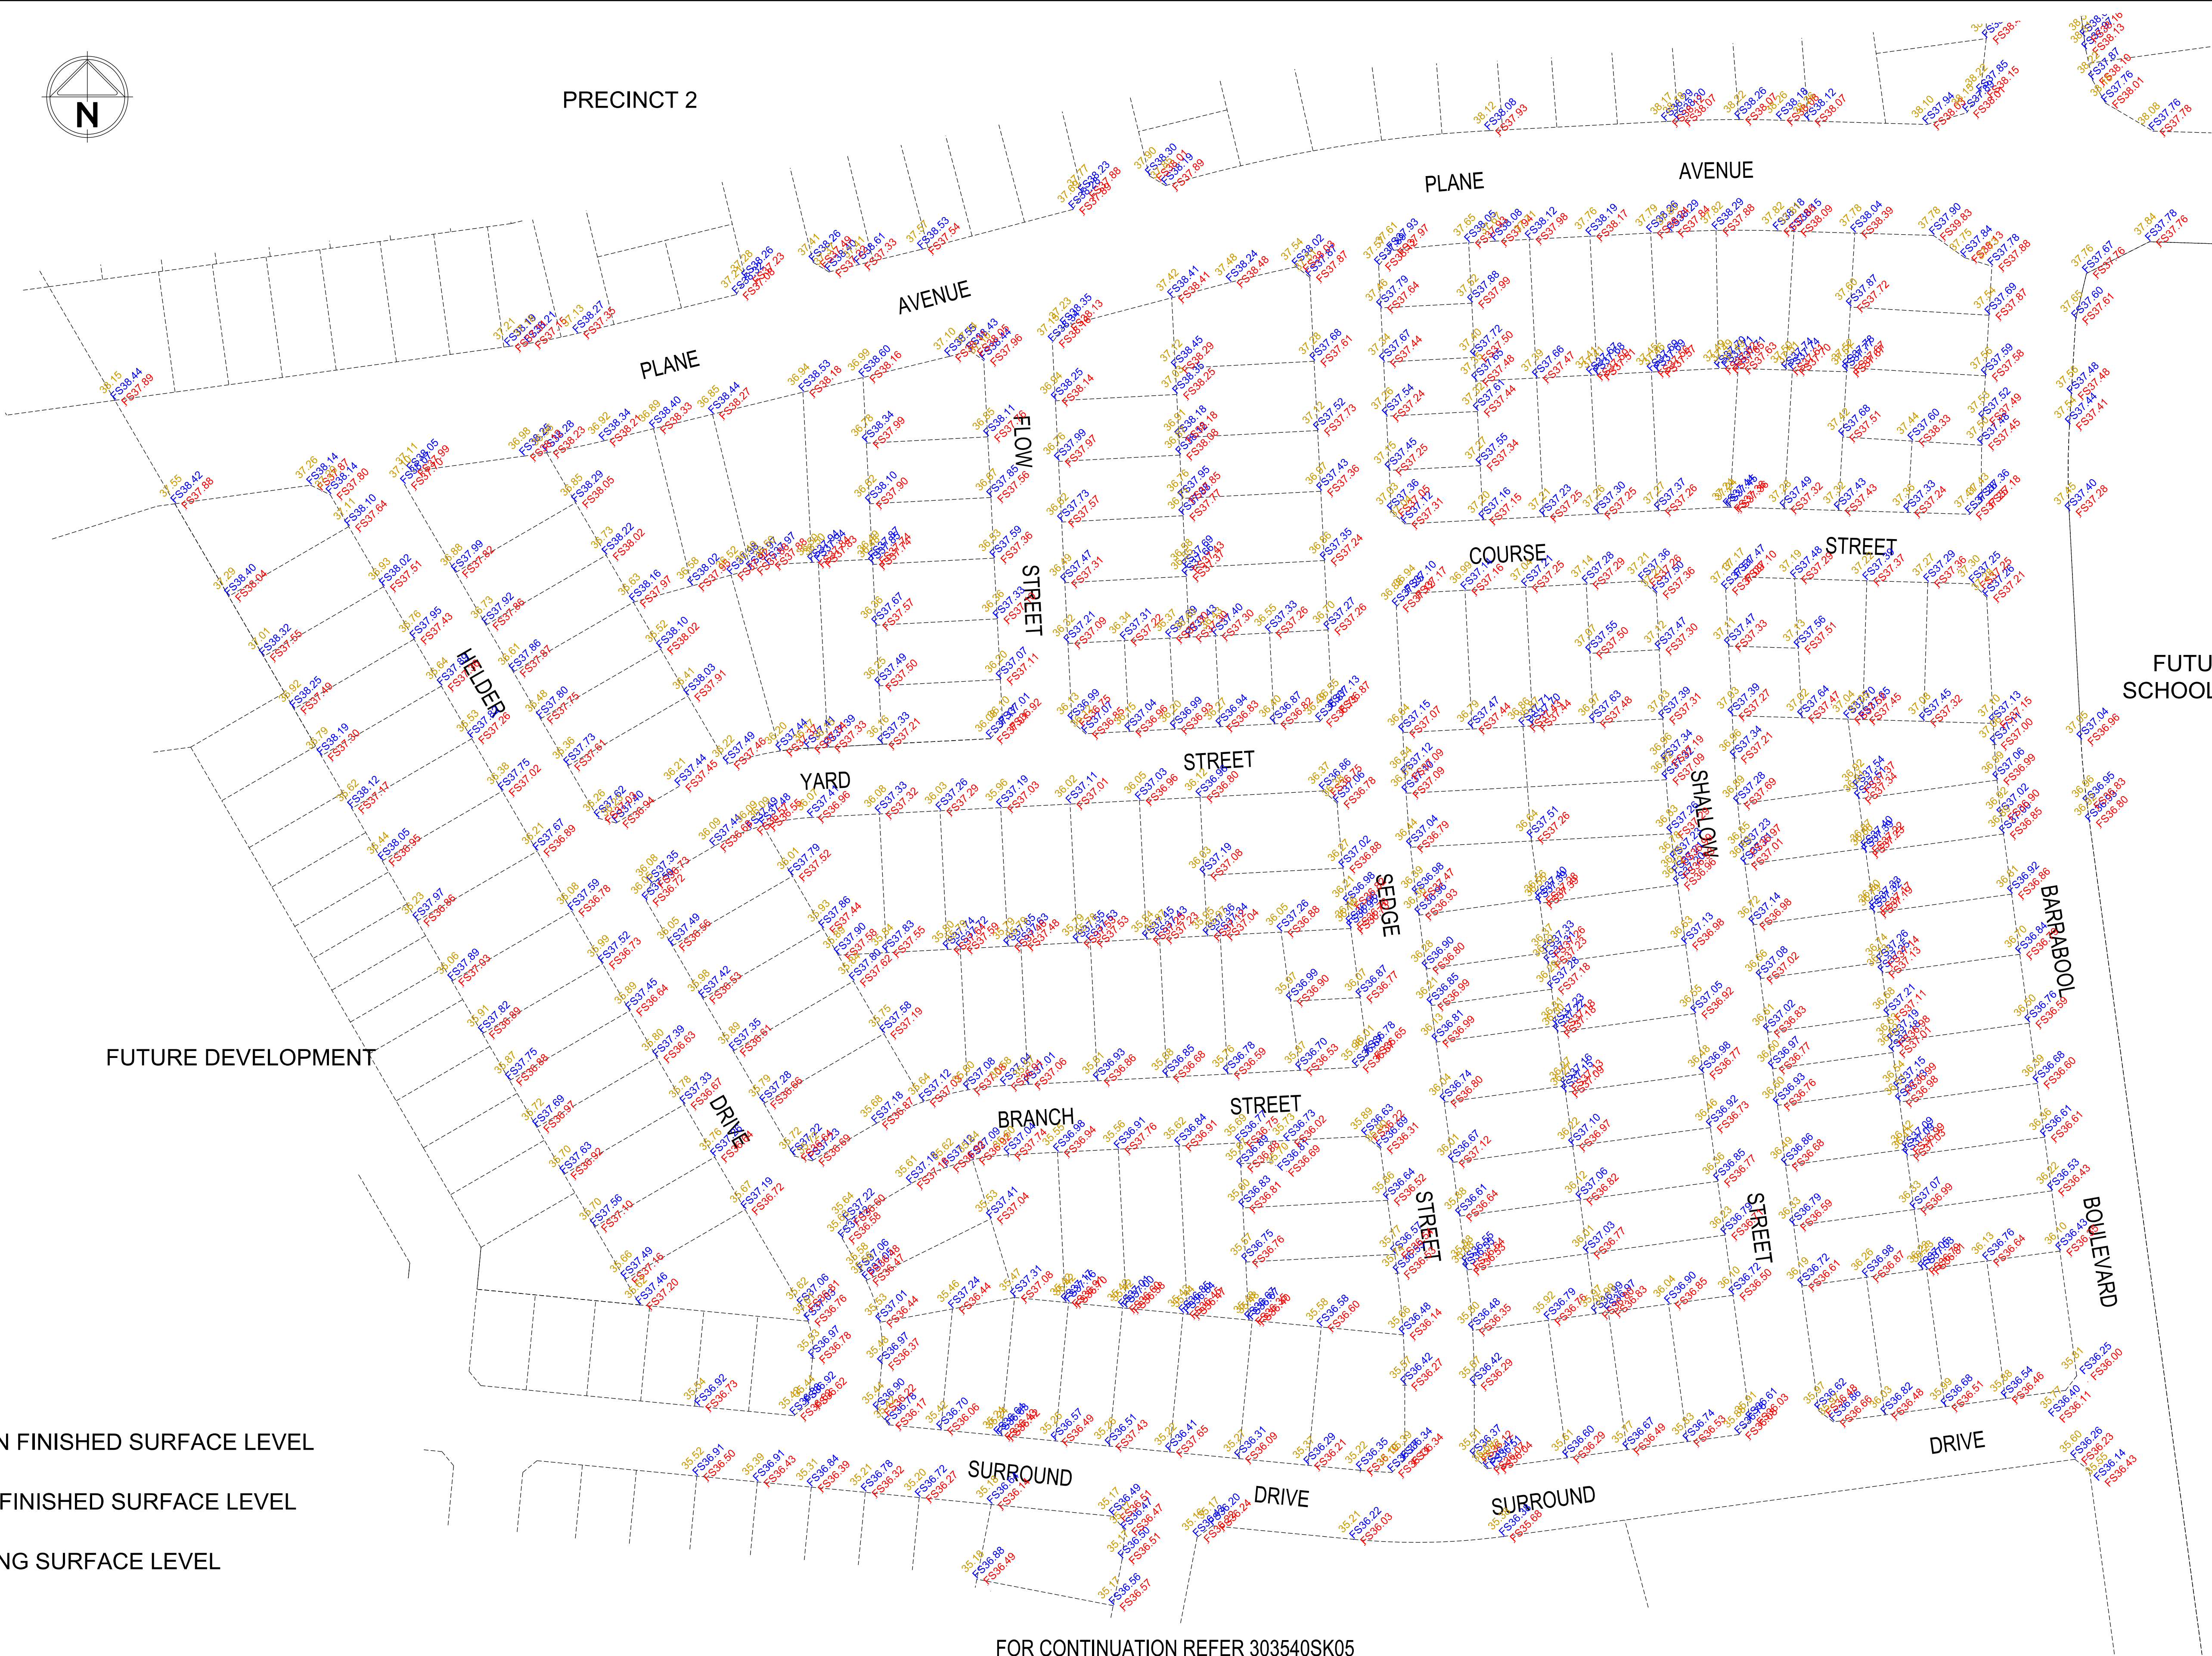
## **Appendix B – Survey Drawings**

Spiire Australia Pty Ltd (Spiire) have provided us with a copy of a survey showing the levels of the stripped and finished surfaces of Precinct 1 of Mambourin Estate. Precinct 1 includes Stage 1 to 5 of the project.

Coffey personnel have provided Level 1 inspection and testing services during the construction of the engineered fill areas within Stage 3 of Mambourin Estate as shown in SMS survey drawing in Appendix B. A geotechnical professional from Coffey (Level 1 Inspector) was on site on a full-time basis during the construction of the engineered fill platforms and observed the construction techniques adopted for the dates noted in section 2 of this report.
