SURVEILLANCE

AND INSPECTION REPORT

Client Name: Symon Bros. Constructions Pty Ltd

Project Name: The Grove West Stage 66

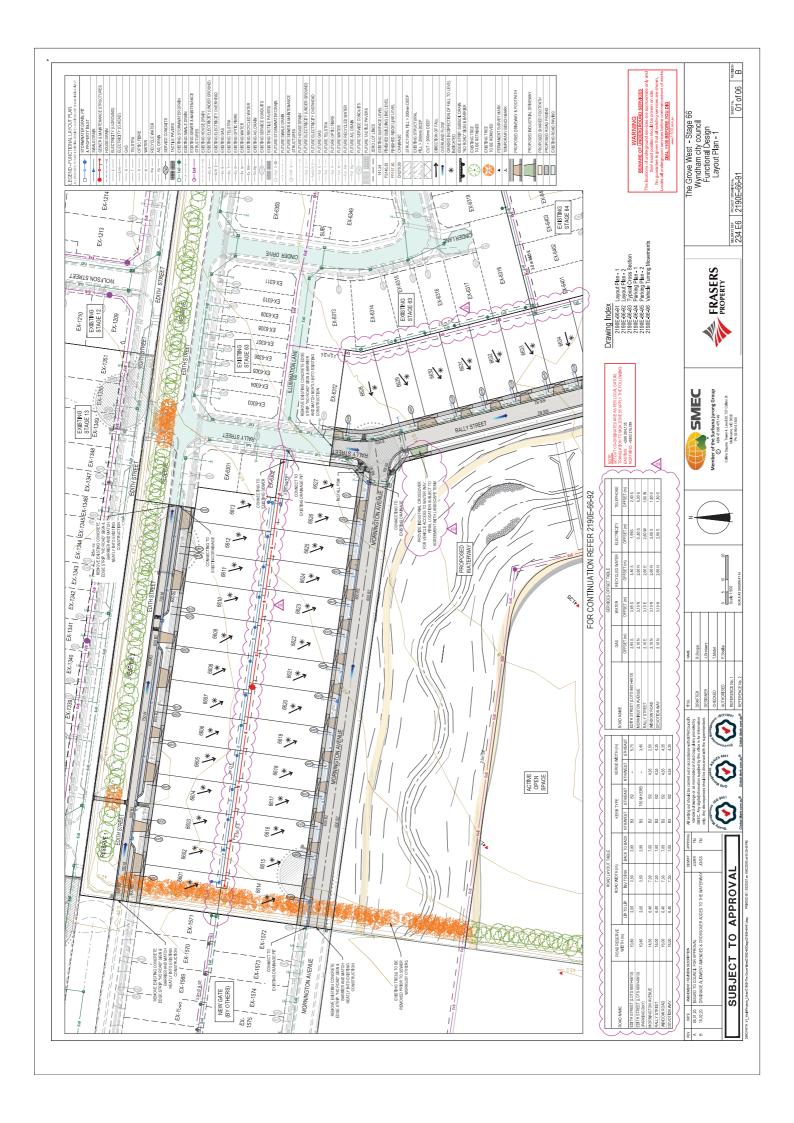
Appendix A Construction Drawings

(1) Road & Drainage Layout Plan Drawing No. 2190E-66-91 – Rev B.

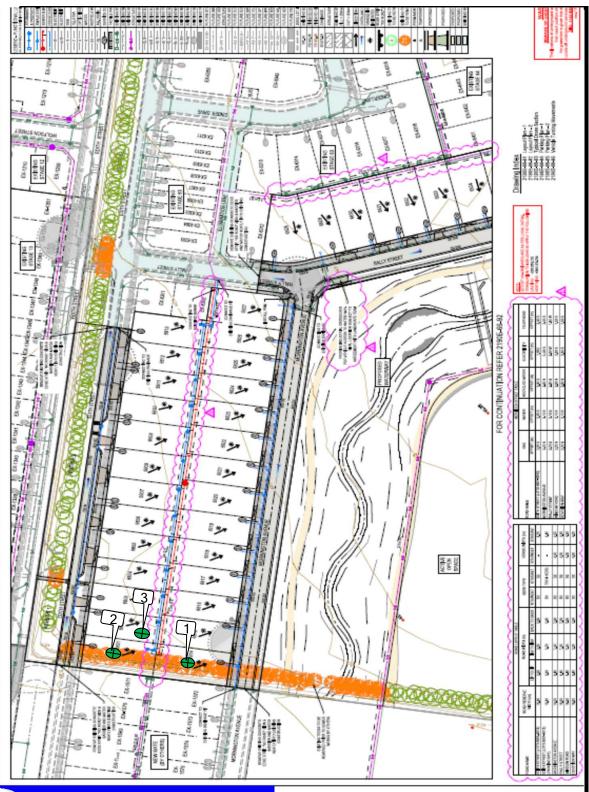
Sketch indicating compaction test locations

DATE: 28/06/2021	JOB No.: 2305/301
OPERATOR: DB	CHECKED: KK
SCALE: NTS	FIGURE No: -

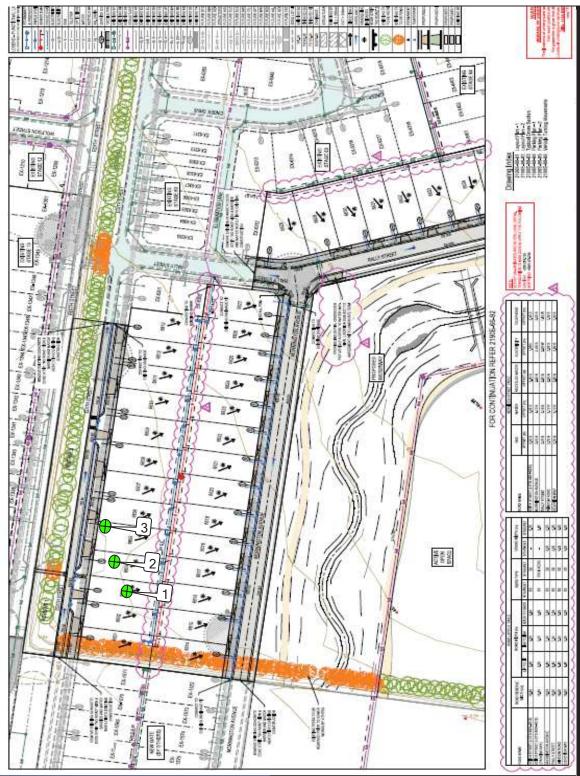
Sketch indicating compaction test locations

DATE: 29/06/2021	JOB No.: 2305/303
OPERATOR: DB	CHECKED: KK
SCALE: NTS	FIGURE No: -

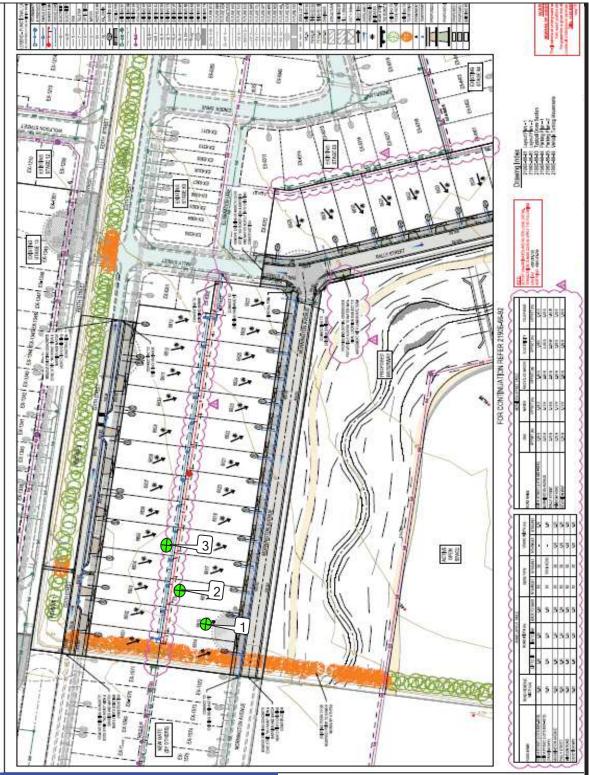
Sketch indicating compaction test locations

DATE: 30/06/2021	JOB No.: 2305/305
OPERATOR: DB	CHECKED: KK
SCALE: NTS	FIGURE No
