# GEOTECHNICAL SITE CLASSIFICATION LOT 221 FIVE FARMS ESTATE STAGE 2, CLYDE NORTH

Prepared for Frasers Property Australia c/- Beveridge Williams Pty Ltd

Report Reference: G4589.2

Date: 17 May 2022

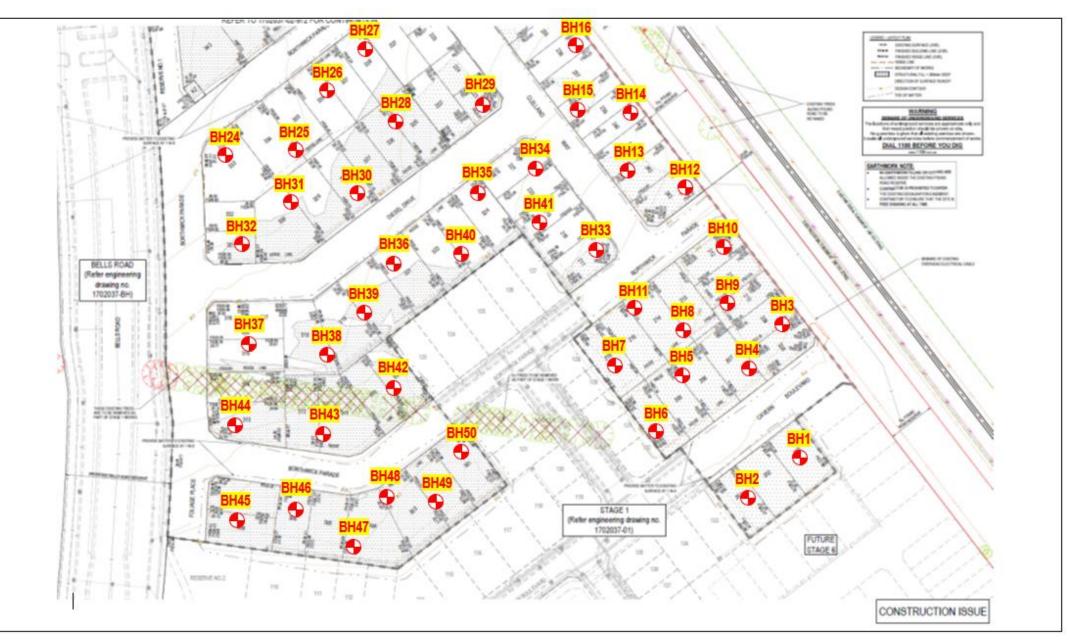
Rev		Drawn	Date	Checked	Scale	Legend		
					3	Approximate Borehole Location	STAGE 2 & 3 BOREHOLE LOCATIONS	
							FIVE FARMS ESTATE, CLYDE NORTH	
					6	_		
							Prepared For: Frasers Property Australia	Course IC in a
0	0 Figure 2 of 2: Proposed Boreholes		14.04.22	GS	NTS	<b>U</b>	Job No: G4589.2 & G4589.3	GroundScience
