Frasers Property Level 1 Inspection and Testing Report, Stage 4, Mambourin Estate 754-MELGE221991AH

15 June 2020

Level 1 Inspection and Testing Report, Stage 4, Mambourin Estate

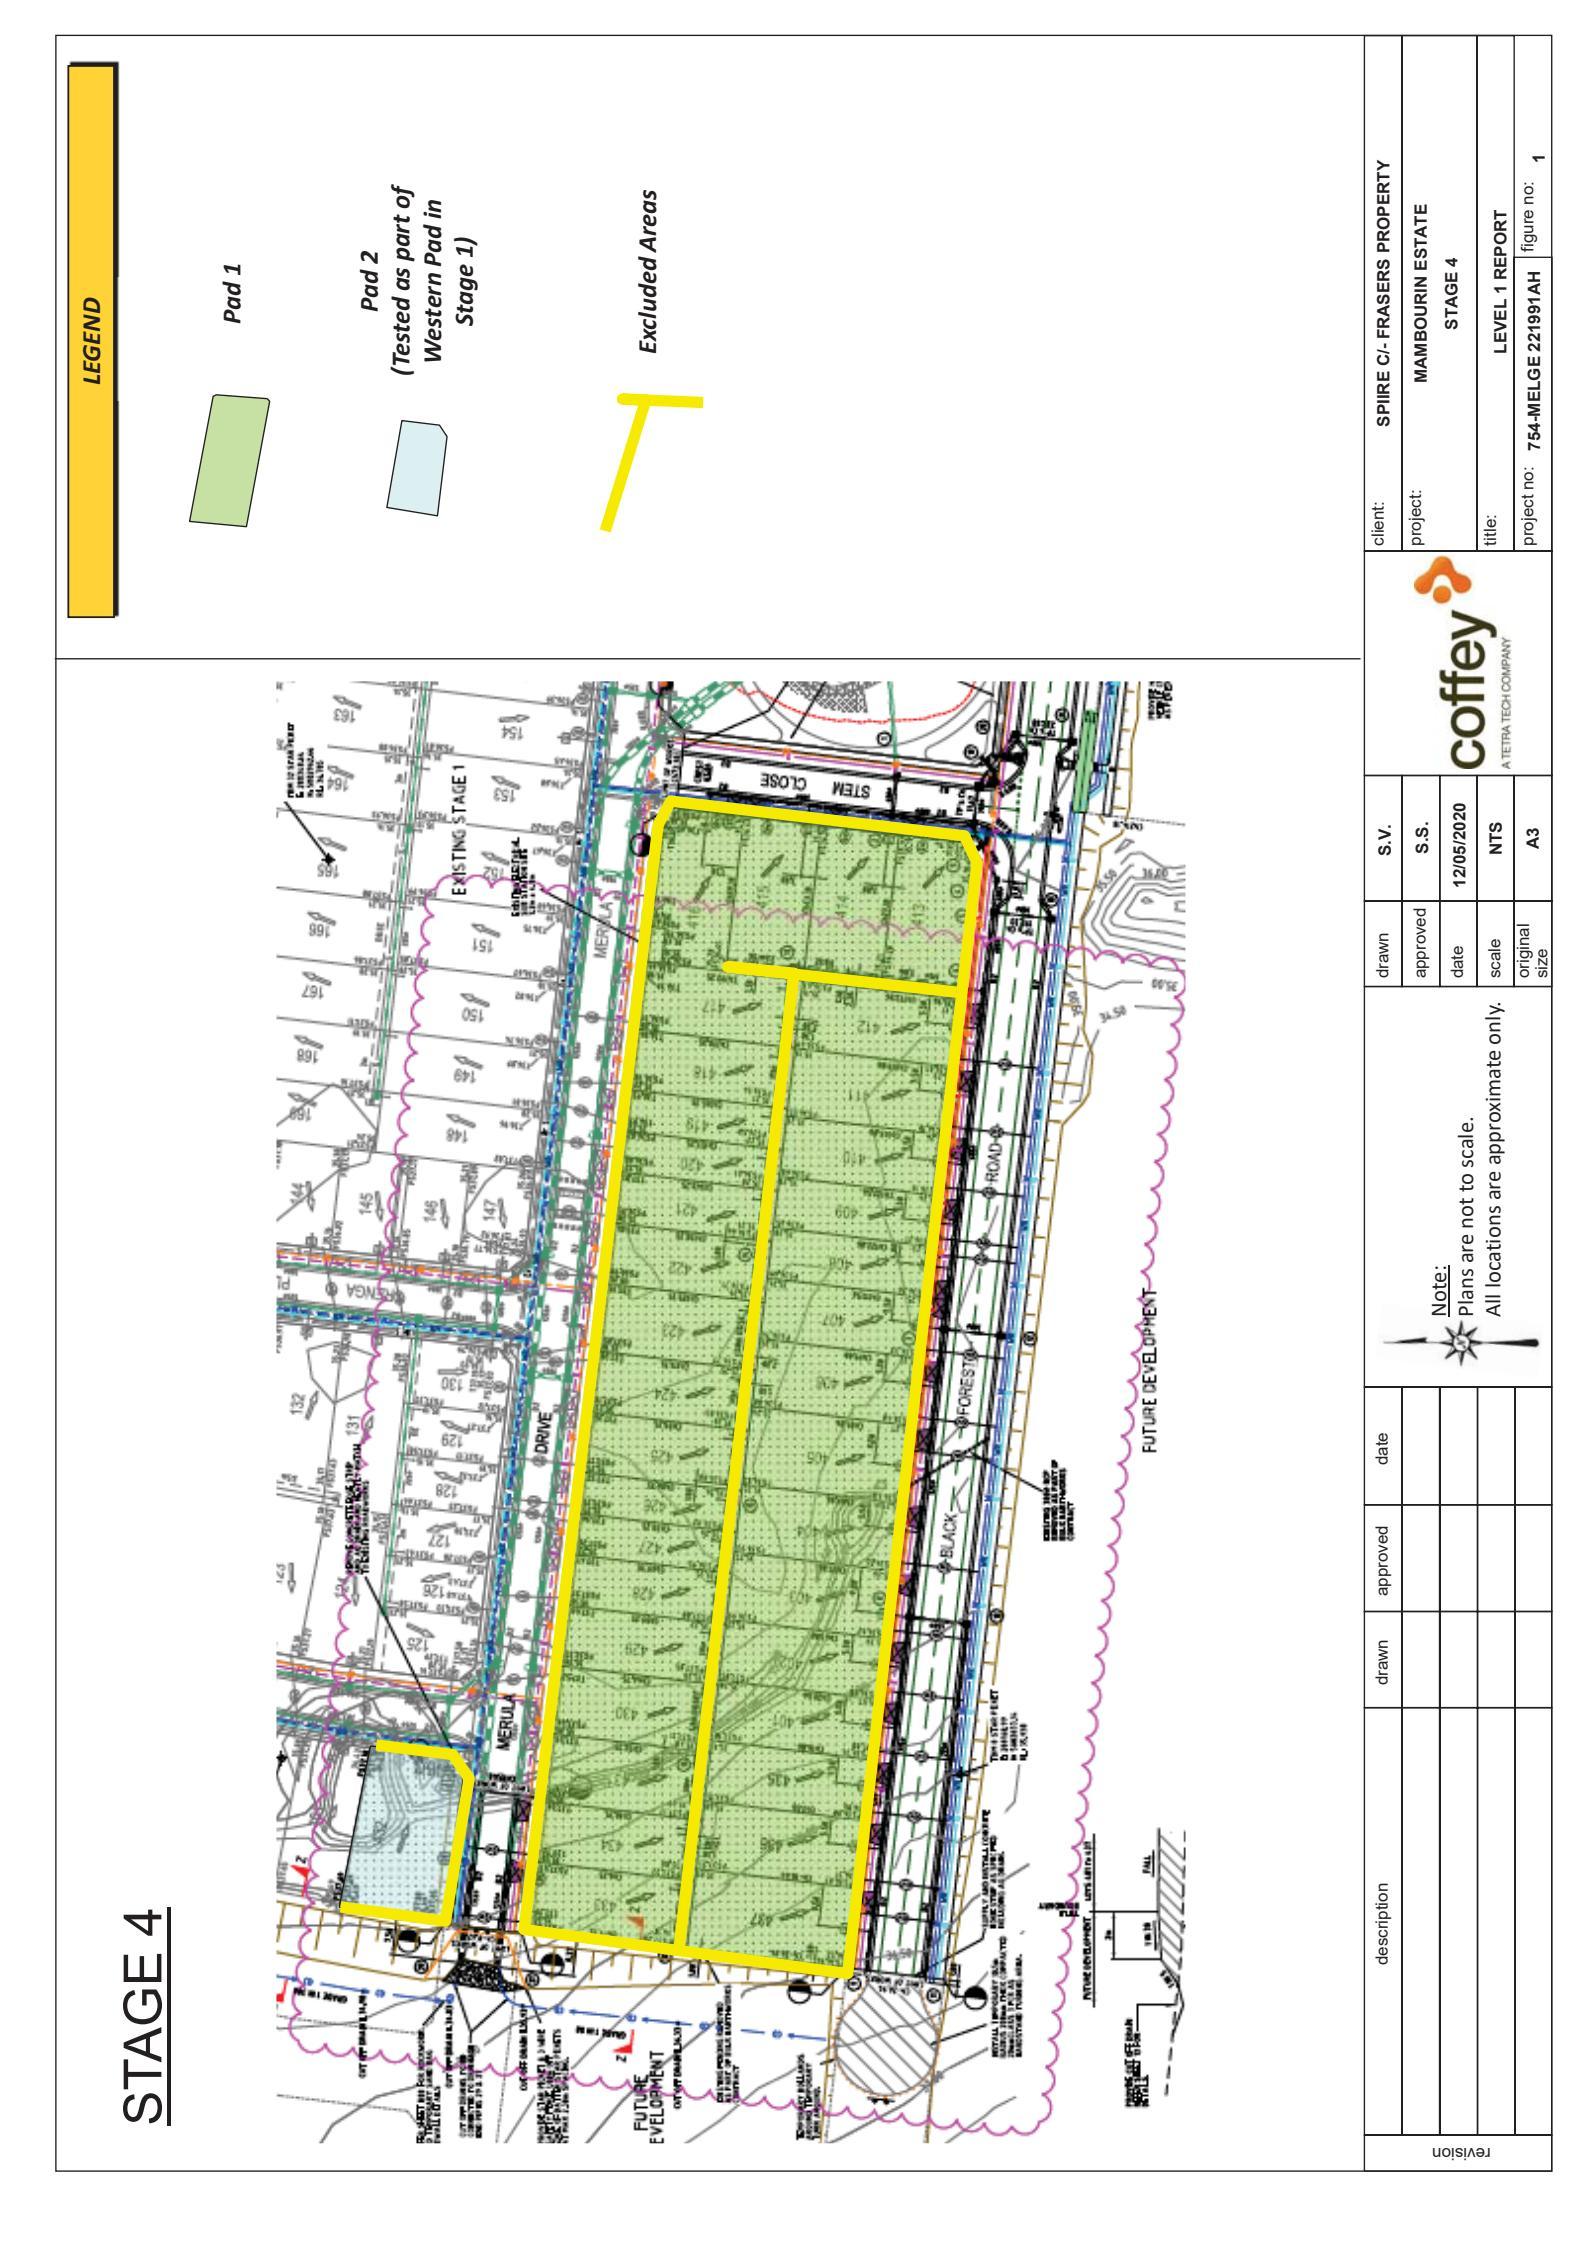
Figure 1 – Fill Area and Exclusion Zone Location Plan

We understand that Frasers require fill placement within Stage 4 of the Mambourin Estate, in the area as shown in Figure 1, to be constructed under Level 1 Inspection and Testing undertaken by a Geotechnical Inspection and Testing Authority (GITA).

This report is applicable to material placed by Winslow within Stage 4 of the Mambourin Estate, as shown in Figure 1 and with reference to Section 2.2 (Excluded Areas) of this report. The filling areas encompass two Fill Pads of Stage 4 as shown in Table 2.

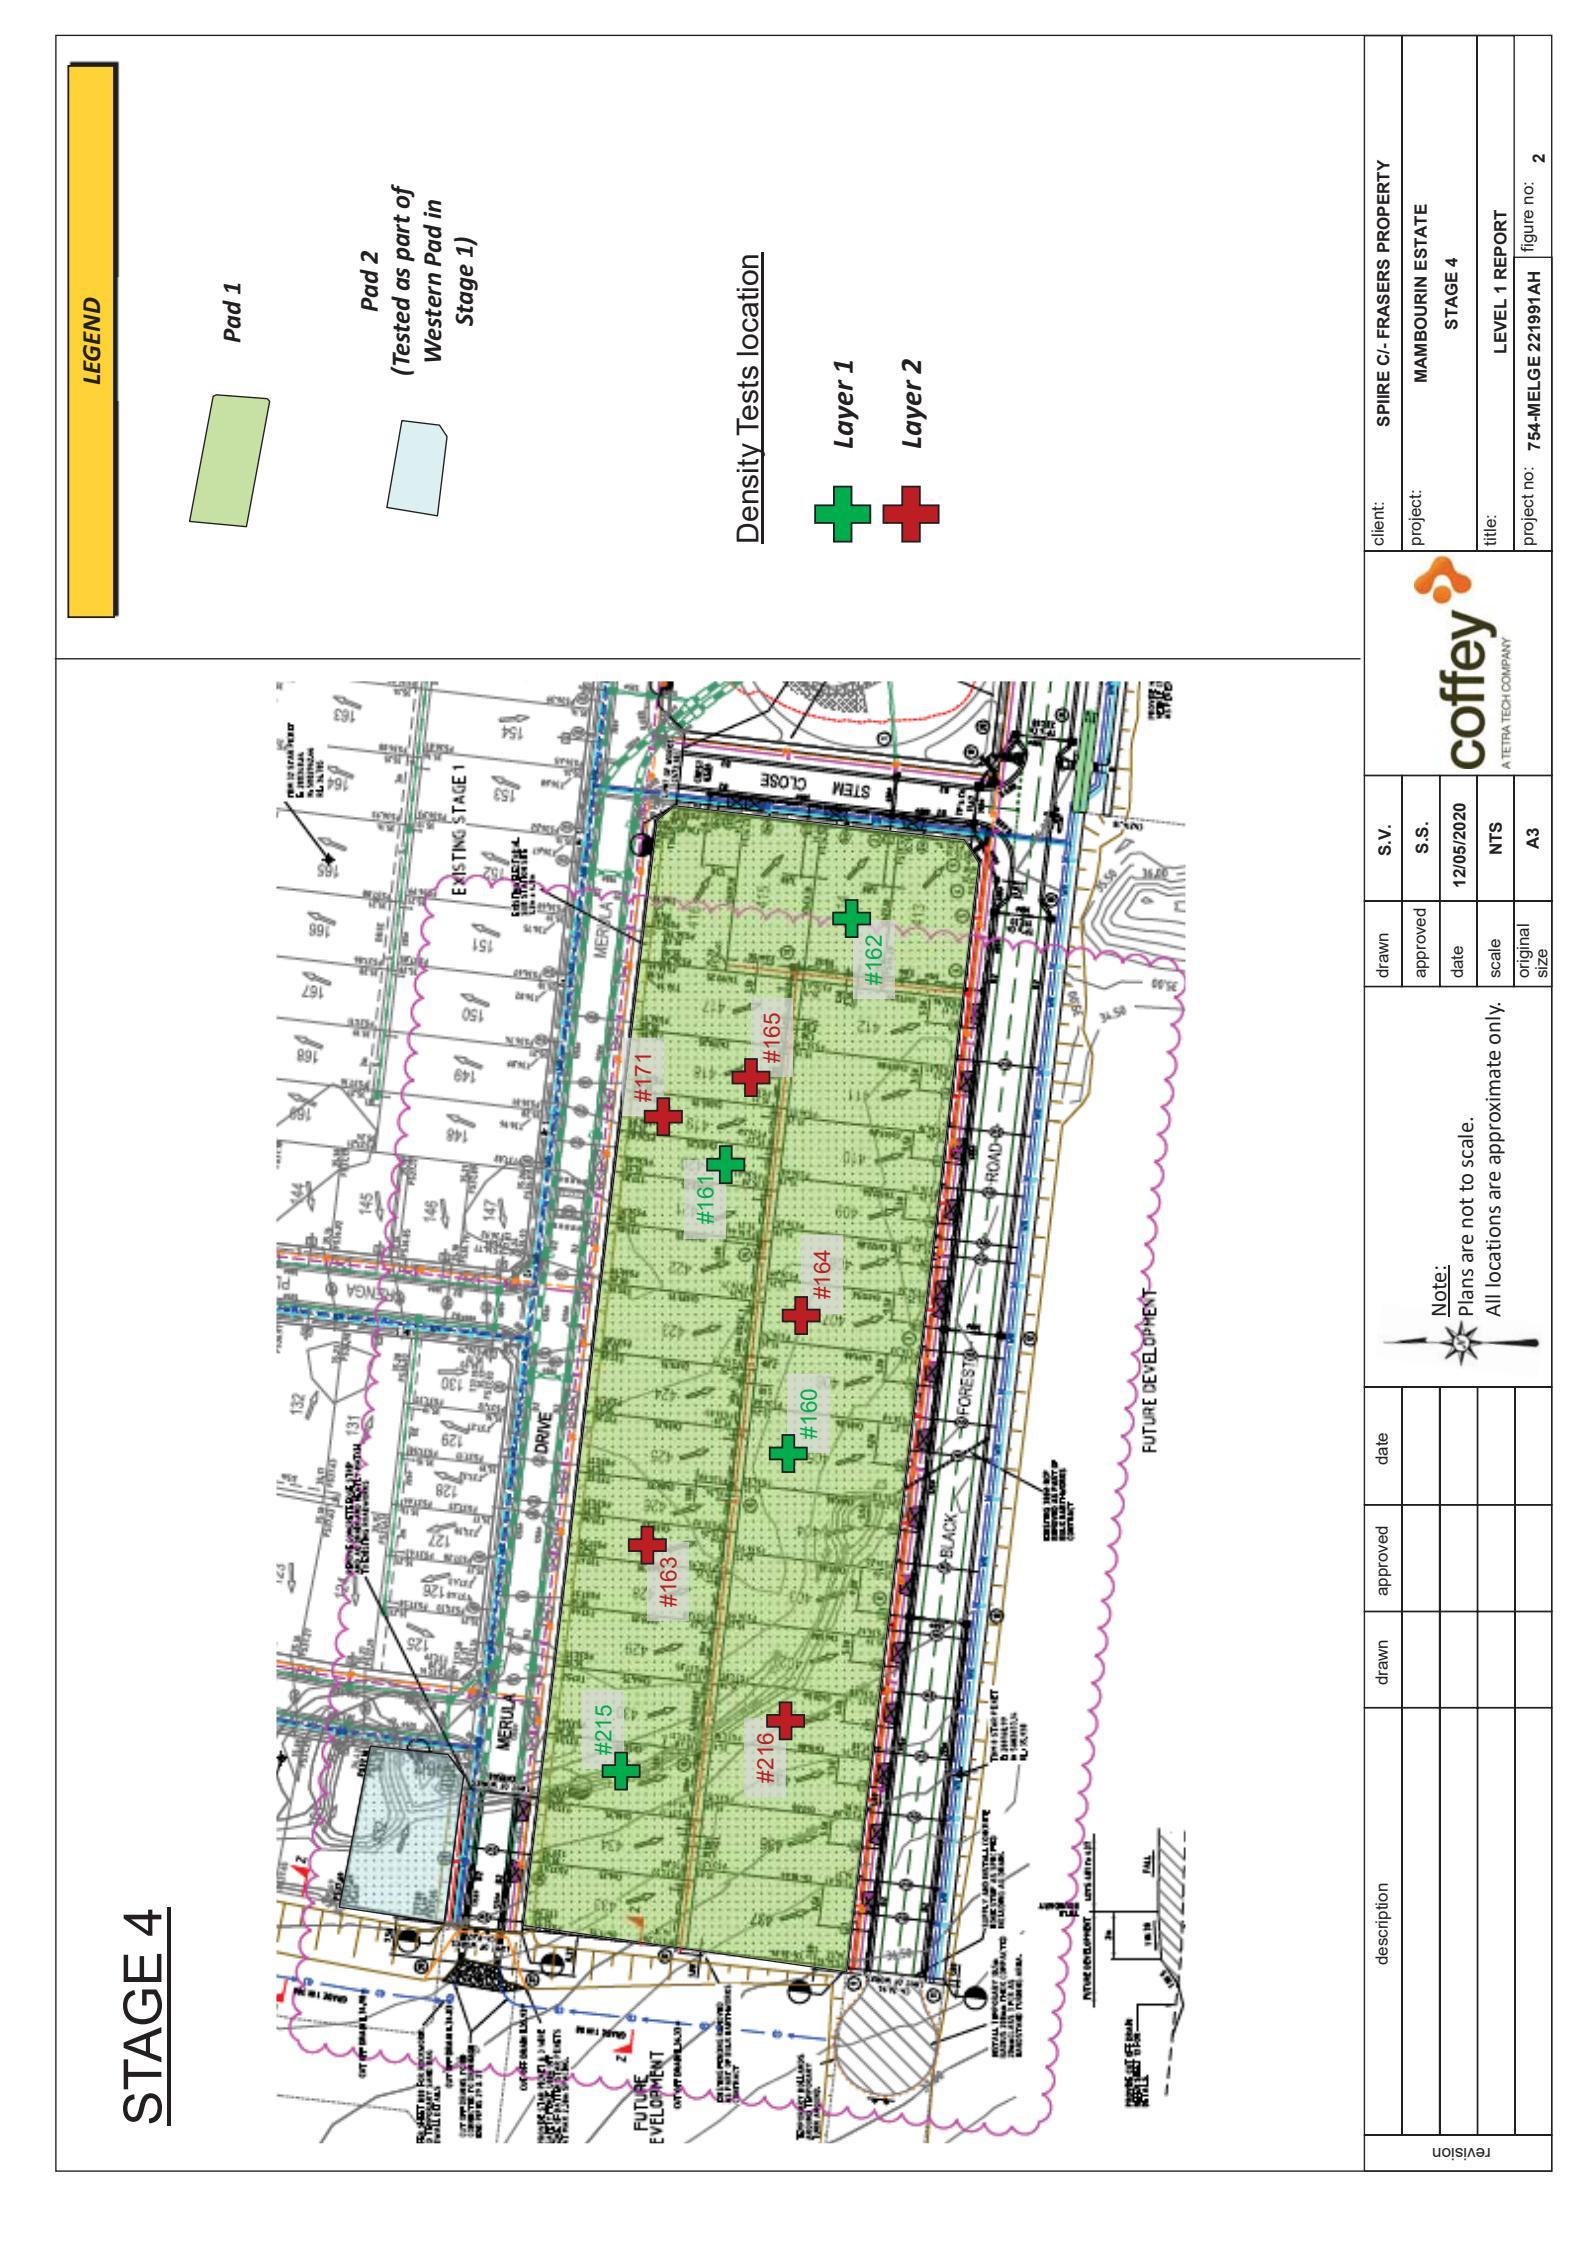
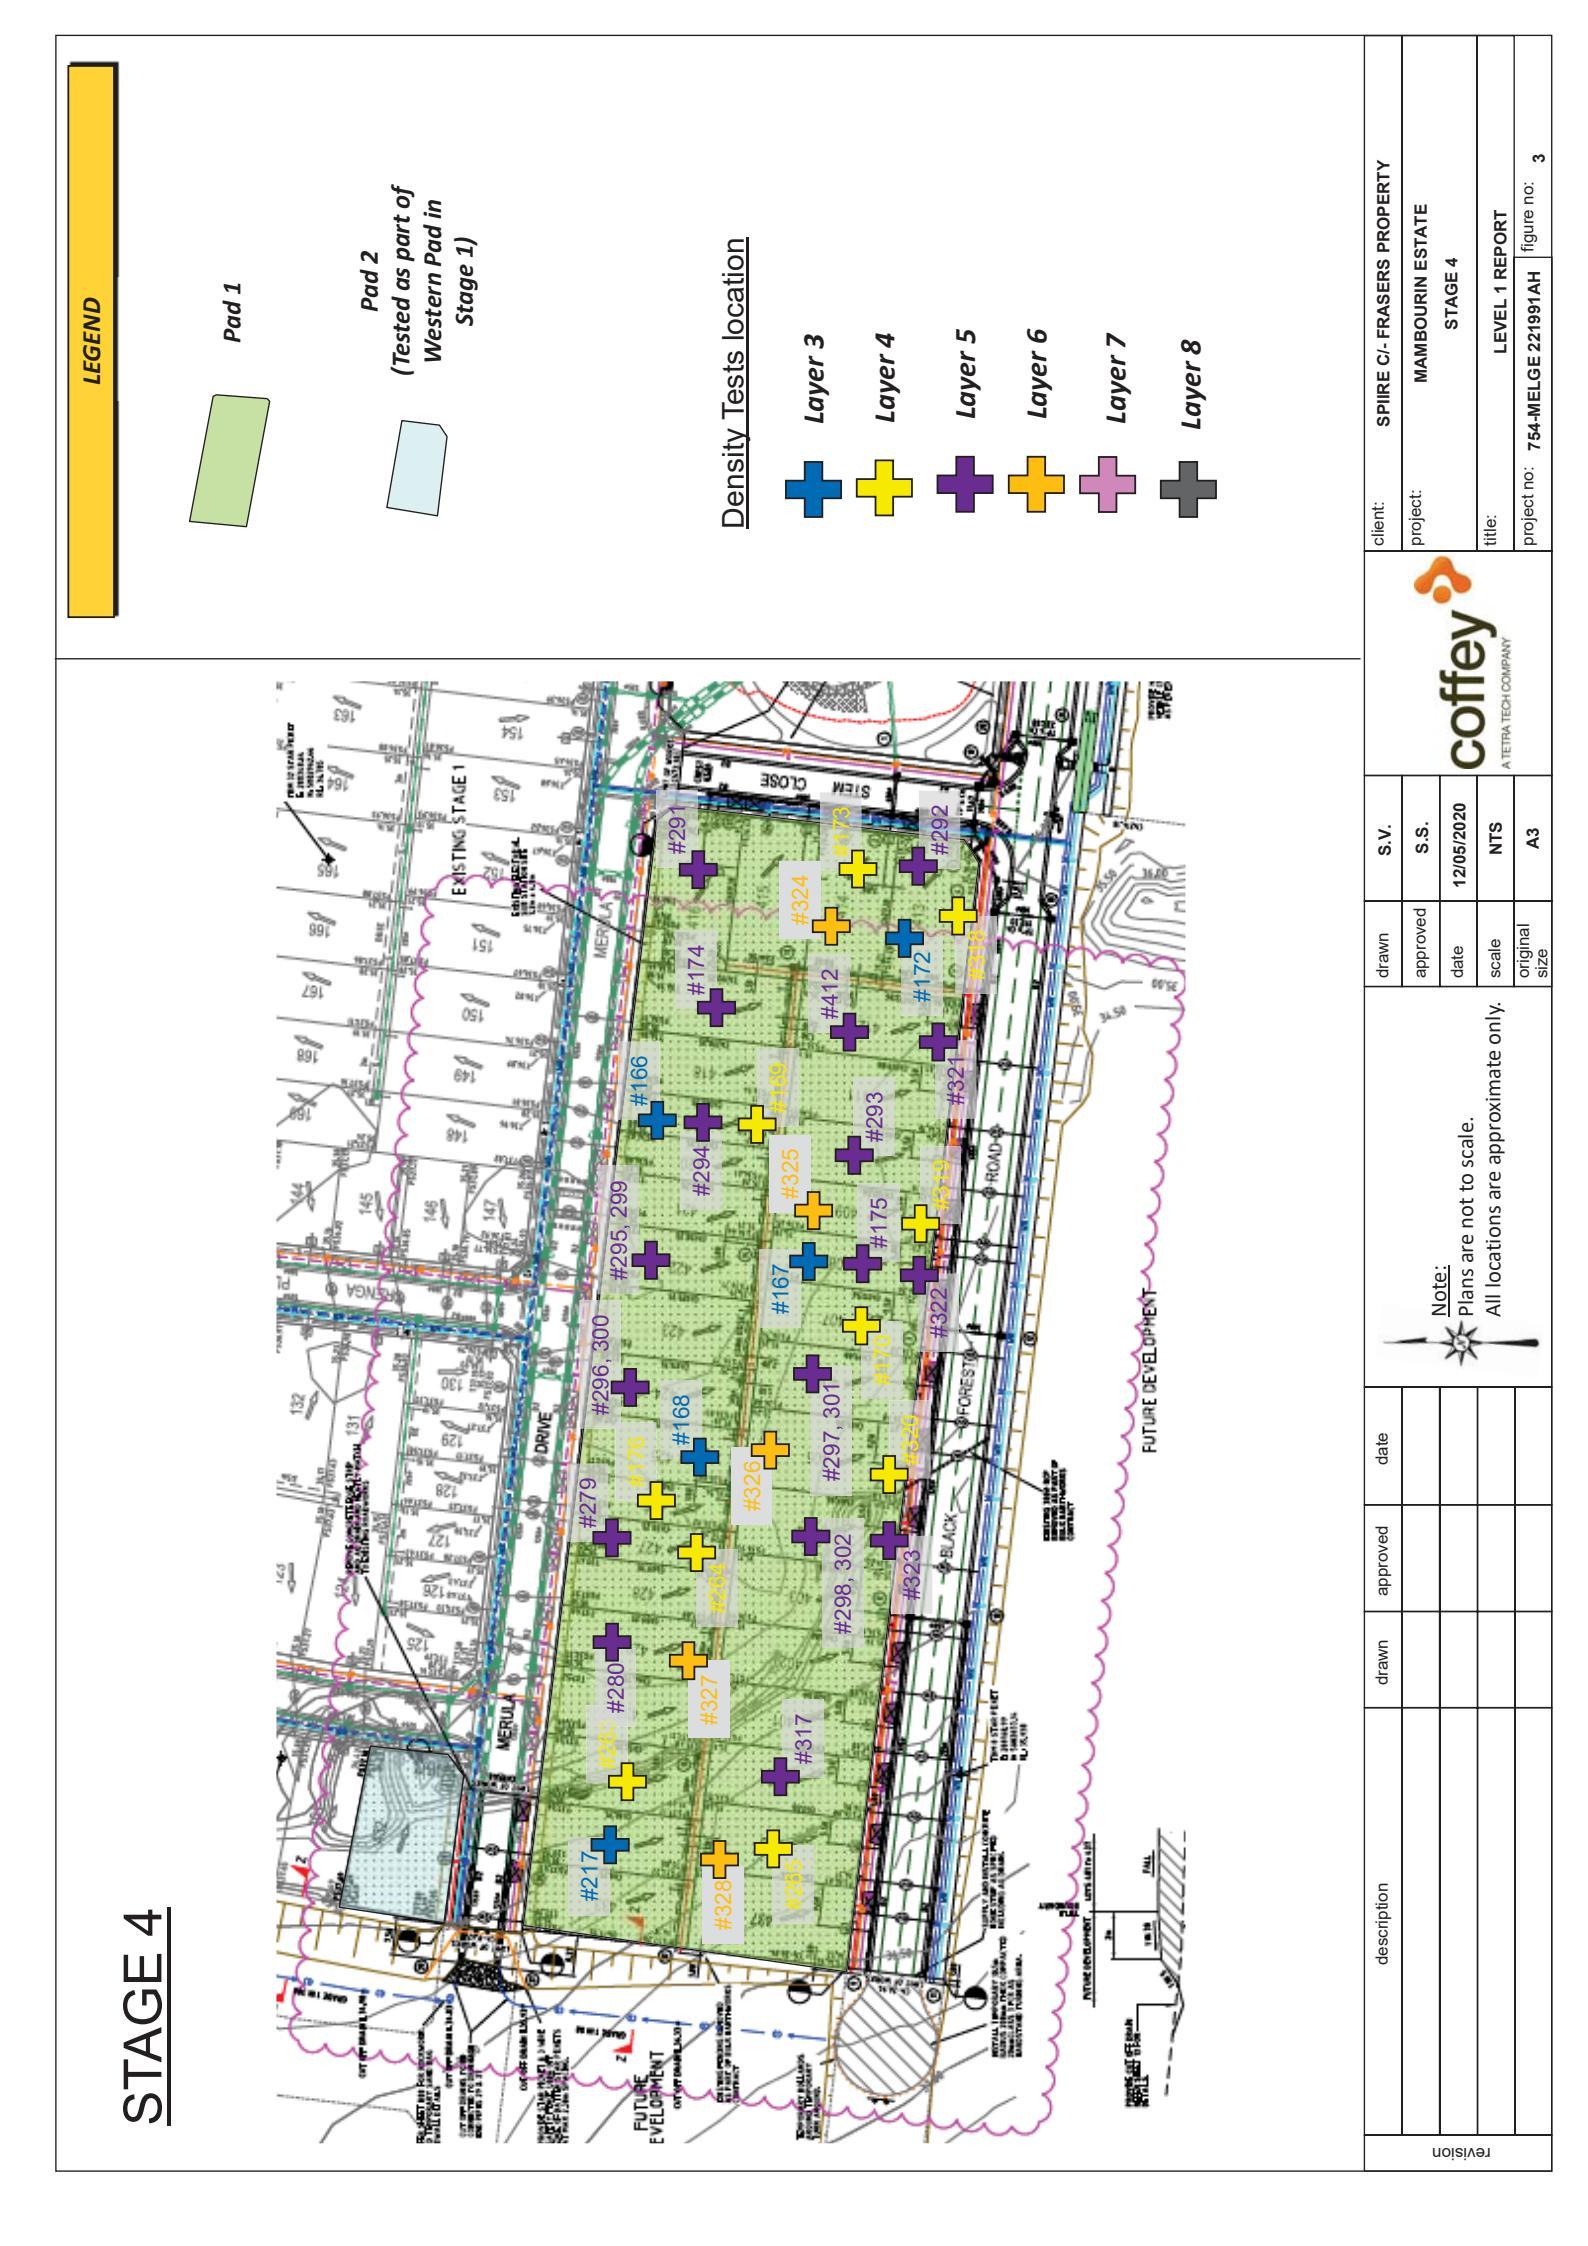
Figure 2, 3 – Field Density Test Location Plan

A total of 48 density tests were performed during the earthworks in the locations as presented in Figures 2 and 3. Of the 48 tests, 4 did not meet the specified criteria. These areas were subsequently re-worked and re-tested. Once re-tested, the 4 test results met the specified dry density ratio criteria of 95% Standard compactive effort and moisture variation of $\pm 3\%$ of the Optimum Moisture Content (OMC).

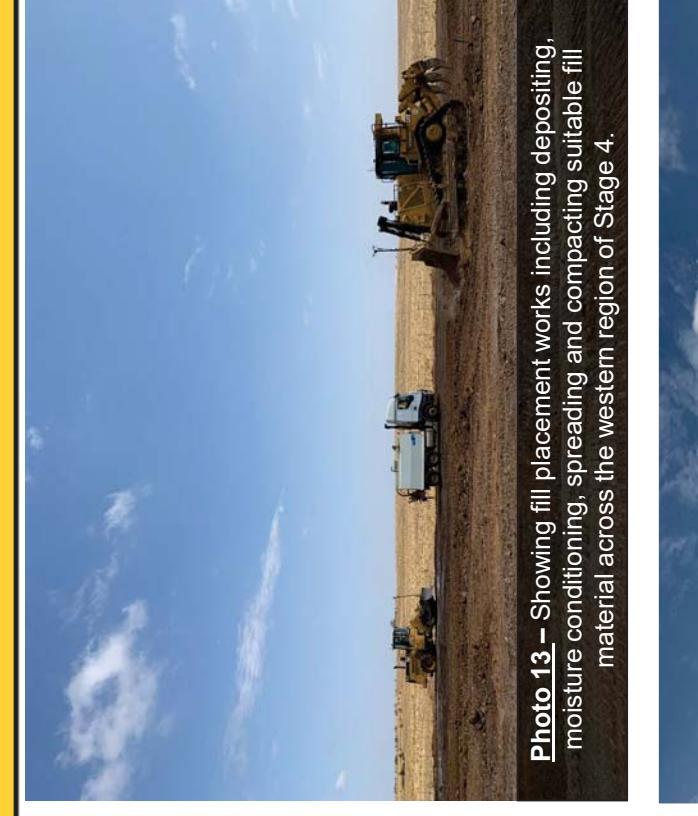
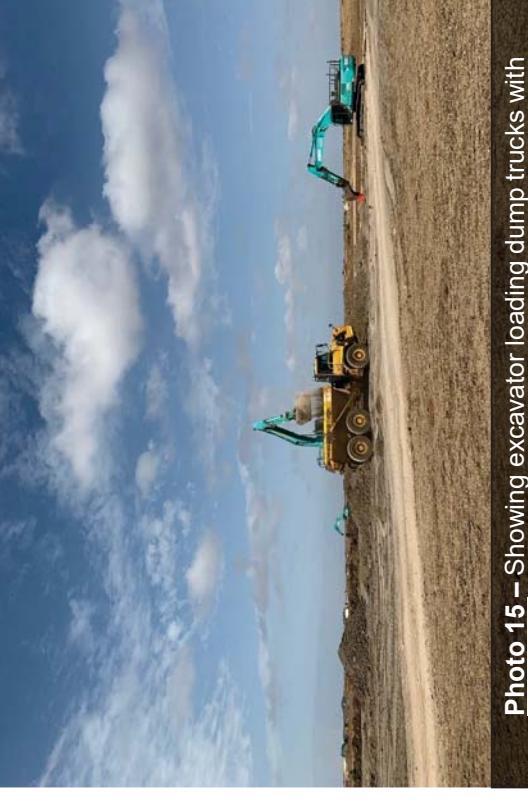
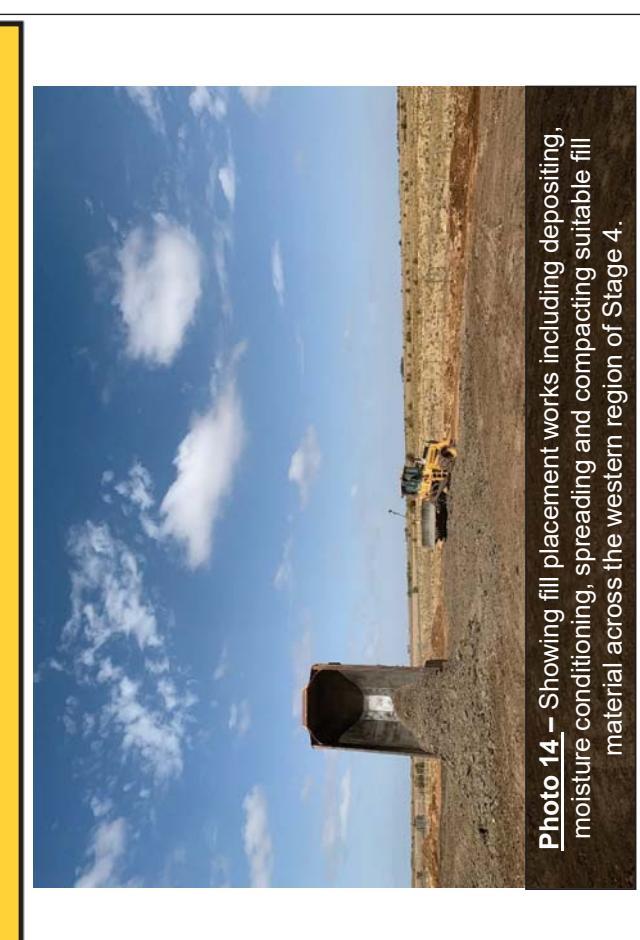
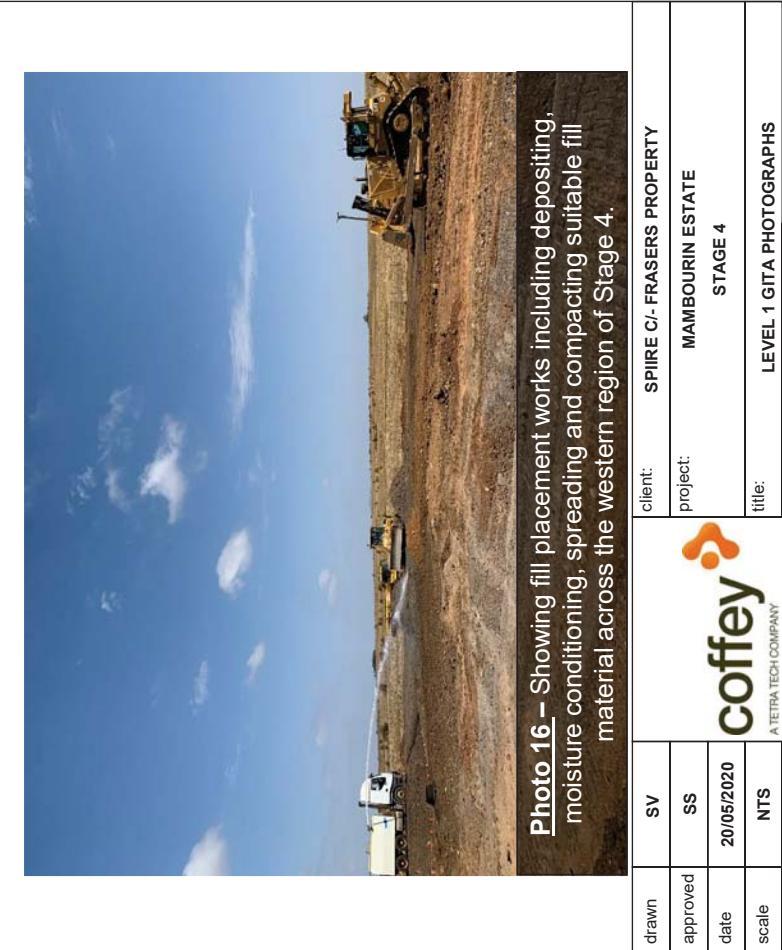
754-MELGE 221991AH figure no: 8

previously sorted excavated material within Stage 2 for fill Photo 15 - Showing excavator loading dump trucks with placement across western regions of Stage 4.
