Frasers Property Level 1 Inspection and Testing Report, Stage 5, Mambourin Estate 754-MELGE221991AI

Level 1 Inspection and Testing Report, Stage 5, Mambourin Estate

This report presents the results of the Level 1 Inspection and Testing for fill placement within Stage 5 of Mambourin Estate, Wyndham Vale, undertaken by Coffey Services Australia Pty Ltd (Coffey).

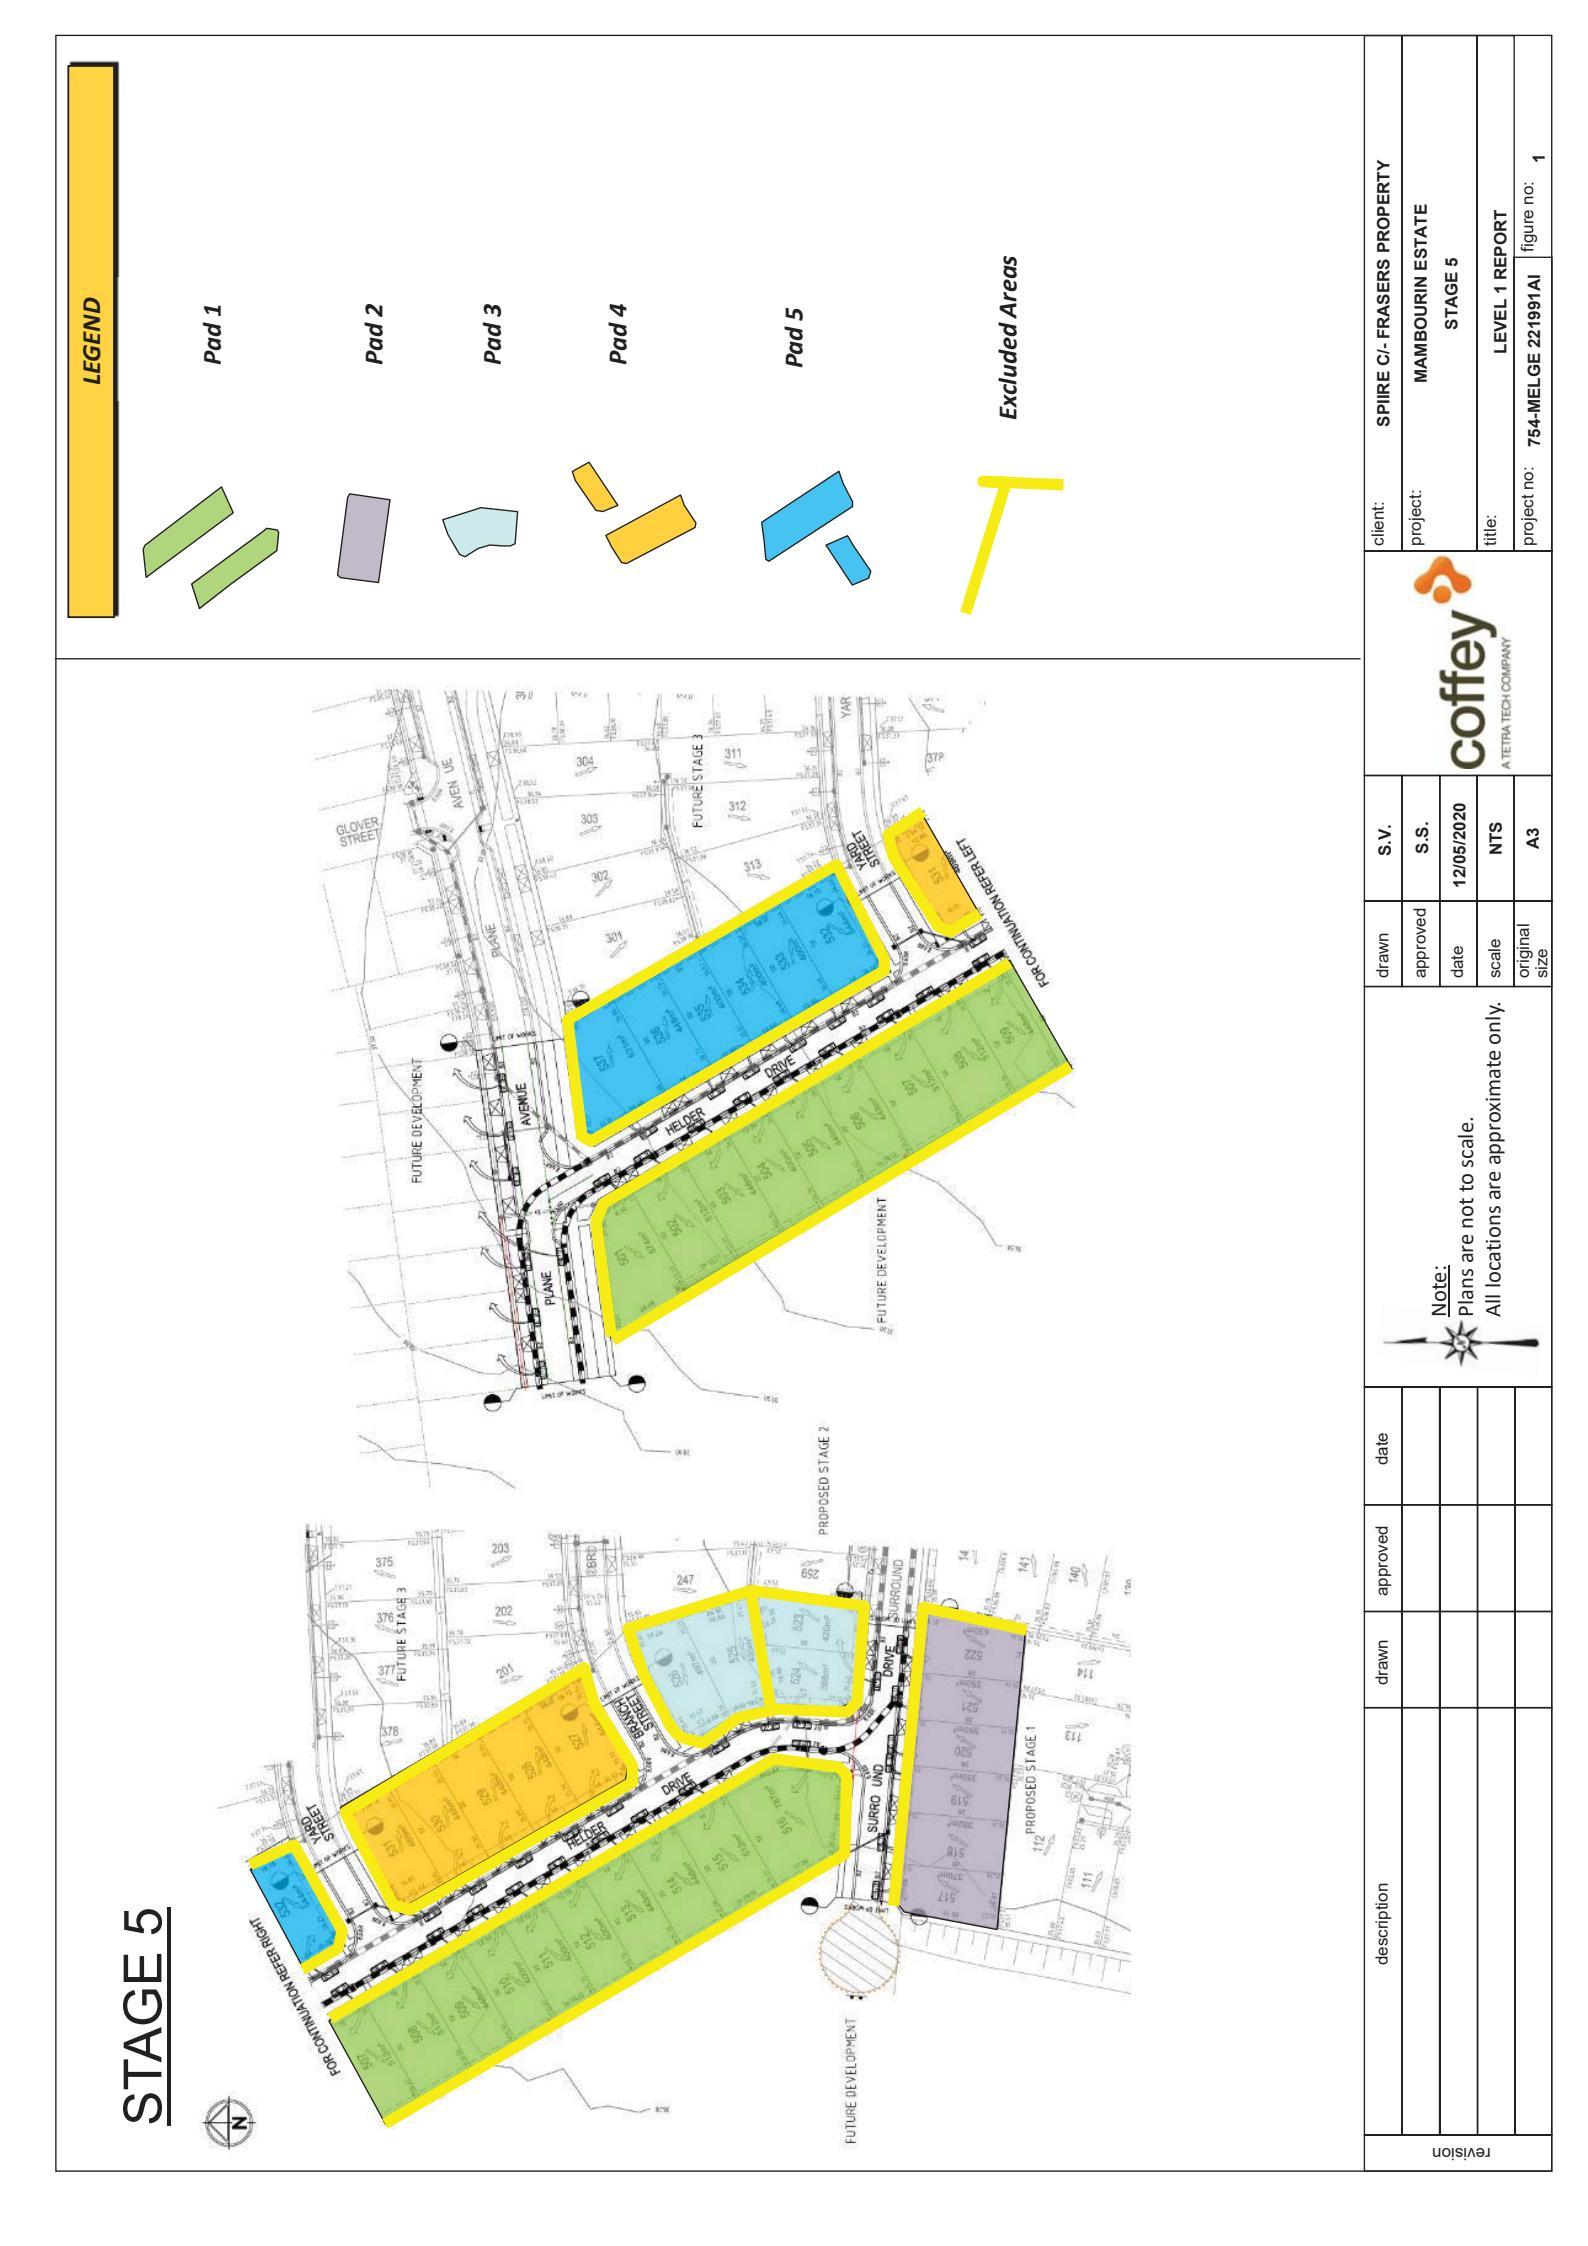
We understand that Frasers require fill placement within Stage 5 of the Mambourin Estate, in the area as shown in Figure 1, to be constructed under Level 1 Inspection and Testing undertaken by a Geotechnical Inspection and Testing Authority (GITA).

This report is applicable to material placed by Winslow within Stage 5 of the Mambourin Estate, as shown in Figure 1 and with reference to Section 2.2 (Excluded Areas) of this report. The filling areas encompass five Fill Pads of Stage 5 as shown in Table 2.

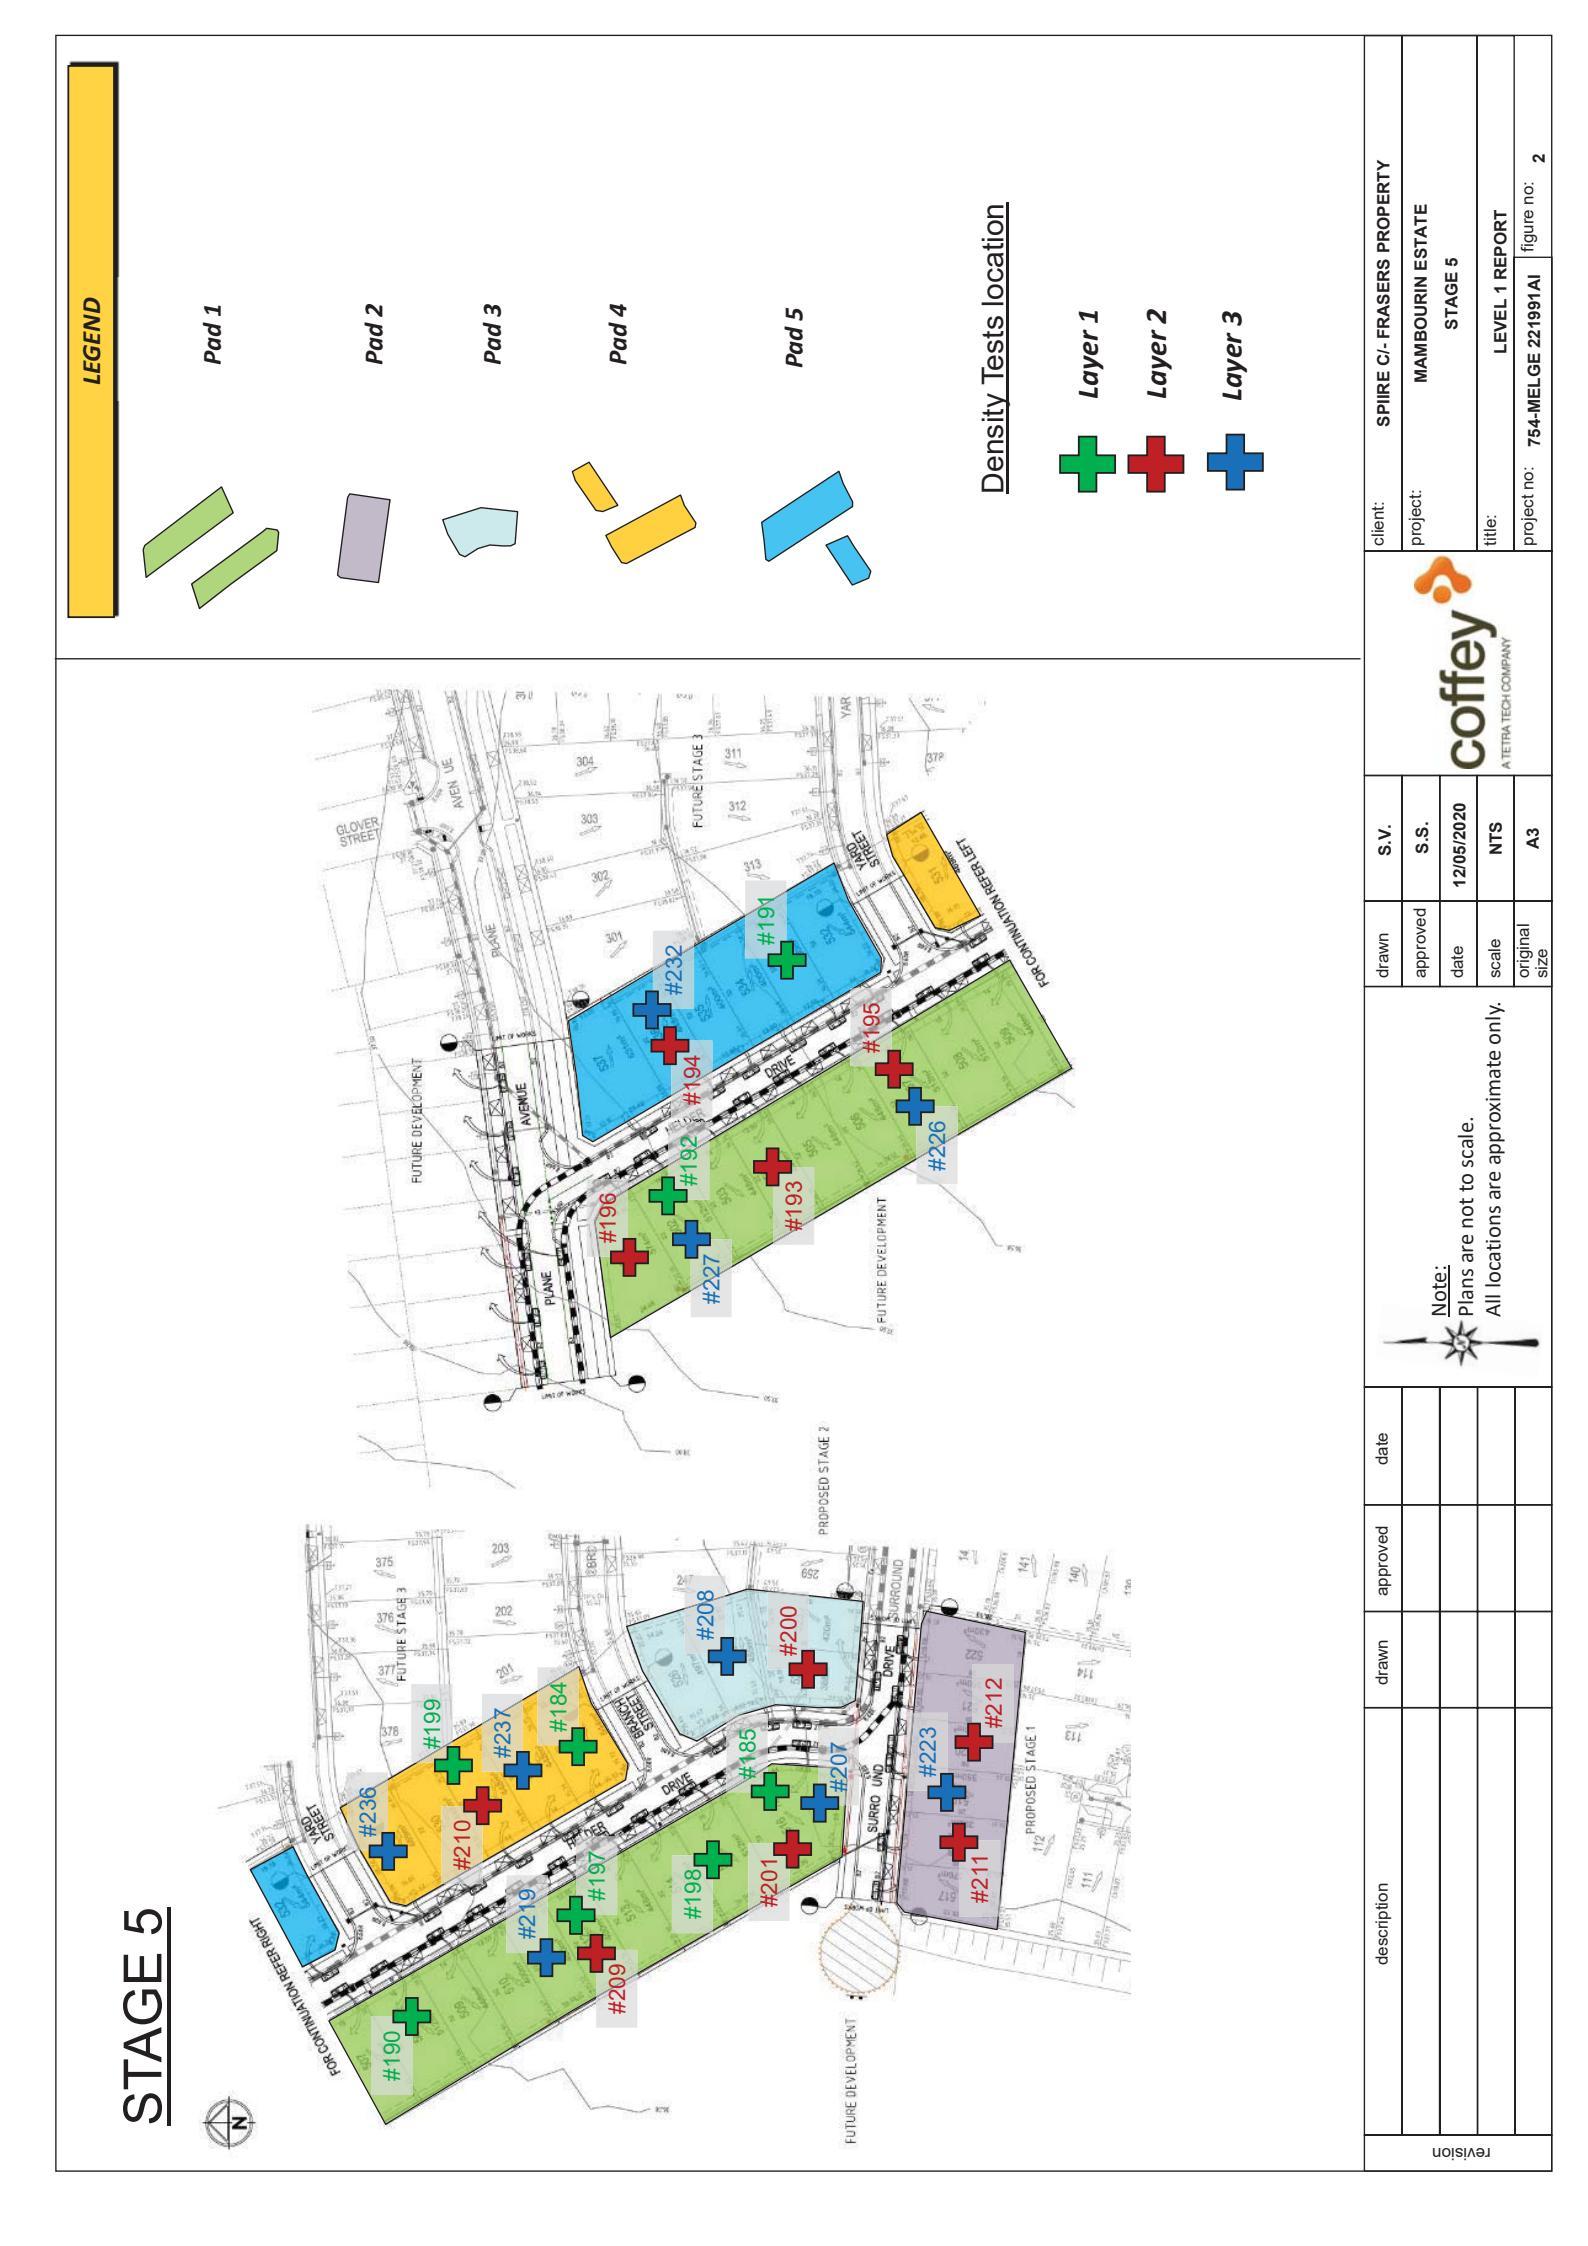
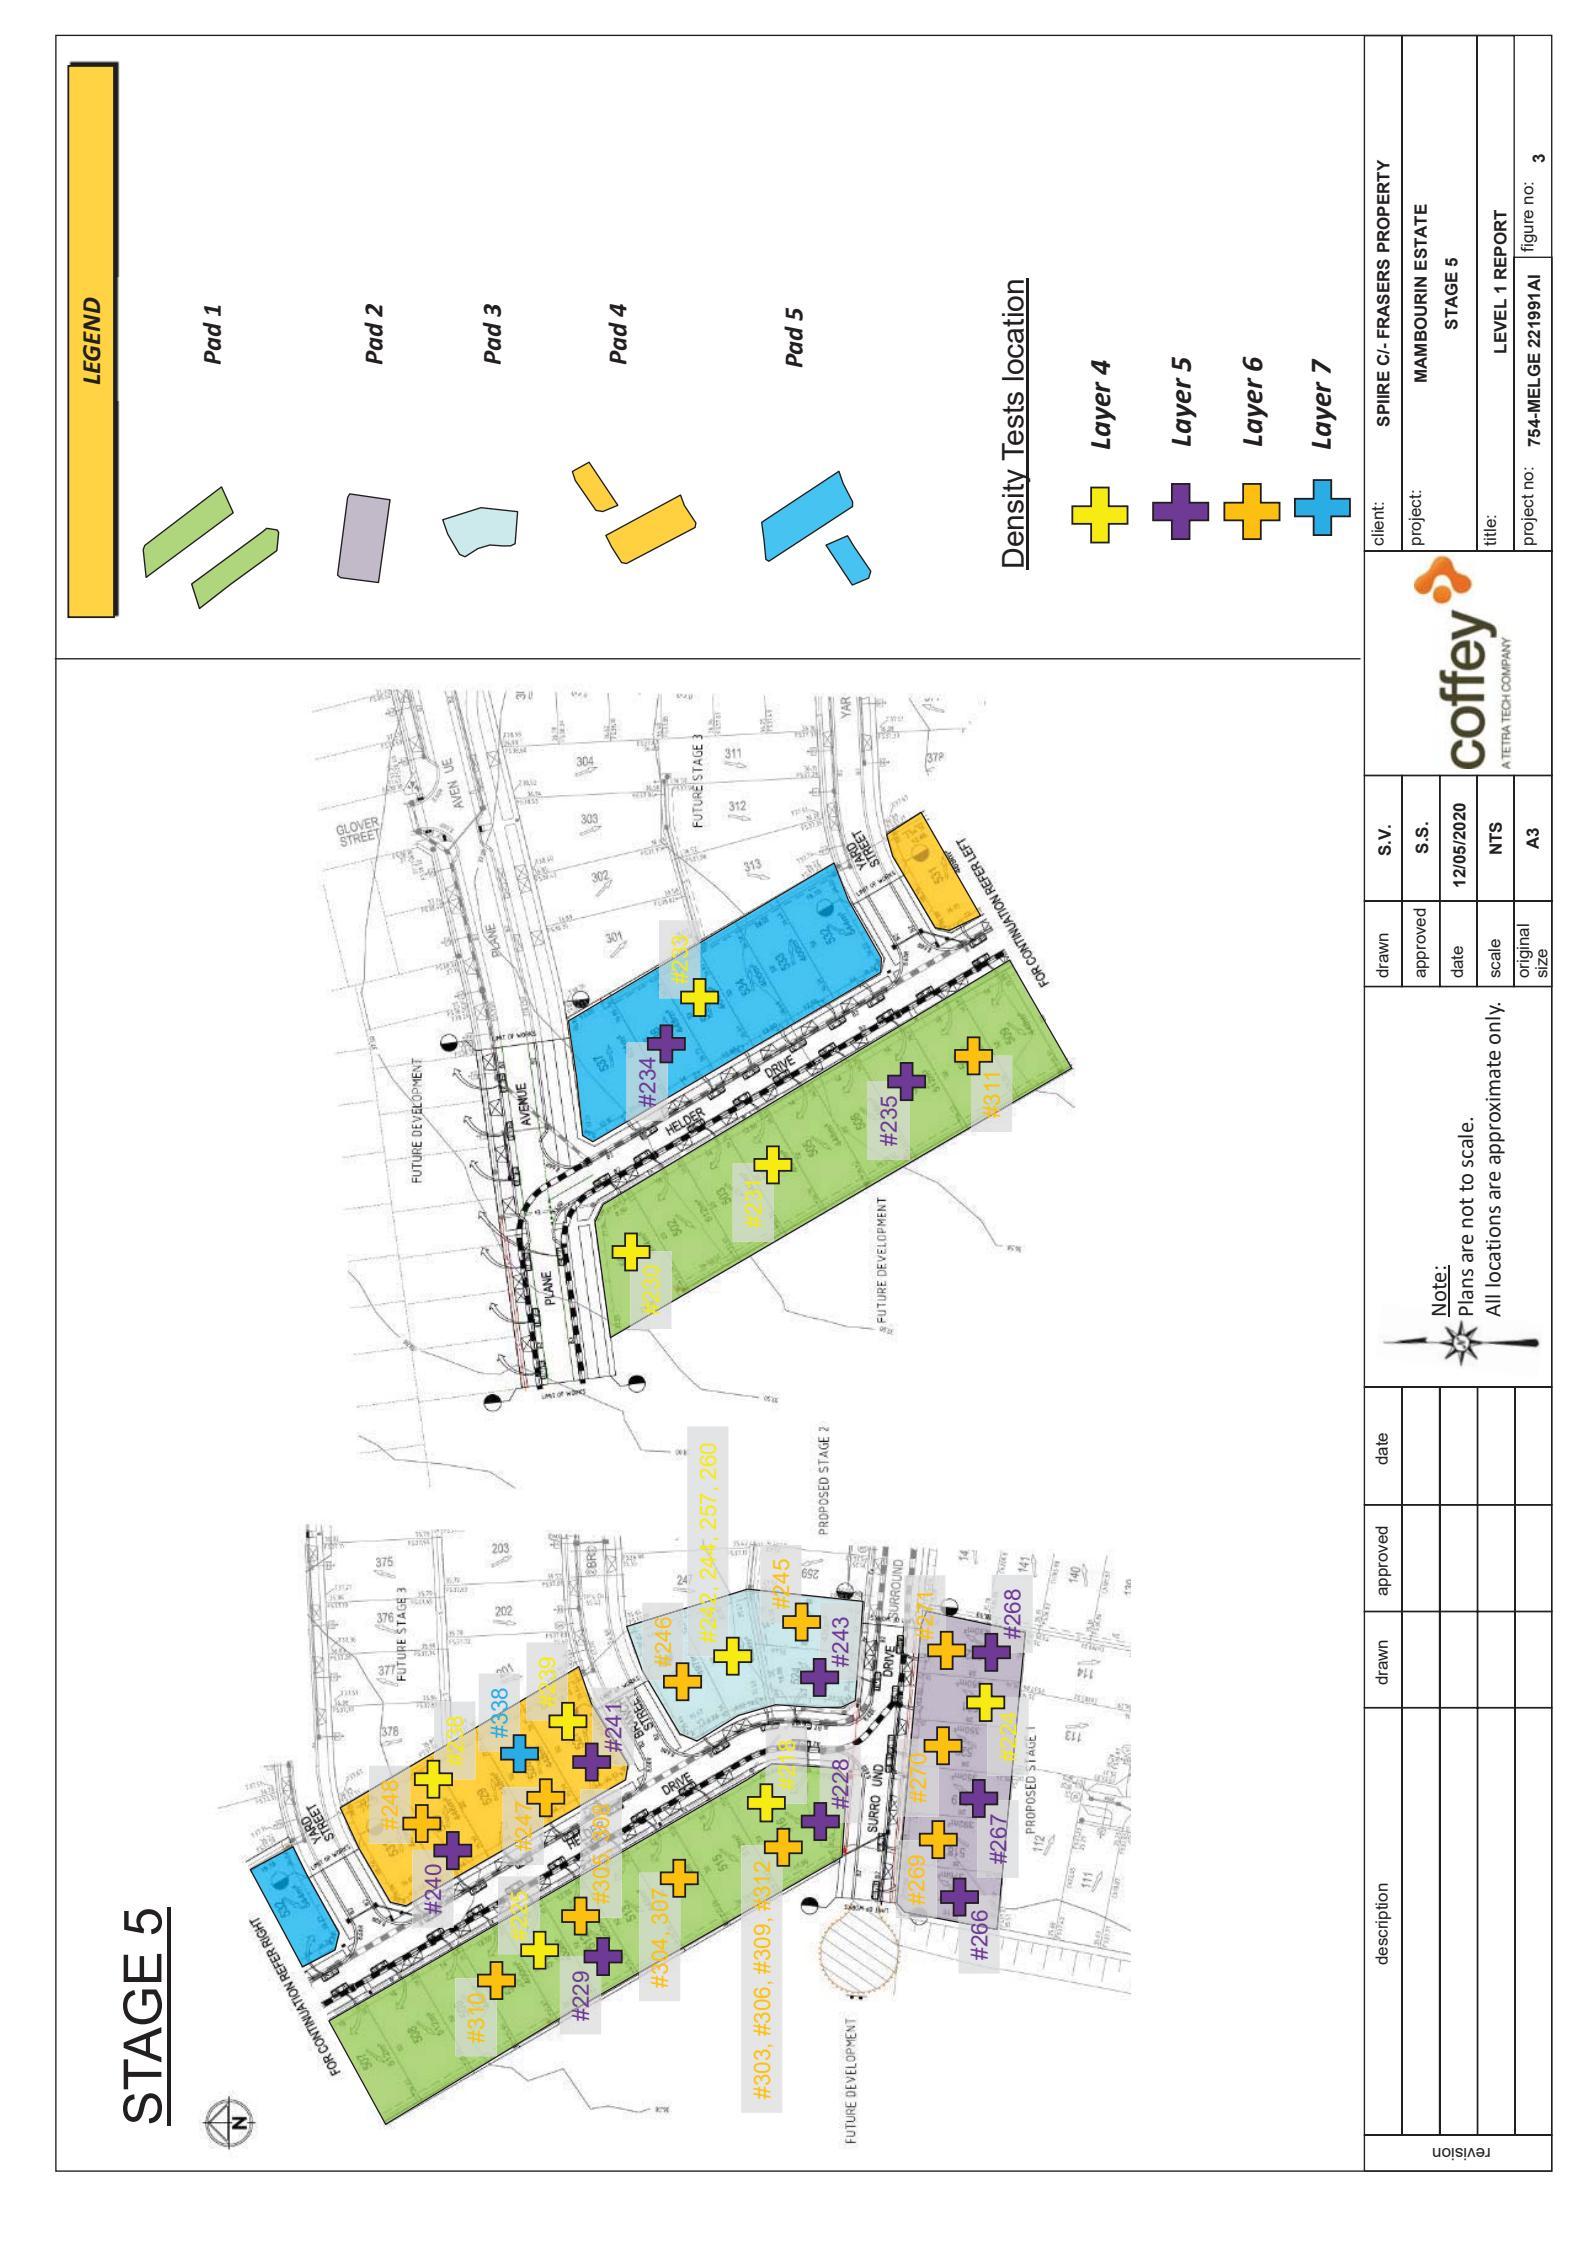
A total of 67 density tests were performed during the earthworks in the locations as presented in Figures 2 and 3. Of the 67 tests, 8 did not meet the specified criteria. These areas were subsequently re-worked and re-tested. Once re-tested, the 8 test results met the specified dry density ratio criteria of 95% Standard compactive effort and moisture variation of $\pm 3\%$ of the Optimum Moisture Content (OMC).

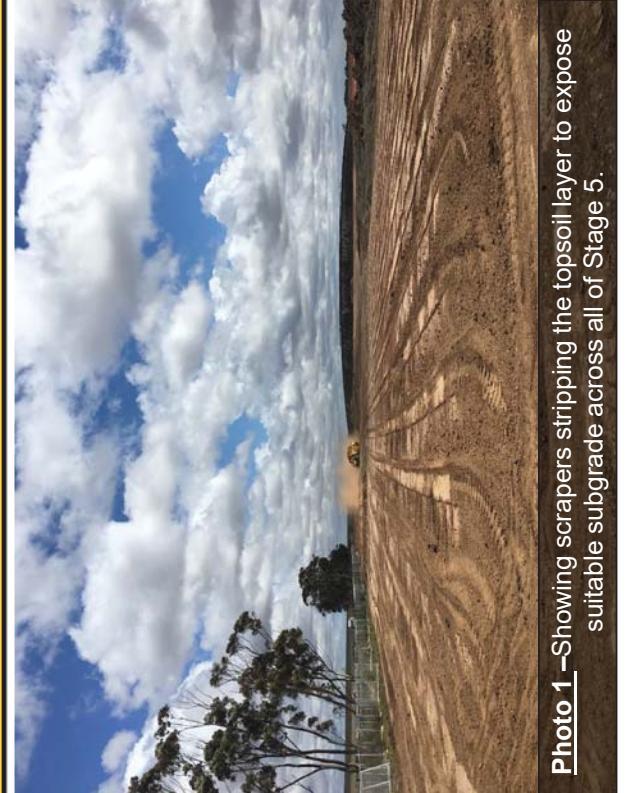
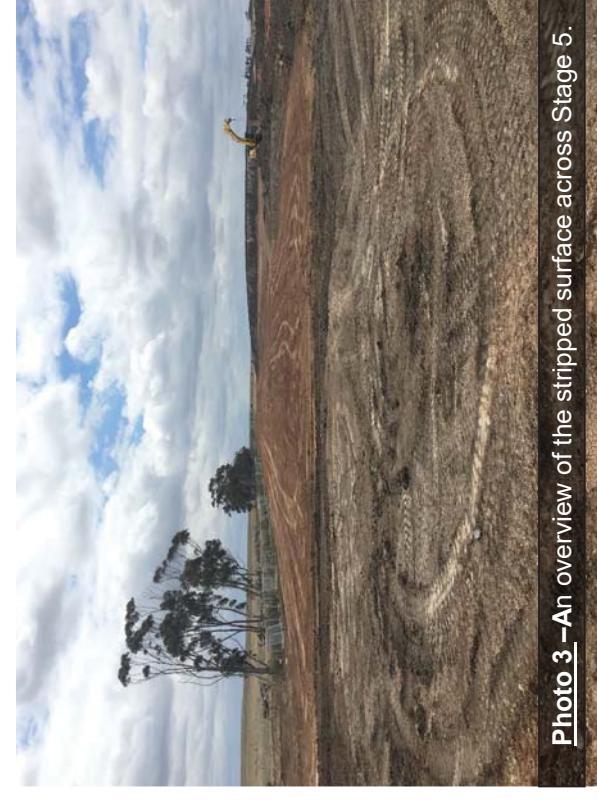
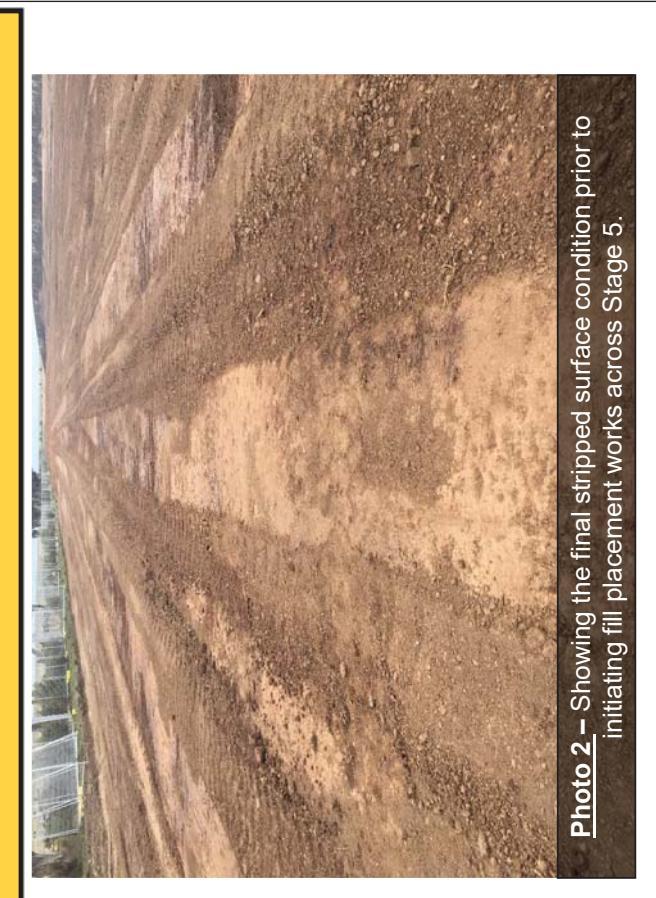
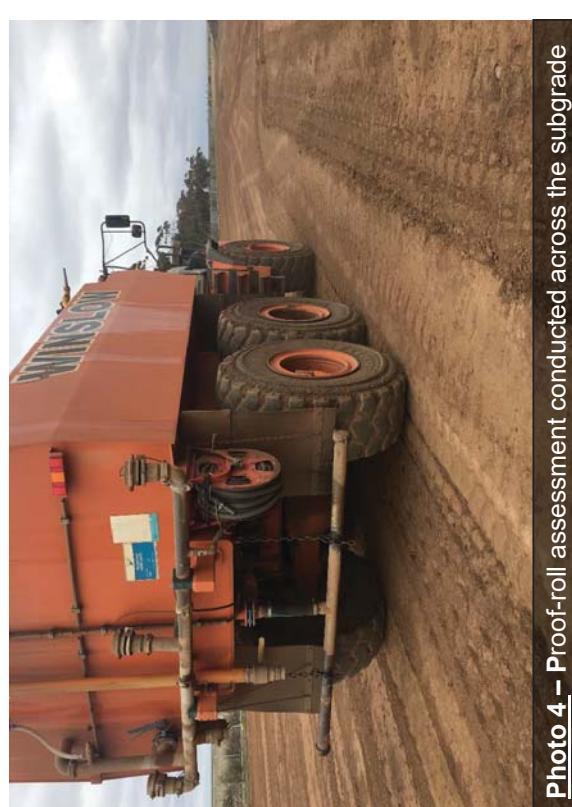
CONSTRUCTION PHOTOGRAPHS

All sourced fill was trucked in, spread with a bulldozer, compactor or grader and compacted with a compactor and/or a pad foot roller. A water cart was present onsite during works for moisture conditioning of the materials.

Prior to placement of the fill, the subgrade was scarified and moisturised to allow better bonding. The fill was then placed in horizontal layers not exceeding 300mm thickness. If any organic matter, oversize particles or unsuitable material was observed, the contractor was advised to remove this from the fill pad. Once the placed fill was approved, the layer was compacted accordingly.

of Stage 5 fill pads.
