CONSTRUCTION CERTIFICATE No. J/74556/01

Issued under the Environmental Planning and Assessment Act 1979 Sections 6.4 and 6.7

Address: Ivanhoe Estate comprising Ivanhoe Place, Wilcannia Way, Nyngan Way, Narromine Way and Cobar Way, part of 2-4 Lyonpark Road and portions of Shrimptons Creek adjacent to the centre line of the creek, Macquarie Park

Description: Stage 1 development application for the redevelopment of the Ivanhoe Estate, including:

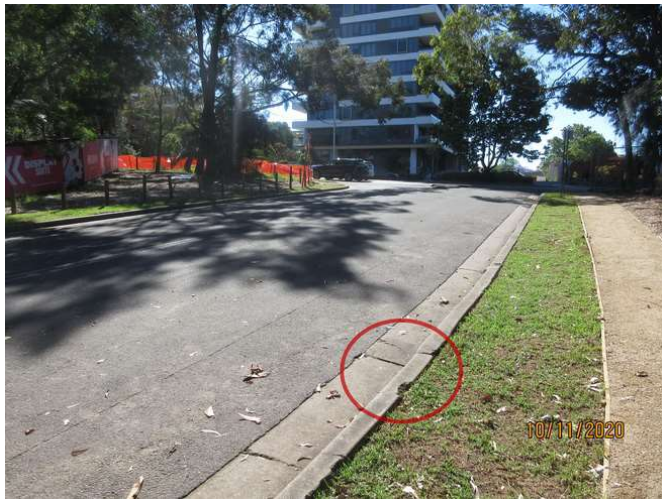
003_Note cracking damage

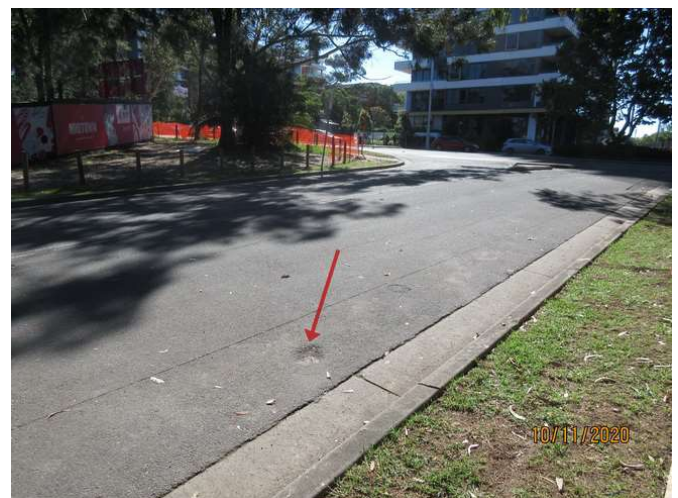
006_Note pothole

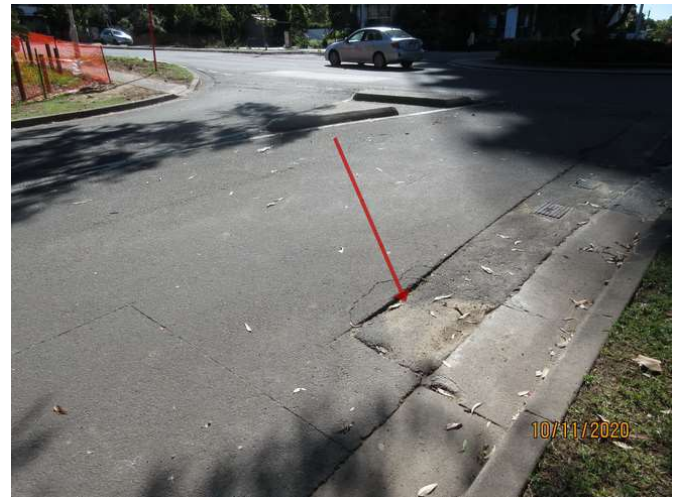
020_Note slight subsidence

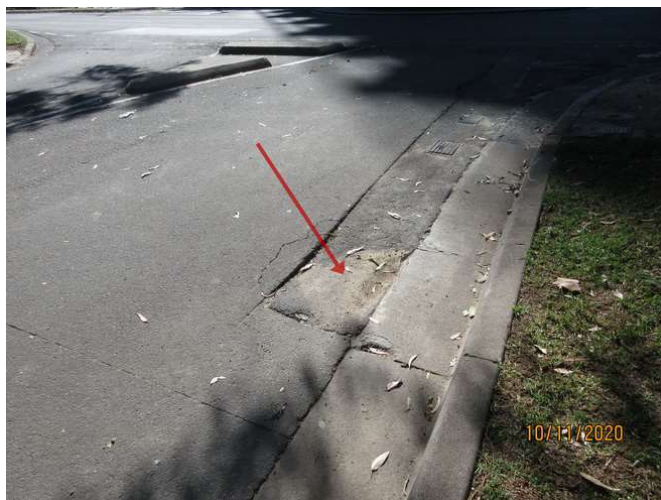
021_Note slight subsidence

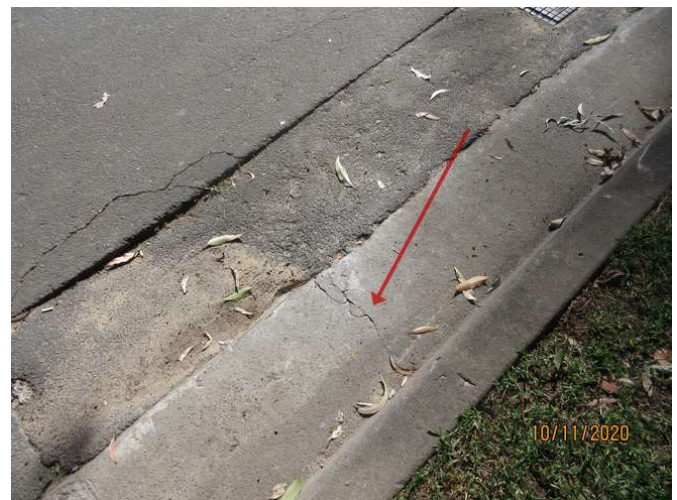
022_Note cracking damage

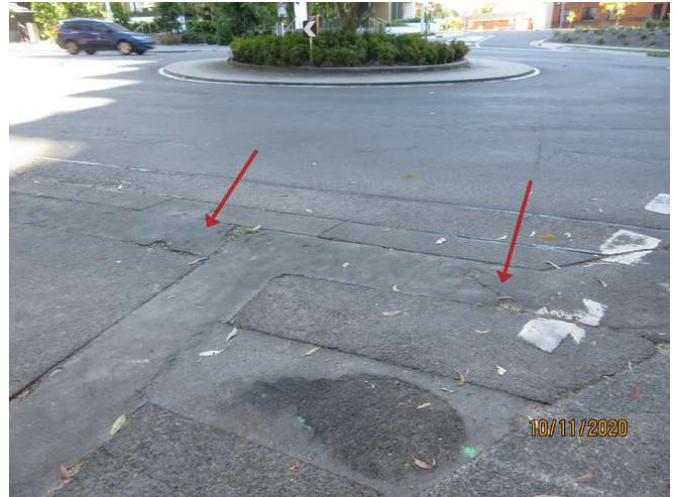
025_Note slight subsidence

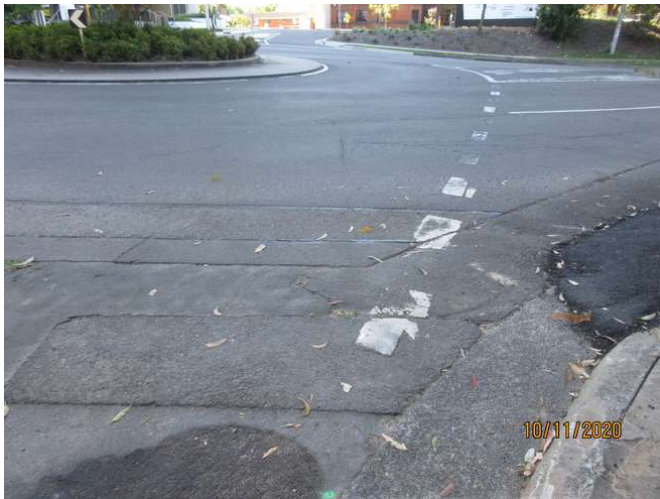
026_Note slight subsidence

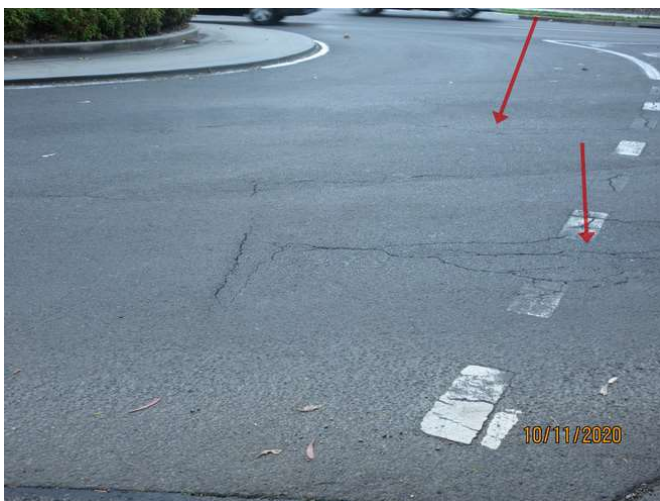
028_Note cracking damage

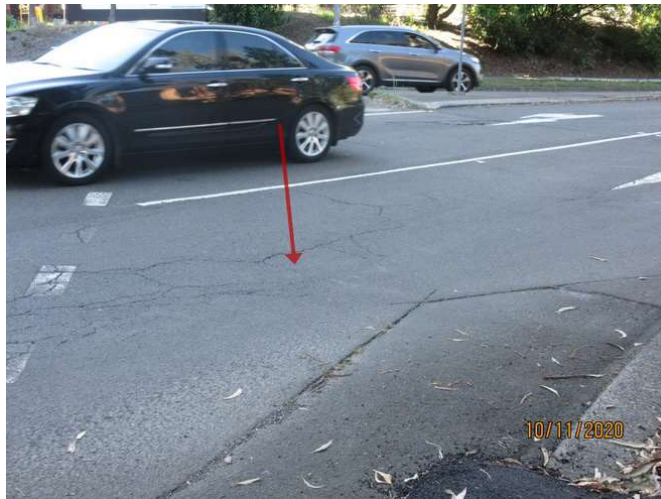
030_Note cracking damage

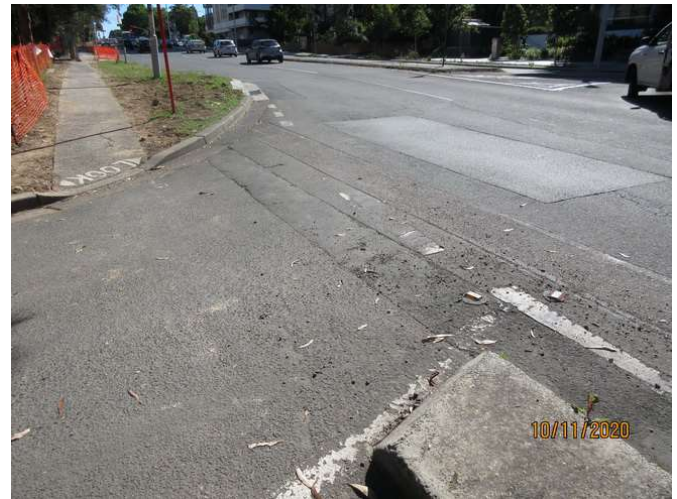
031_Note cracking damage

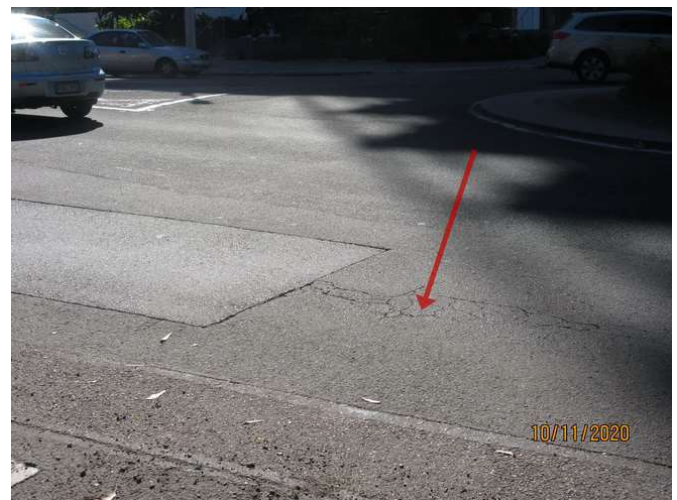
033_Note cracking damage

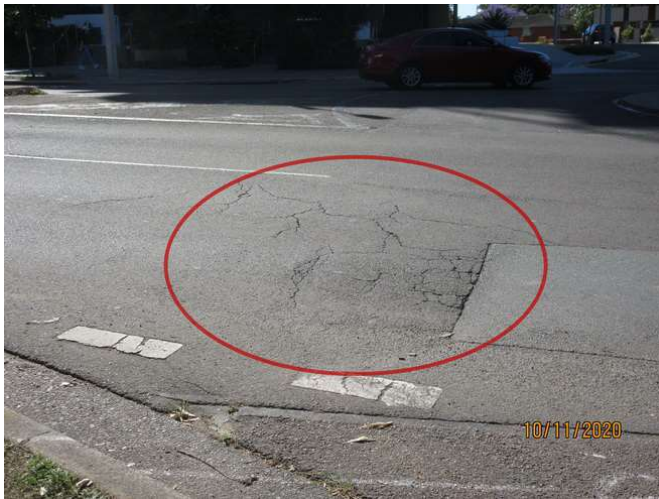
- Evident cracking note to the carriage way approaching roundabout fronting the site entry. Potholes and slight subsidence also noted to this location (see photo 277 to 287);
- Exposed soil ground along the west bound foot path fronting the ParkView construction site (see photo 044 to 051, 086 to 105);
- Two traffic sign poles to site entry driveway were noted leaning from possible impact damage (see photo 036, 037) ;
- Wheel damage to the footpath to the site entry (see photo 038);

038_Note cracking damage to footpath

However, the following defects are considered visually evident and recommended to be monitored during the construction;

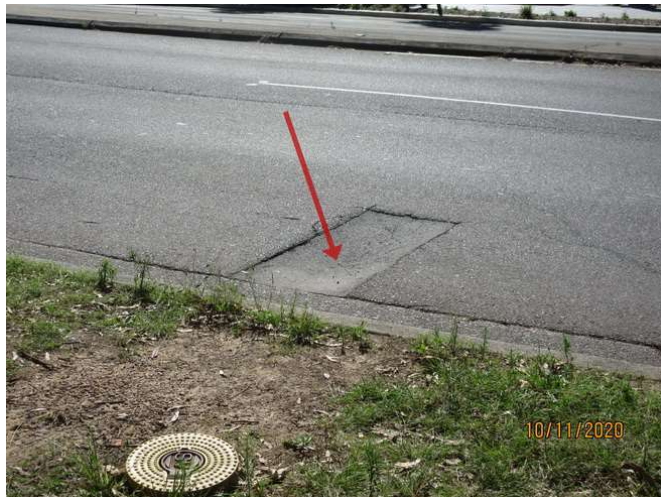
048_Note slight subsidence

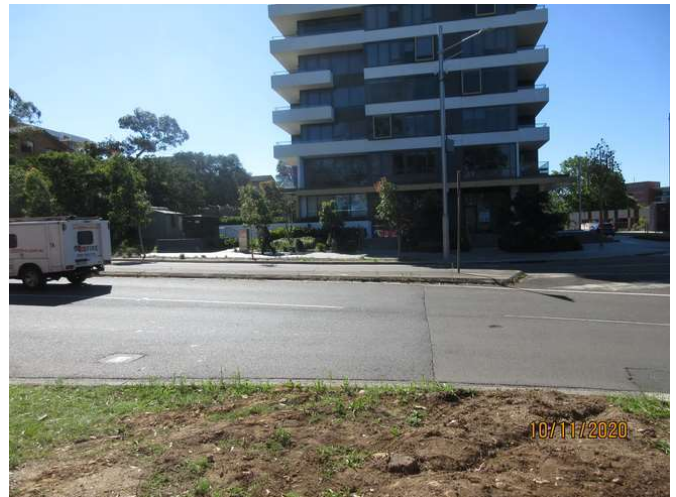
049_Note slight subsidence

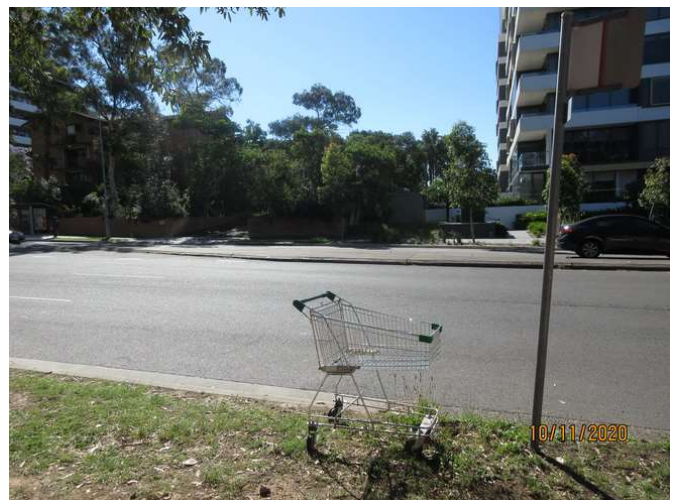
051_Note exposed soil ground along footpath

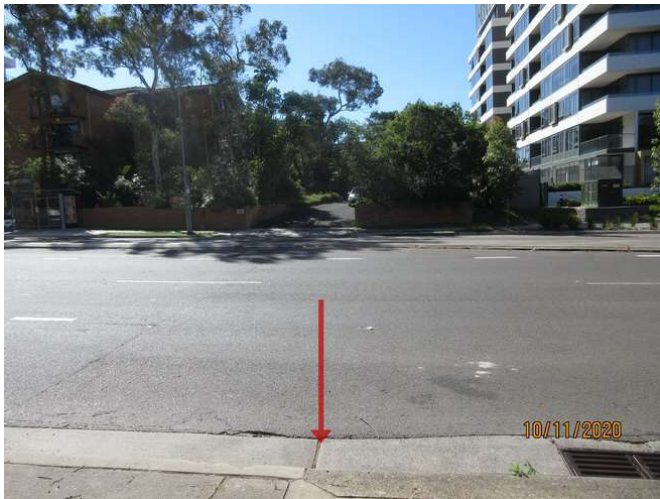
056_Note cracking damage

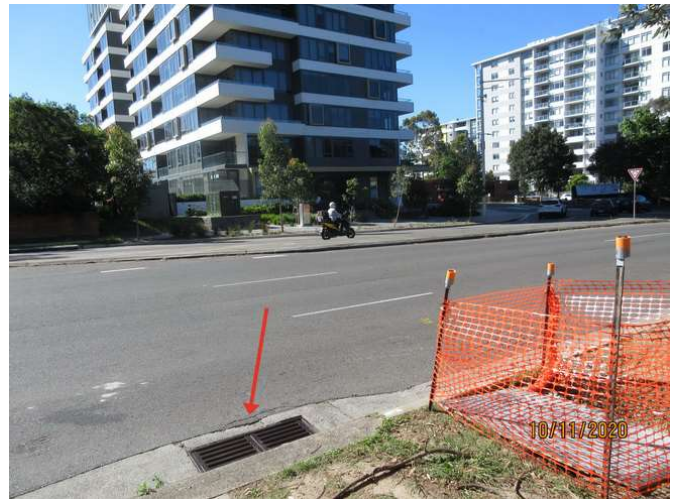
057_Note slight subsidence

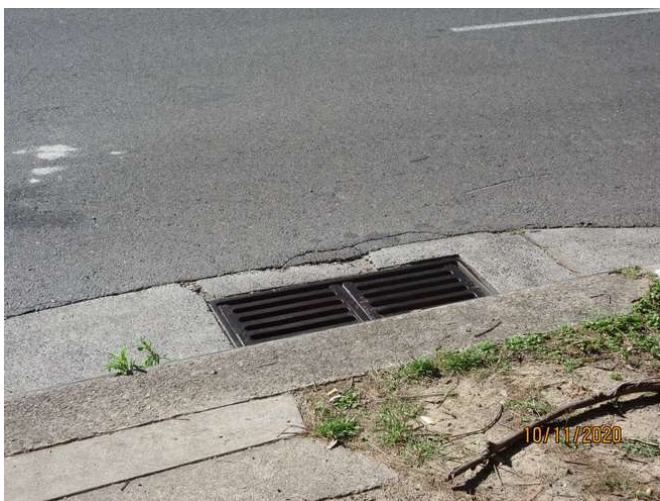
058_Note cracking damage

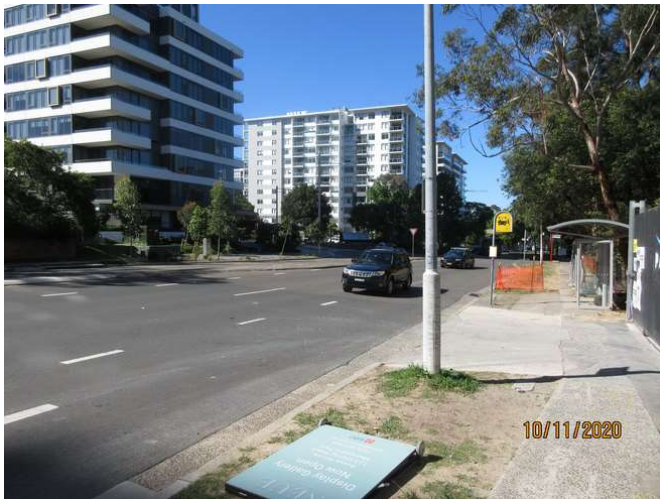
062_Note cracking damage

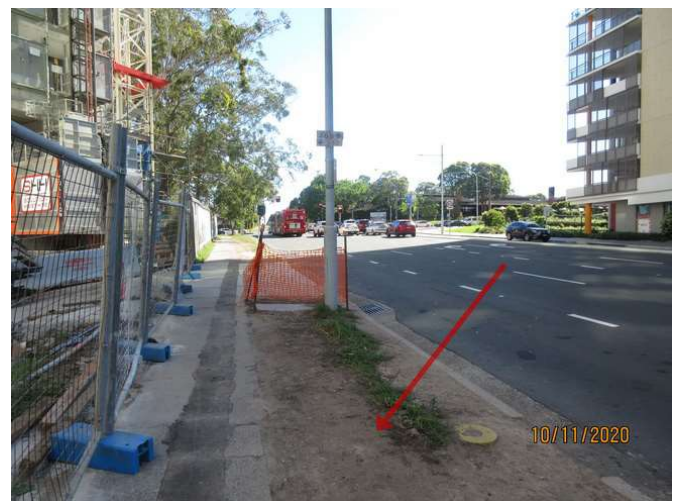
077_Note exposed soil ground along footpath

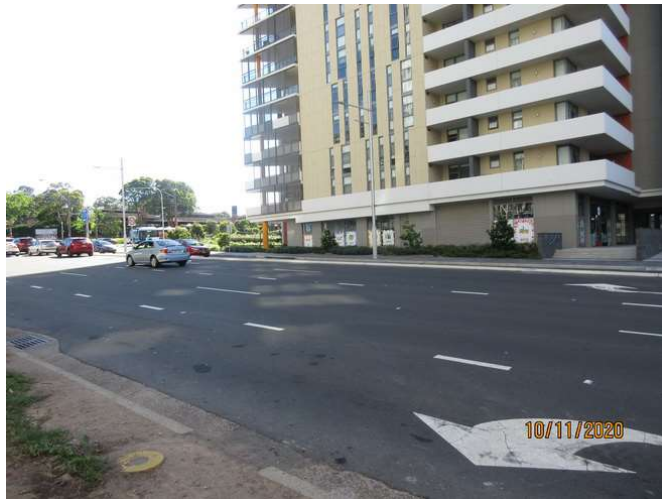
078_Note exposed soil ground along footpath

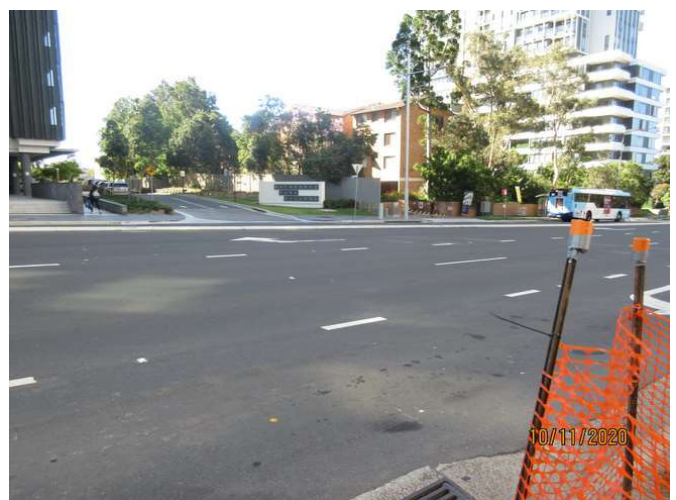
083_Note cracking damage

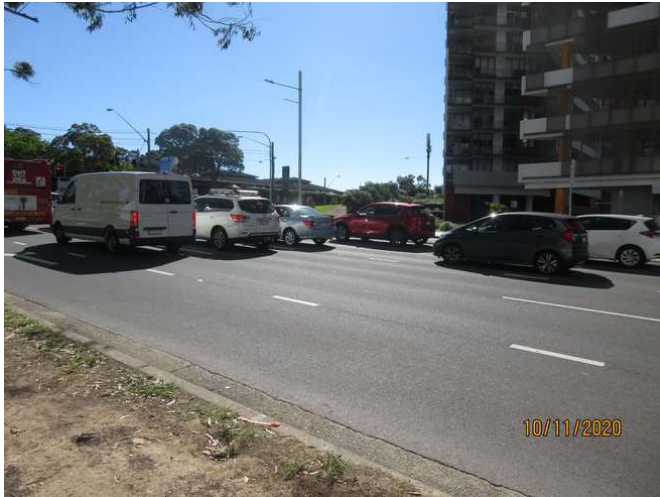
090_Note exposed soil ground along footpath

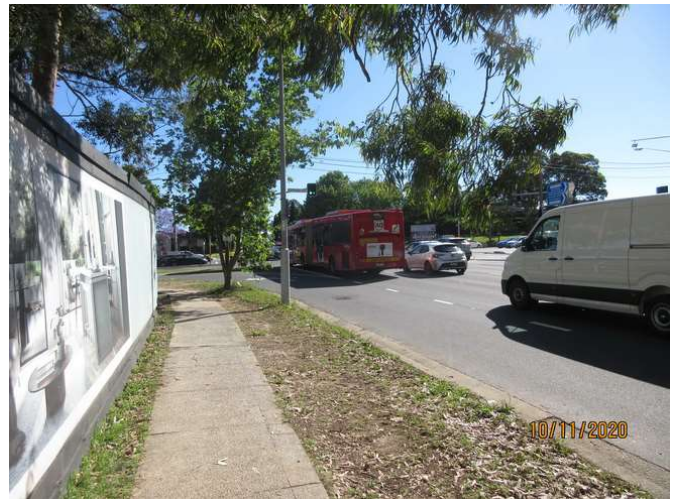
093_Note exposed soil ground along footpath

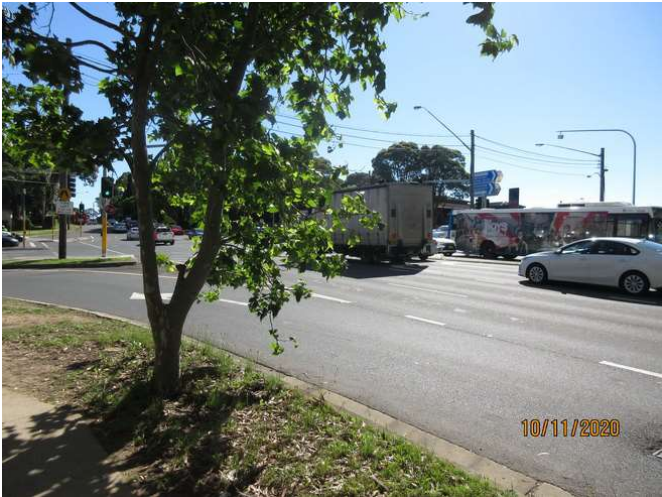
098_Note exposed soil ground along footpath

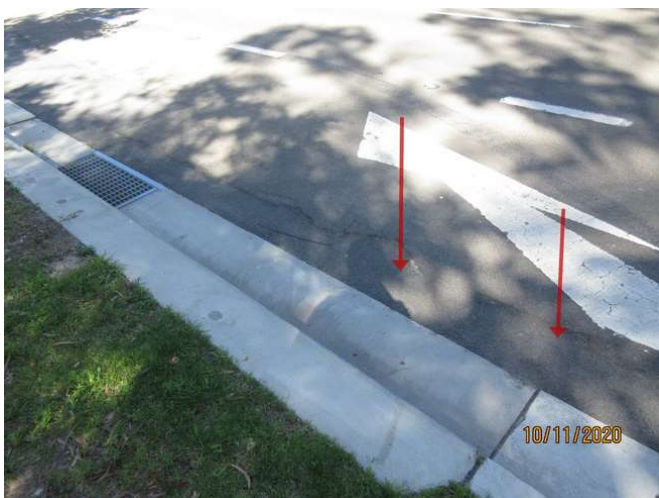
148_Note cracking damage

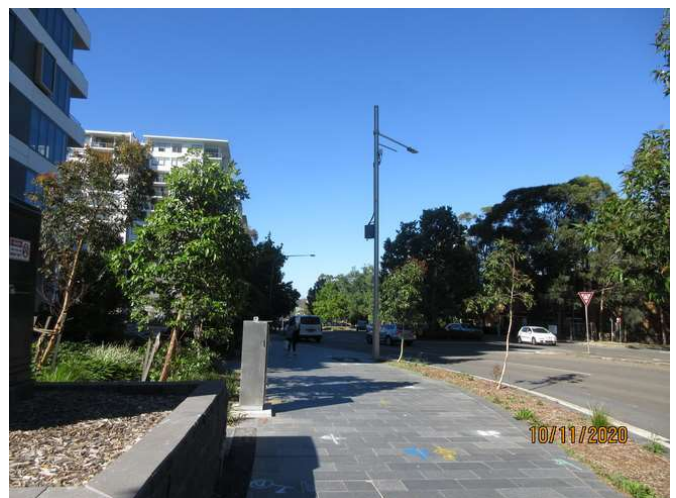
149_Note cracking damage

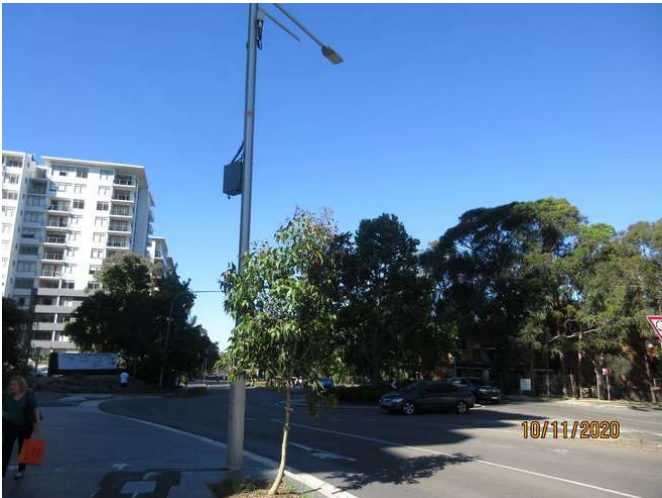
154_Note cracking to medium strip

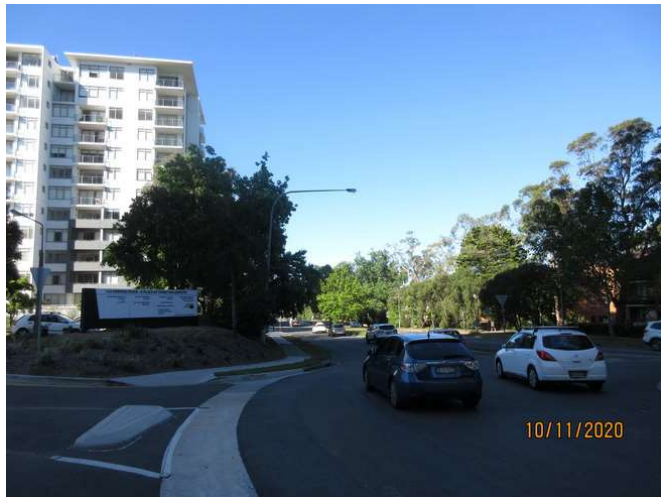
162_Note localised pothole

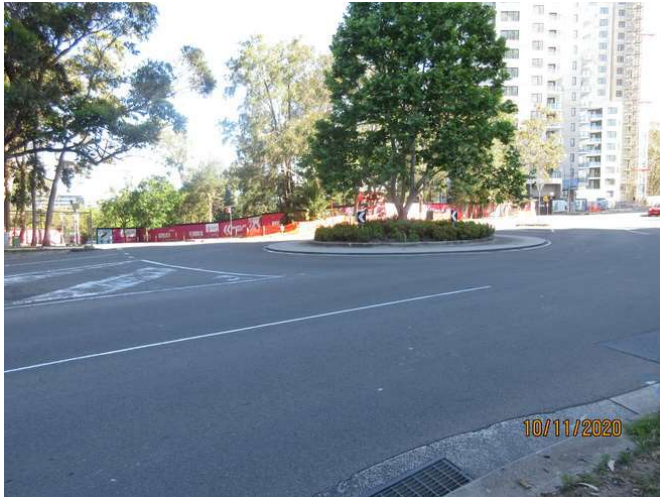
180_Note cracking damage

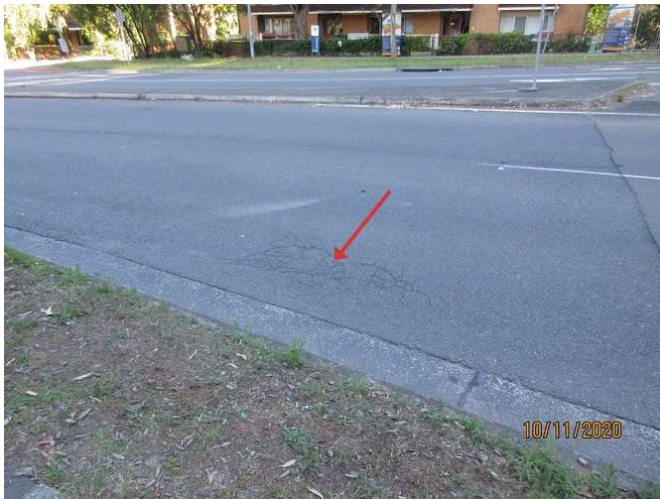
182_Note cracking damage

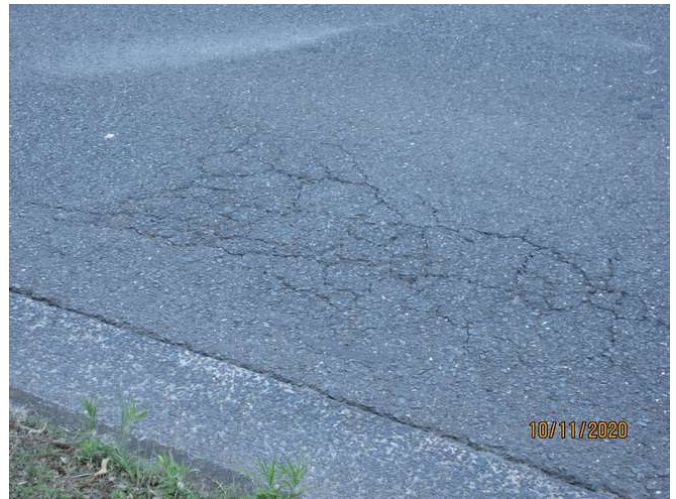
183_Note cracking damage

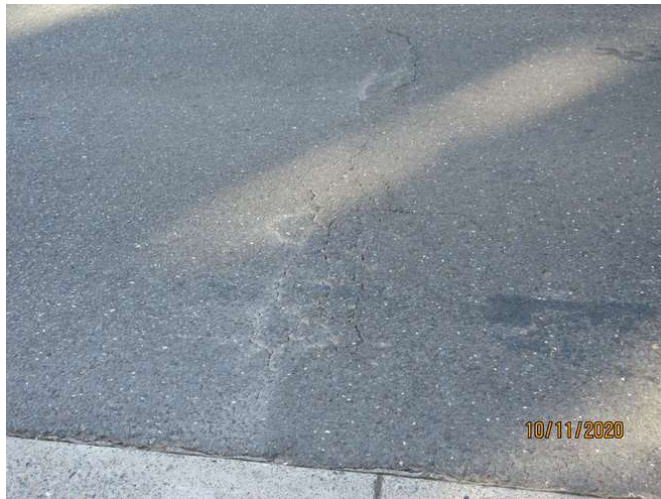
210_Note cracking damage

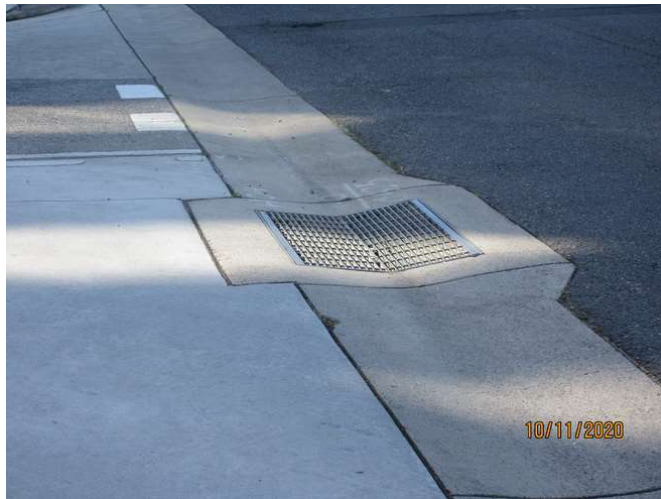
212_Note cracking damage

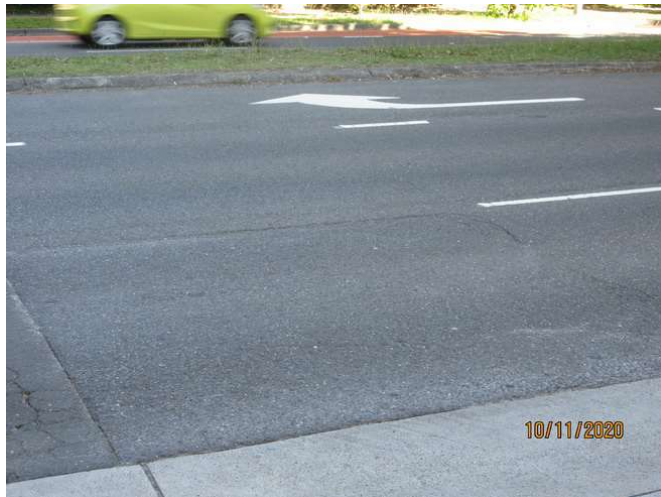
216_Note cracking damage

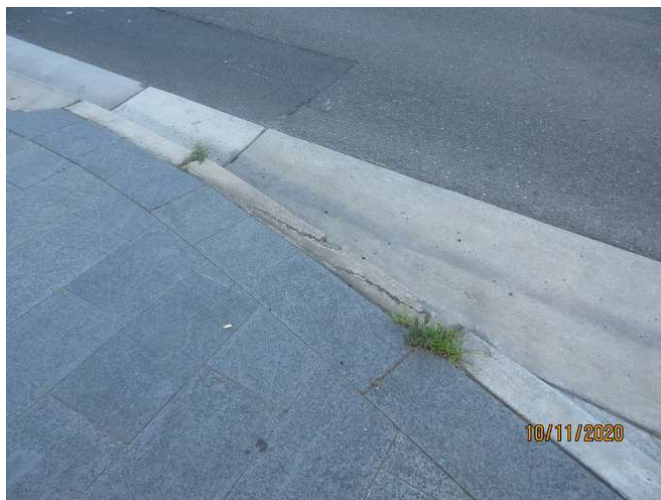
218_Note cracking damage

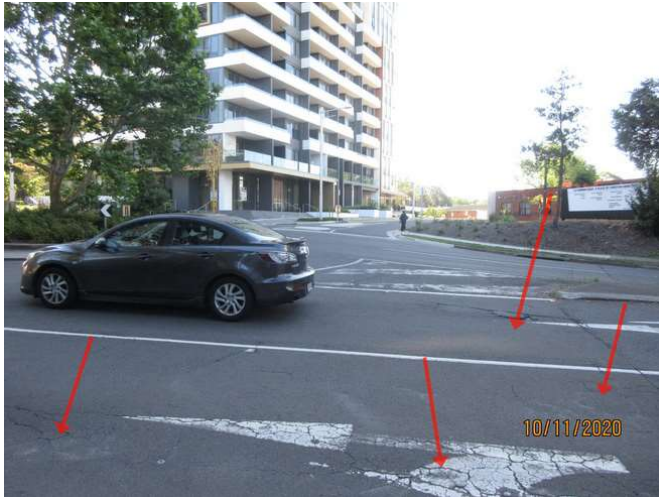
277_Note cracking damage

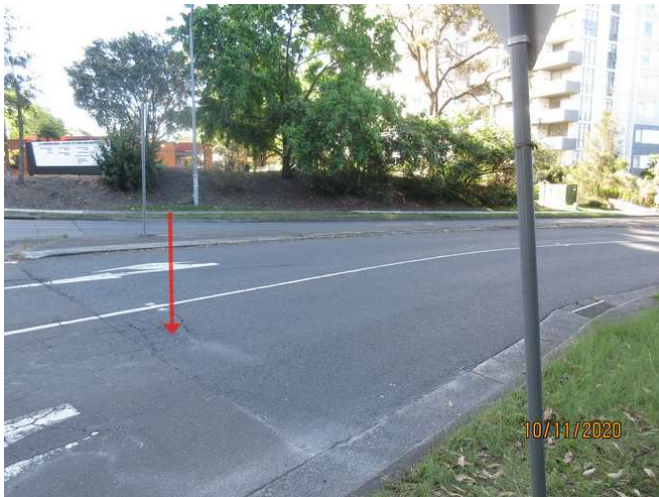
279_Note cracking damage

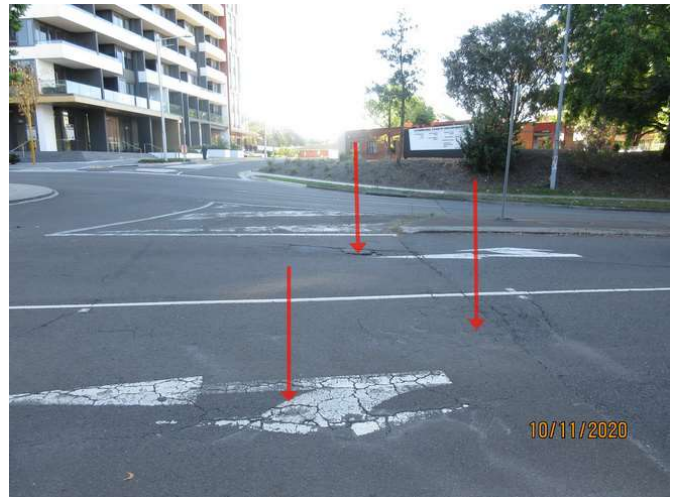
280_Note cracking damage

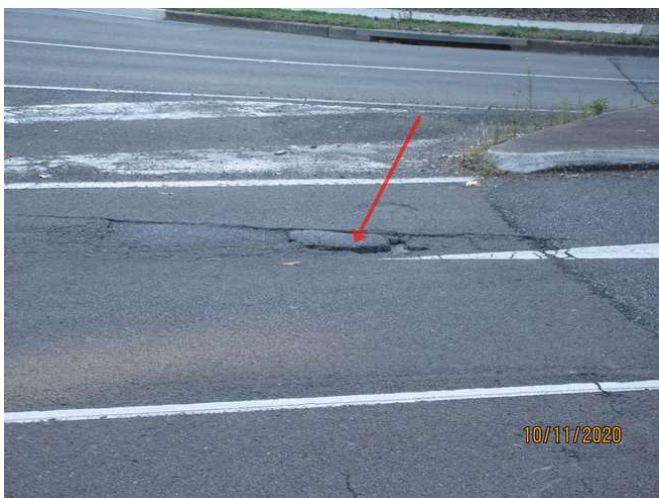
281_Note pothole next to roundabout

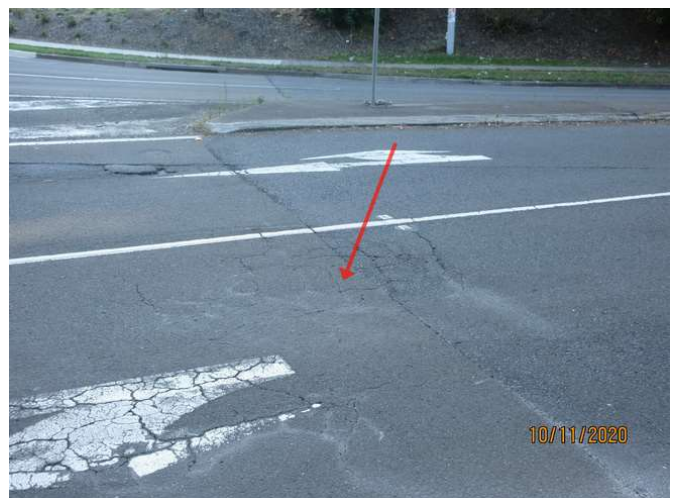
282_Note cracking damage

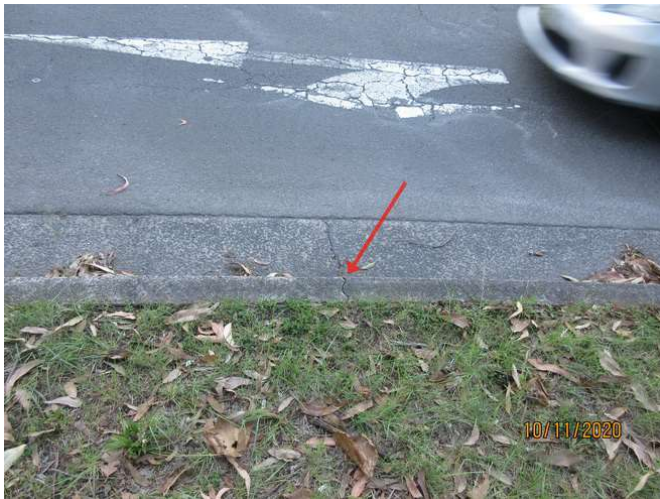
285_Note cracking damage

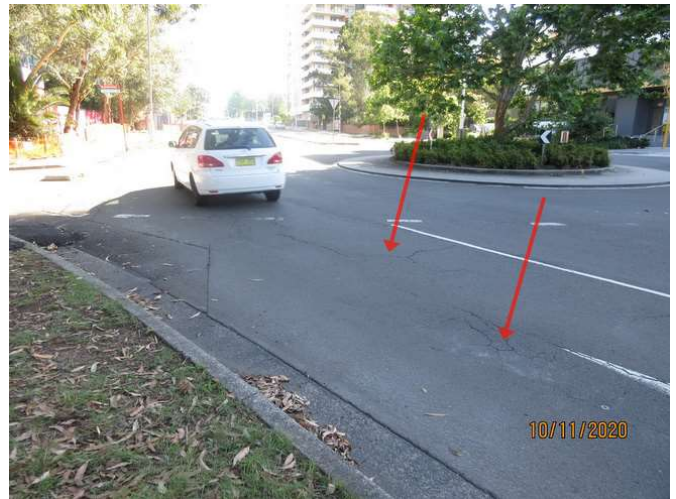
286_Note cracking damage

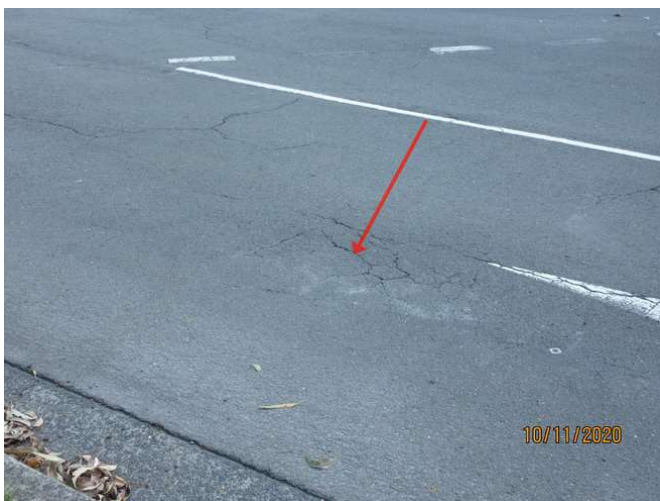
287_Note cracking damage

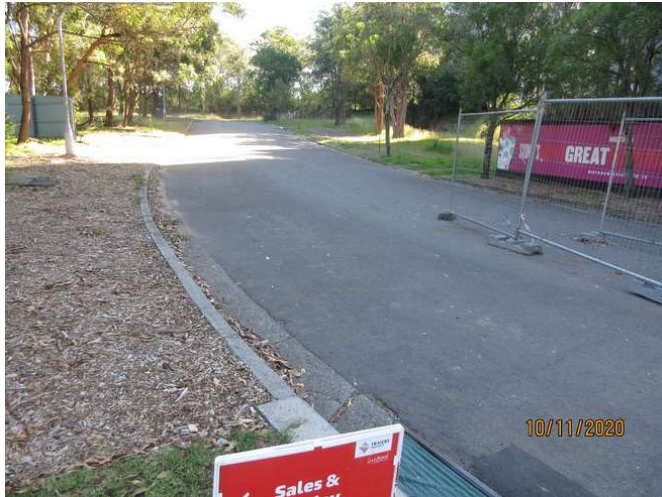
002_Note slight surface cracking and scratch damage

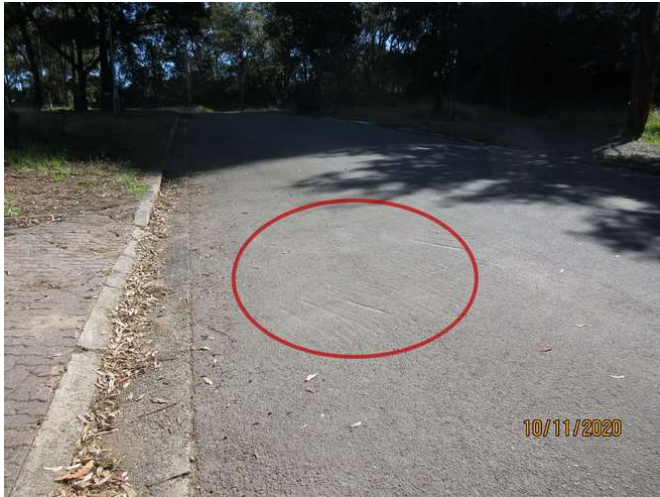
007_Note slight surface cracking and scratch damage

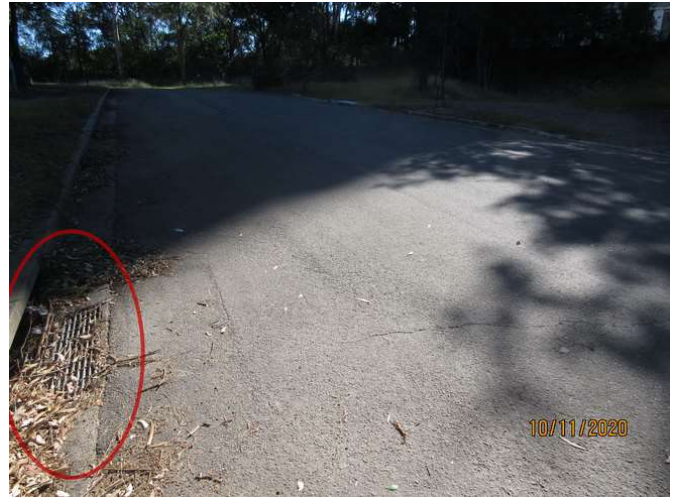
008_Road drains generally noted with leave blockage

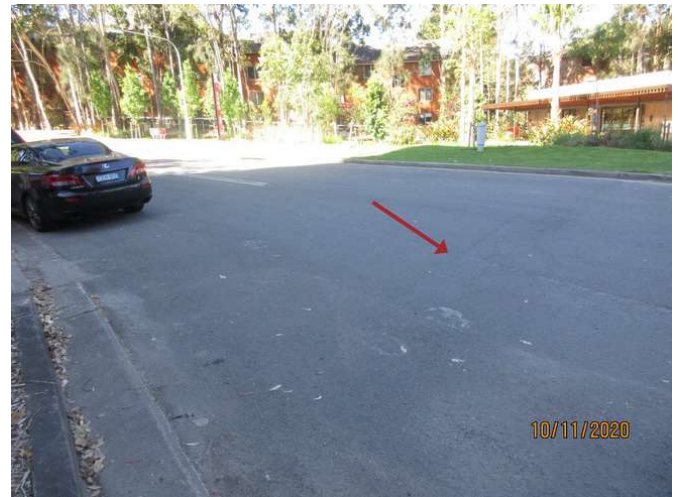
028_Note slight surface cracking and scratch damage

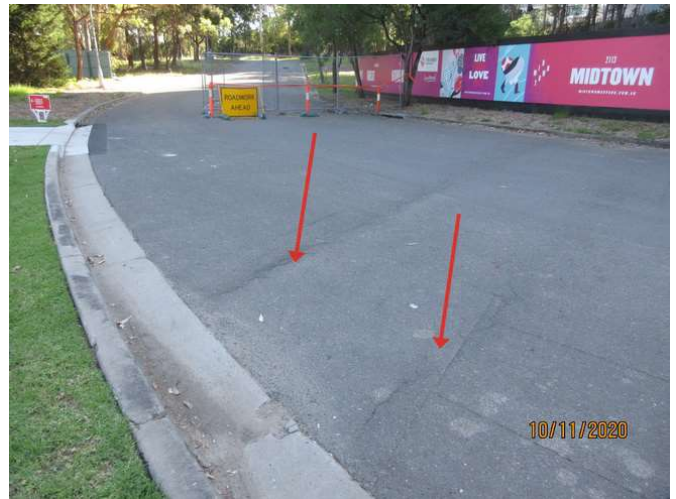
052_Note slight surface cracking and scratch damage

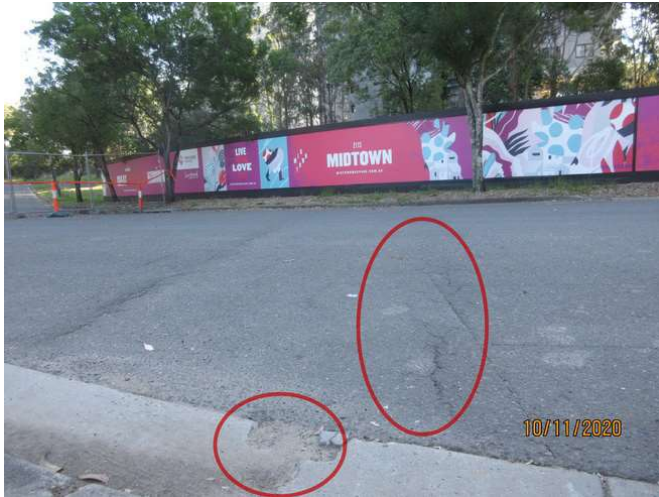
055_Note slight surface cracking and scratch damage

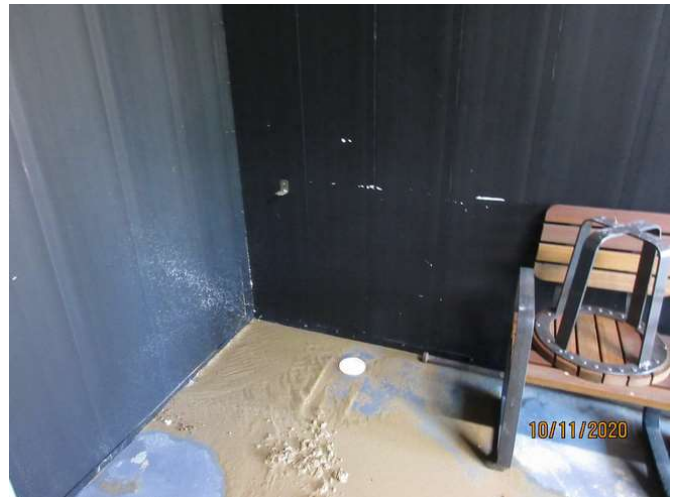
377_Water seepage from back og the retaining wall

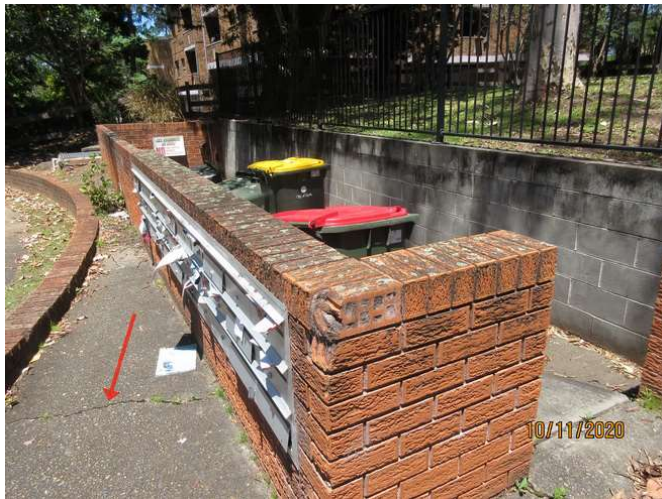
No 1-3_003_Note the cracking damage

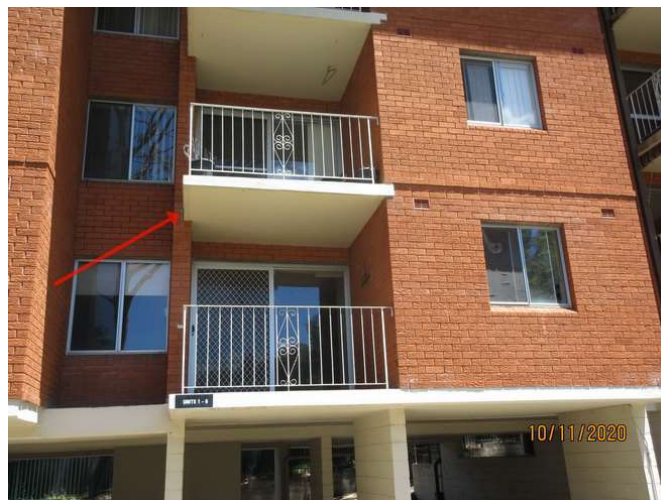
No 1-3_014_Note the gap

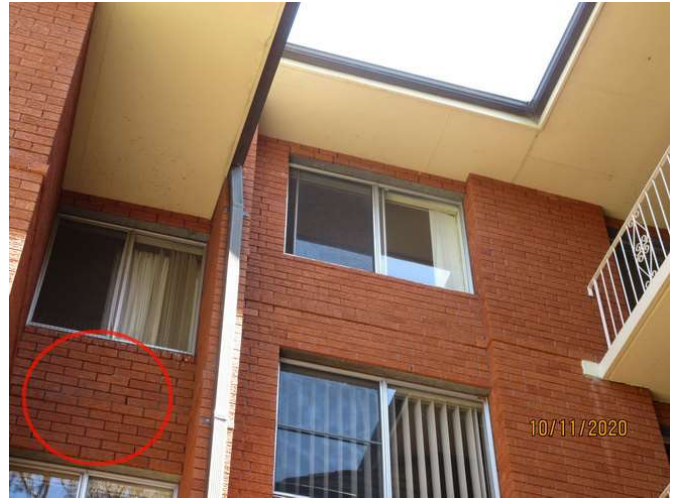
No 1-3_032_Note spalling to course joint lines

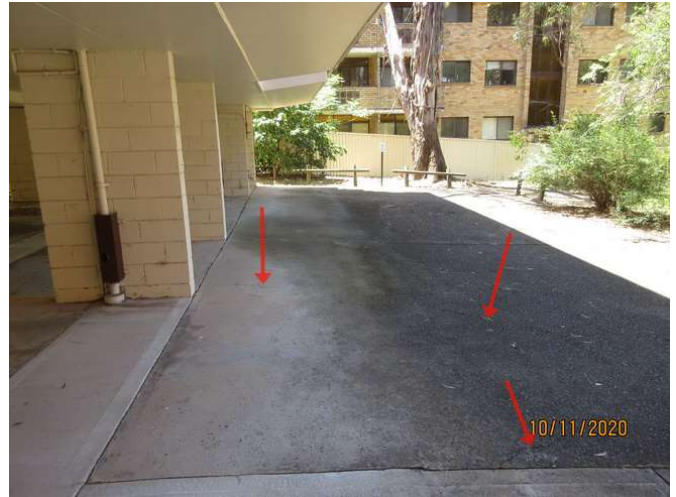
No 1-3_050_Note the cracking damage

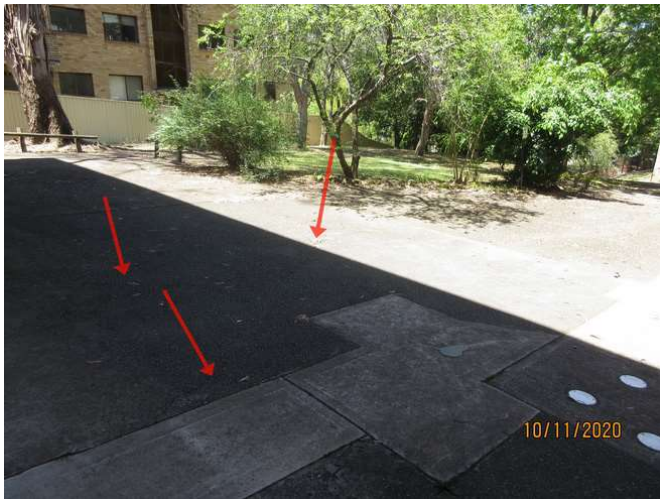
No 1-3_051_Note the cracking damage

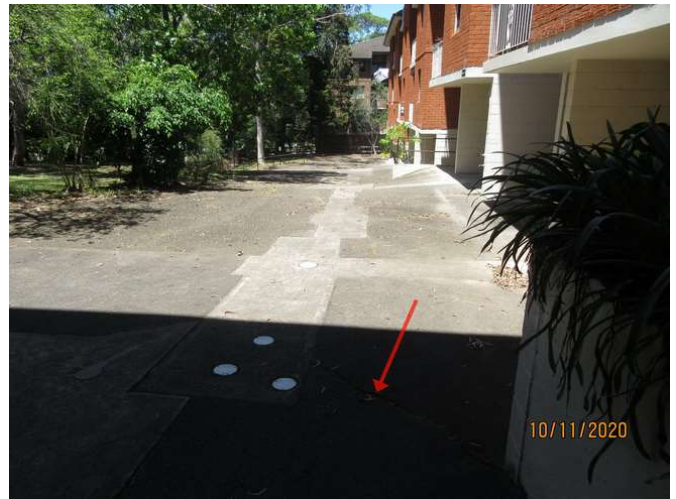
No 1-3_052_Note the cracking damage

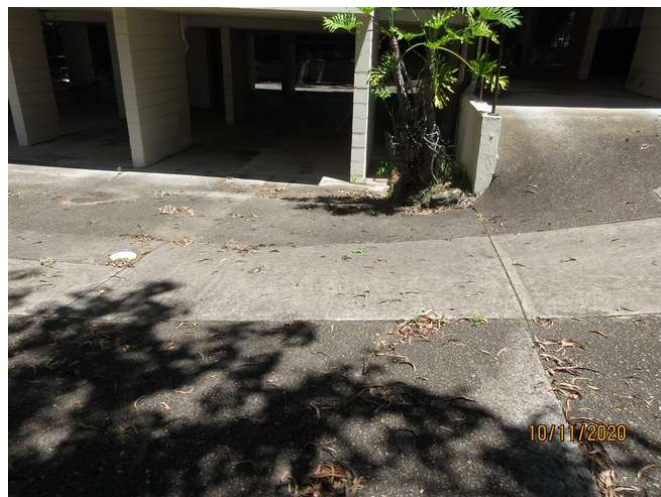
No 1-3_056

- Cracking damage is generally noted to the concrete parking ground under the building
- Evident ground subsidence along the road next to the neighbouring deep excavation (see photo 056)

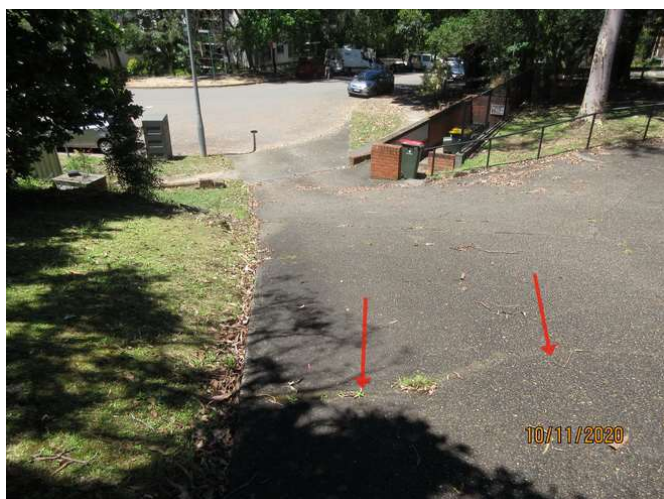
No 1-3_057_Note the cracking damage

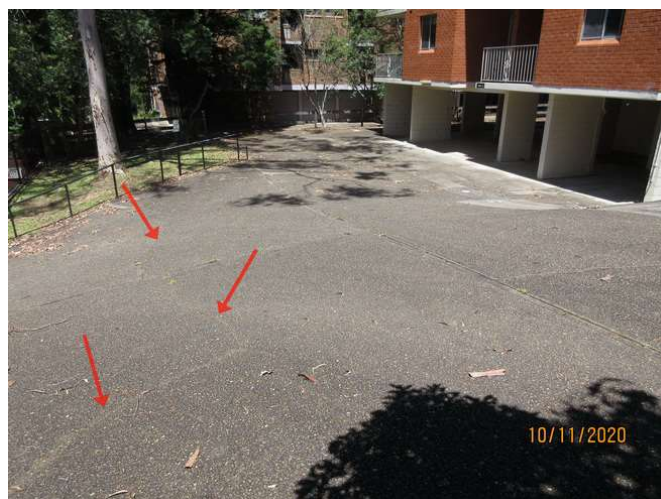
No 1-3_058_Note the cracking damage

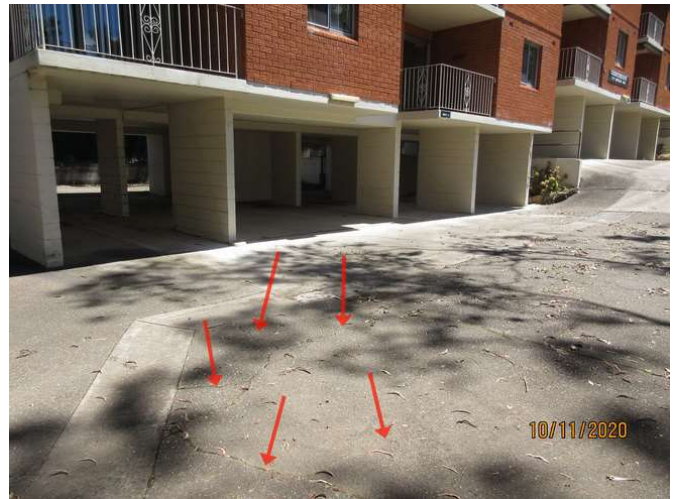
No 1-3_064_Note the cracking damage

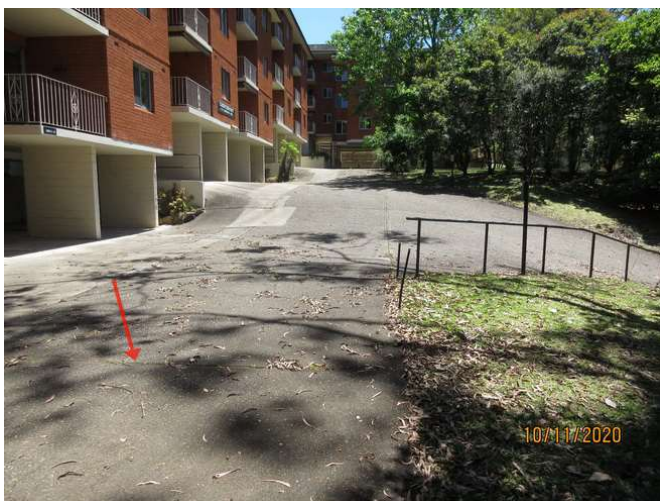
No 1-3_065_Note the cracking damage

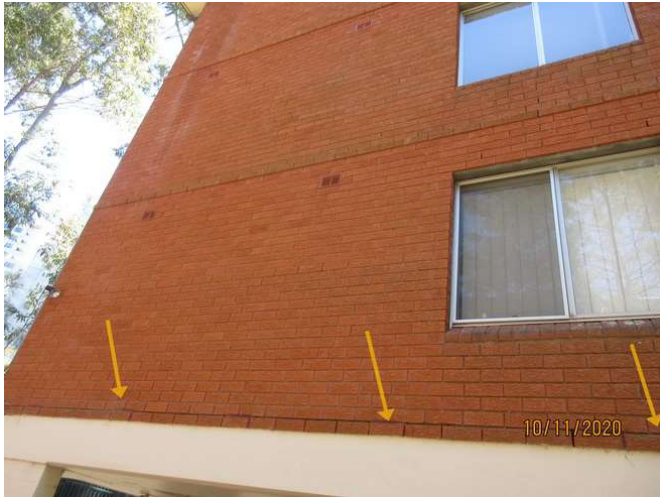
No 1-3_067_Note spalling to course joint lines

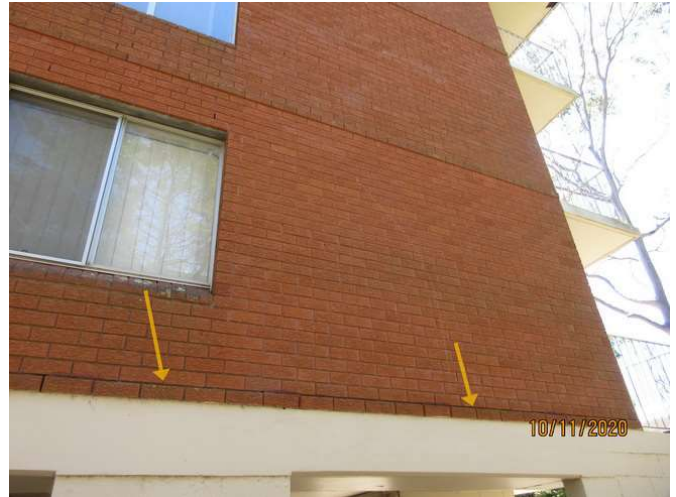
No 1-3_068_Note spalling to course joint lines

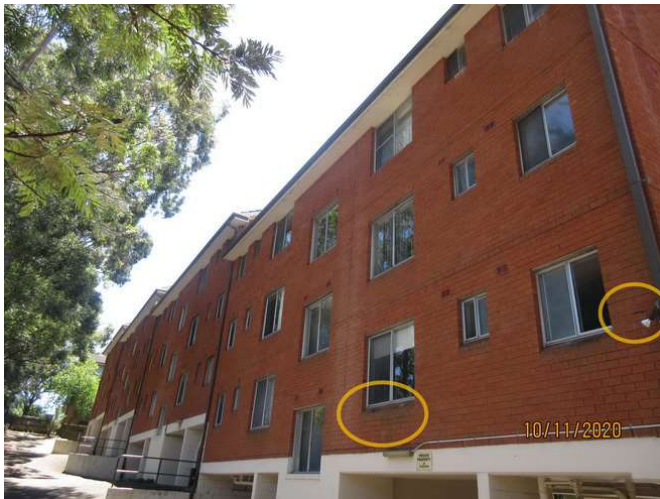
No 1-3_069_Note the cracking damage

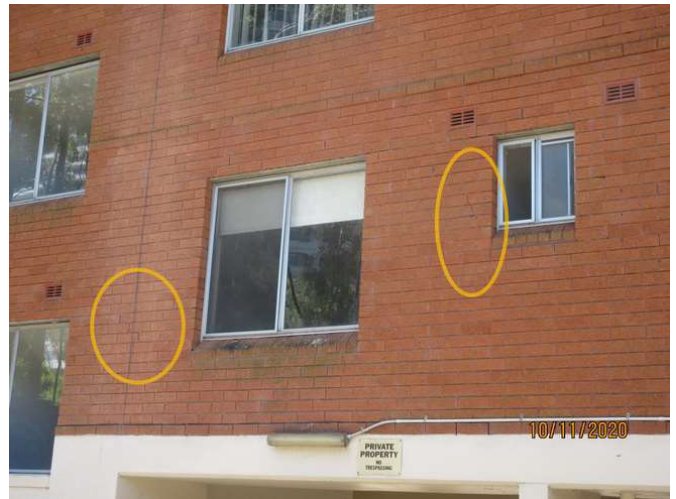
No 1-3_076_Note the cracking damage

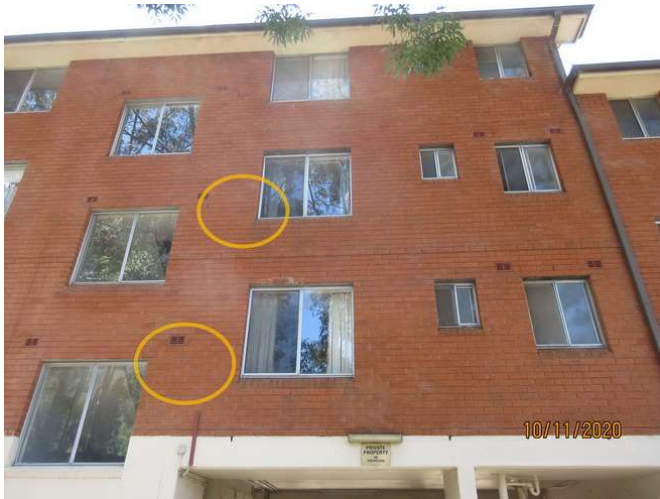
No 1-3_085_Note the cracking damage
