CONSTRUCTION CERTIFICATE No. J/74556/01

Issued under the Environmental Planning and Assessment Act 1979 Sections 6.4 and 6.7

Address: Ivanhoe Estate comprising Ivanhoe Place, Wilcannia Way, Nyngan Way, Narromine Way and Cobar Way, part of 2-4 Lyonpark Road and portions of Shrimptons Creek adjacent to the centre line of the creek, Macquarie Park

Description: Stage 1 development application for the redevelopment of the Ivanhoe Estate, including:

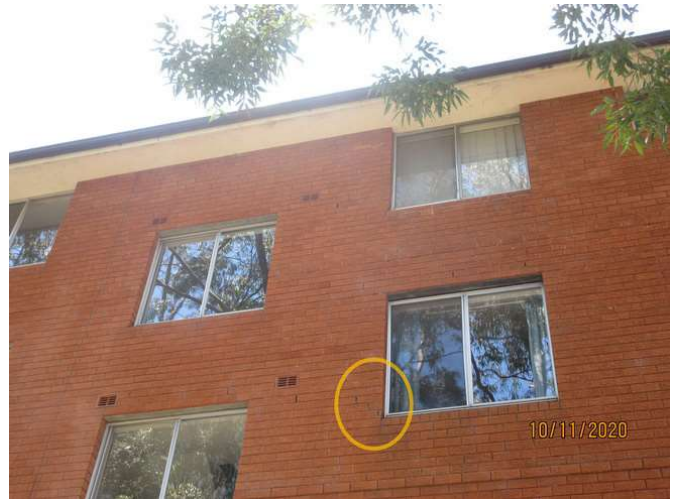
No 1-3_086_Note the cracking damage

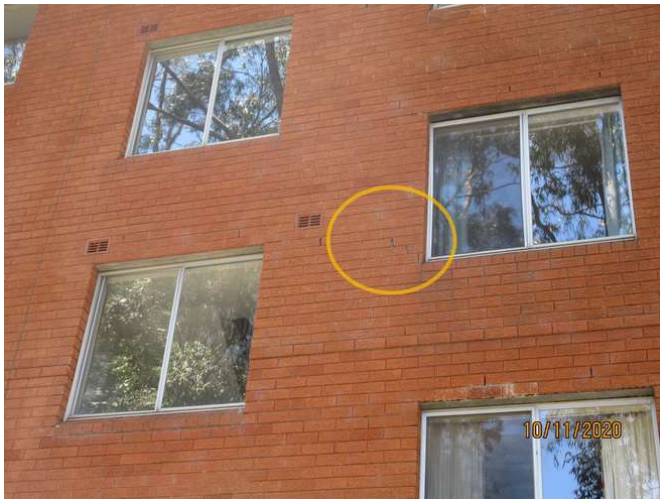
No 1-3_087_Note the cracking damage

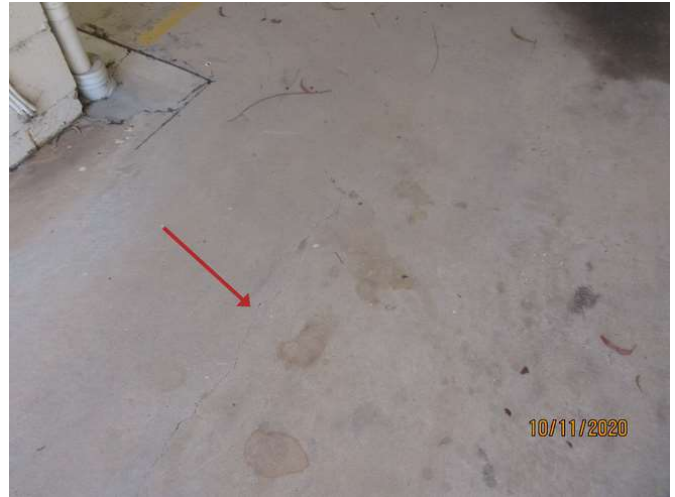
No 1-3_169_Note the cracking damage

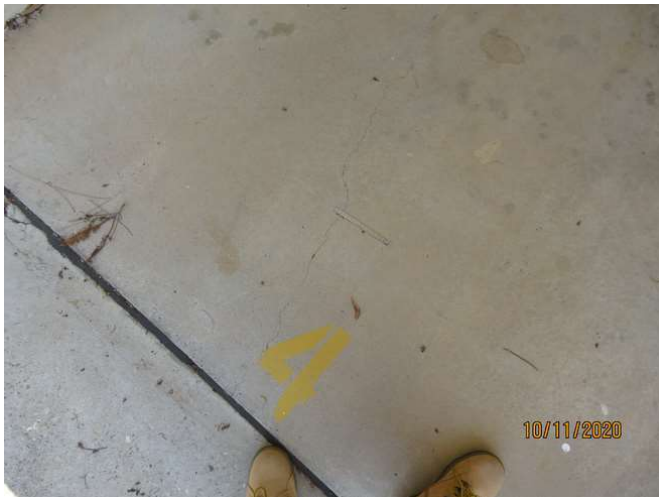
No 1-3_170_Note the cracking damage

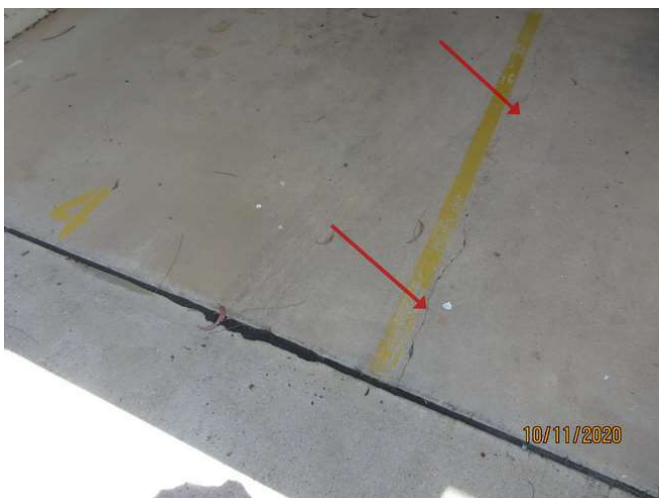
No 1-3_172_Note 1.0mm cracking width at representative location

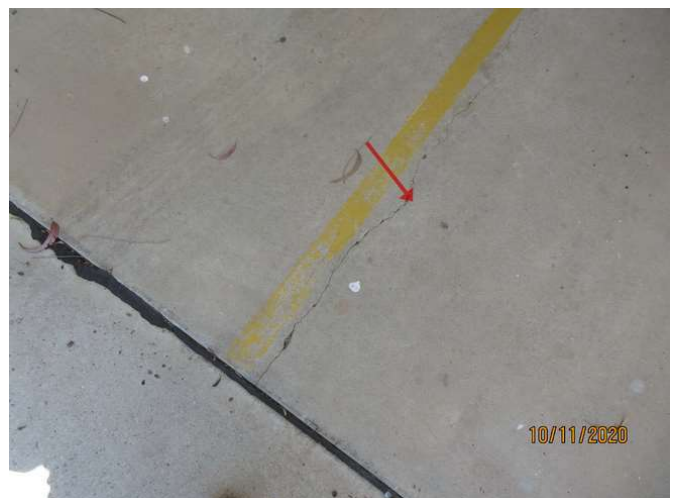
No 1-3_173_Note the cracking damage

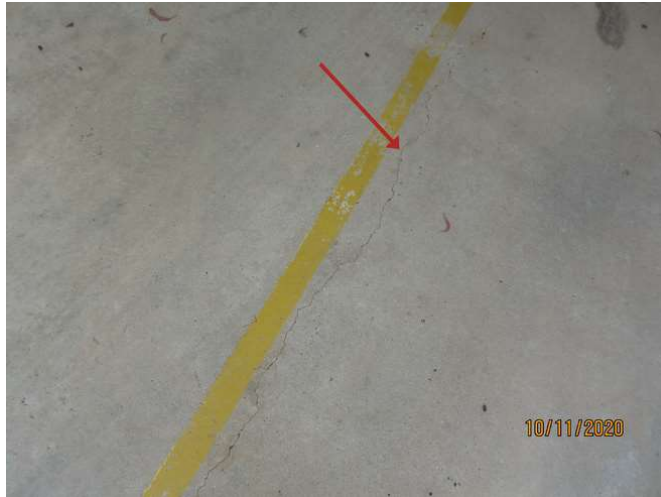
No 1-3_174_Note the cracking damage

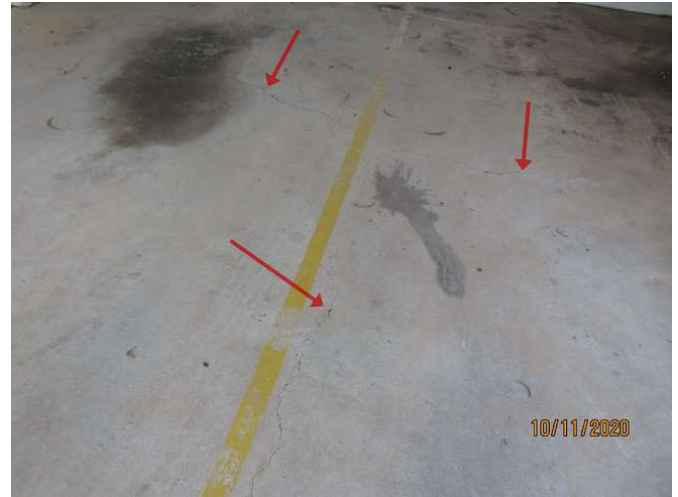
No 1-3_175_Note the cracking damage

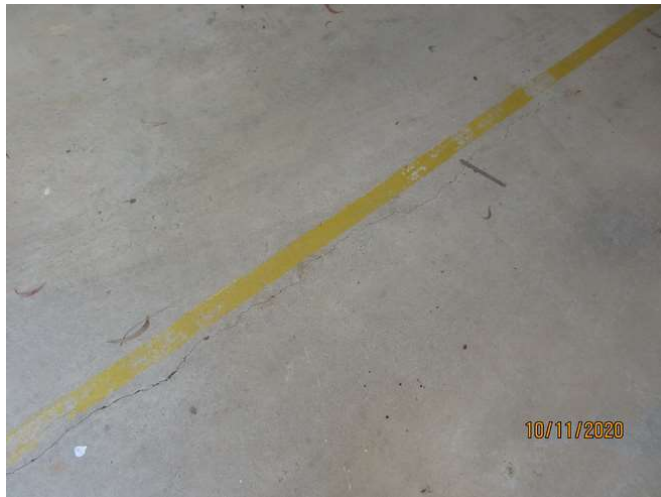
No 1-3_176_Note the cracking damage

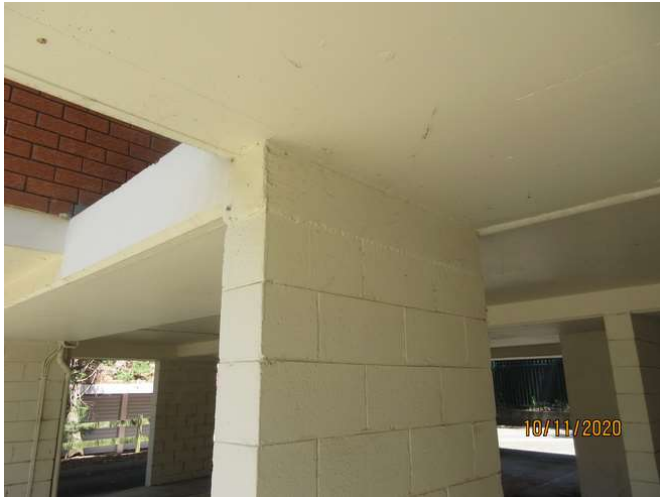
No 1-3_180_Note the cracking damage

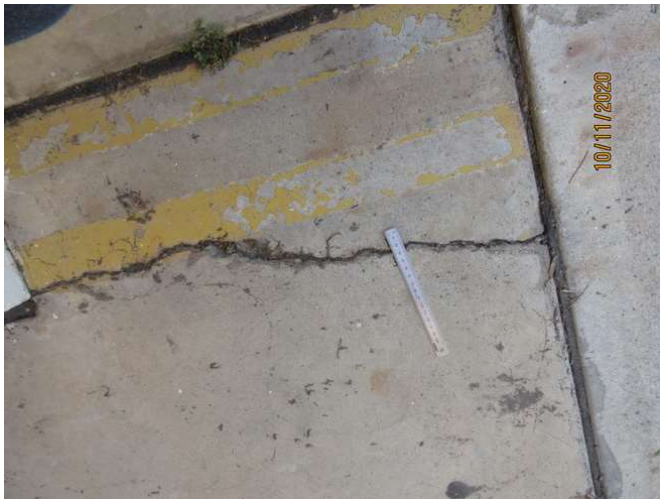
No 1-3_182_Note the cracking damage

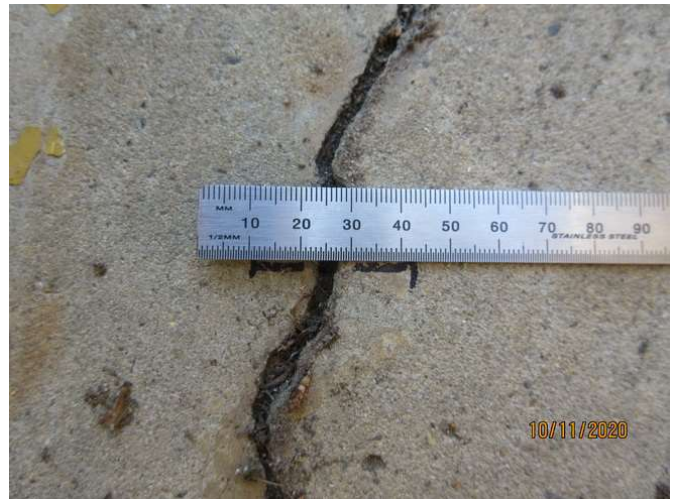
No 1-3_183_Note the cracking damage

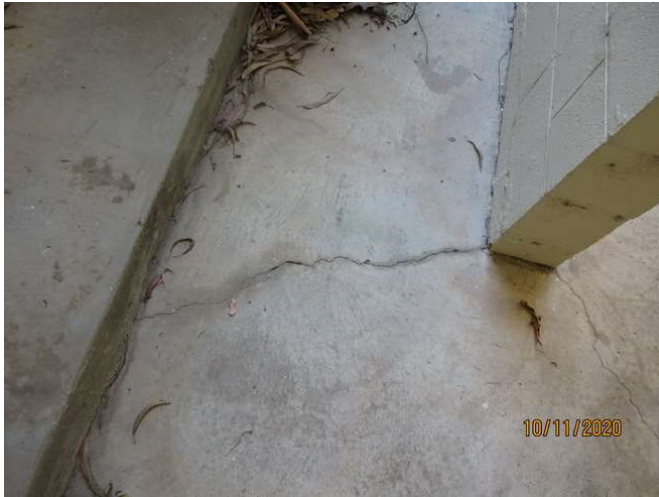
No 1-3_192_Note the cracking damage

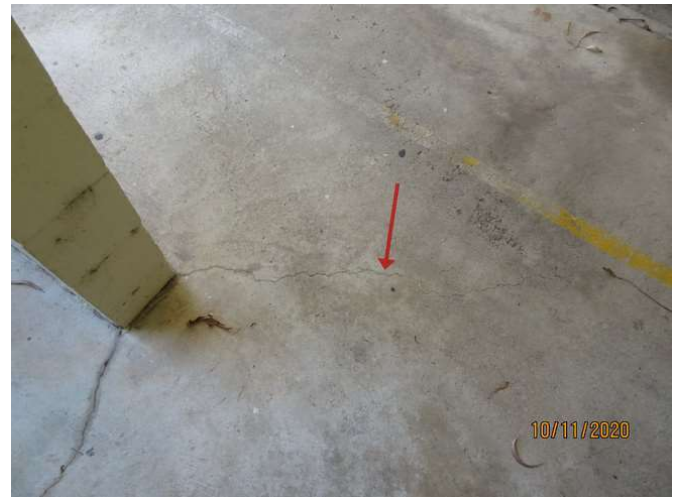
No 1-3_195_Note an estimated 1.0mm cracking width at representative location

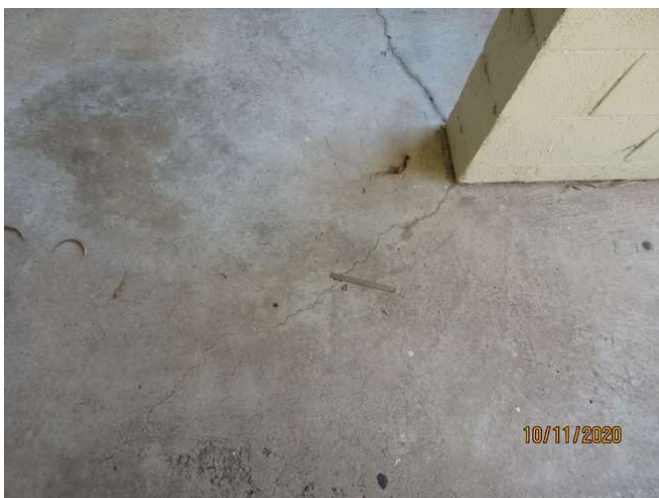
No 1-3_196_Note the cracking damage

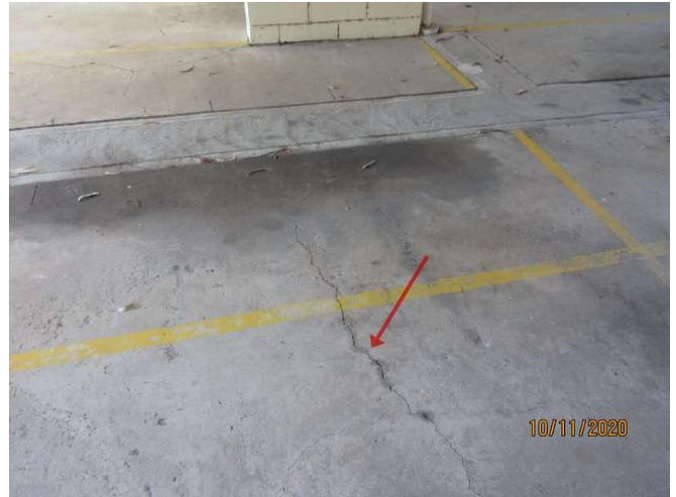
No 1-3_200_Note the cracking damage

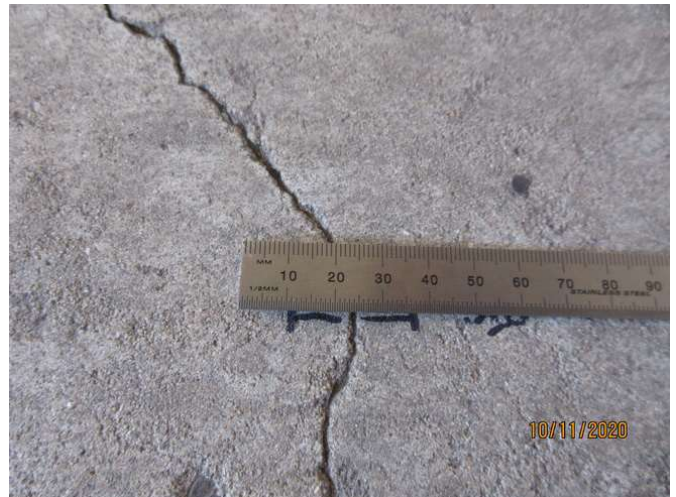
No 1-3_202_Note an estimated 1.5mm cracking width at representative location

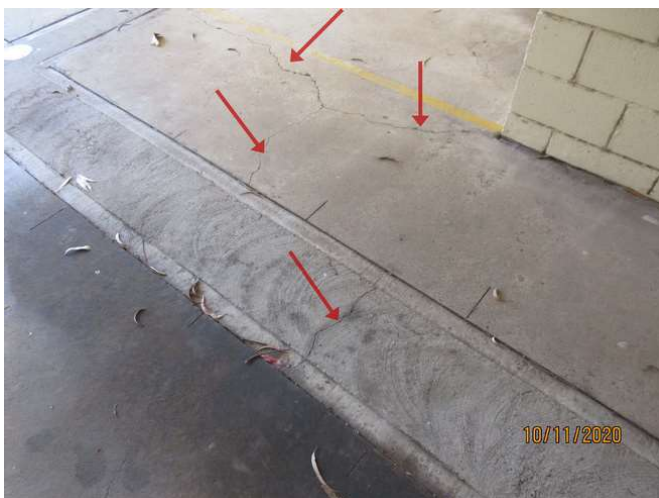
No 1-3_203_Note the cracking damage

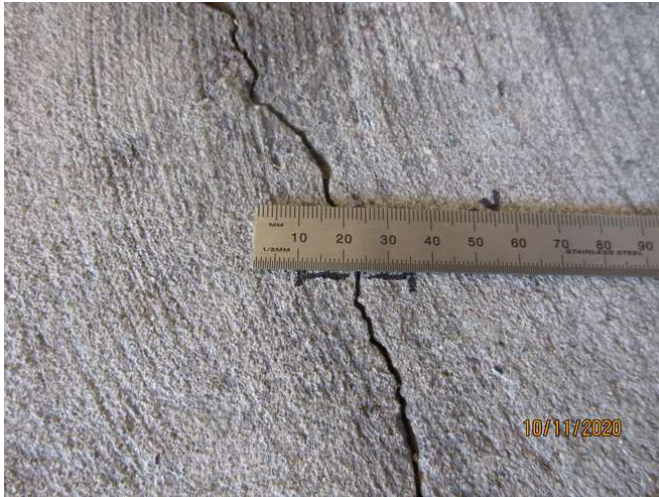
No 1-3_205_Note an estimated 1.5mm cracking width at representative location

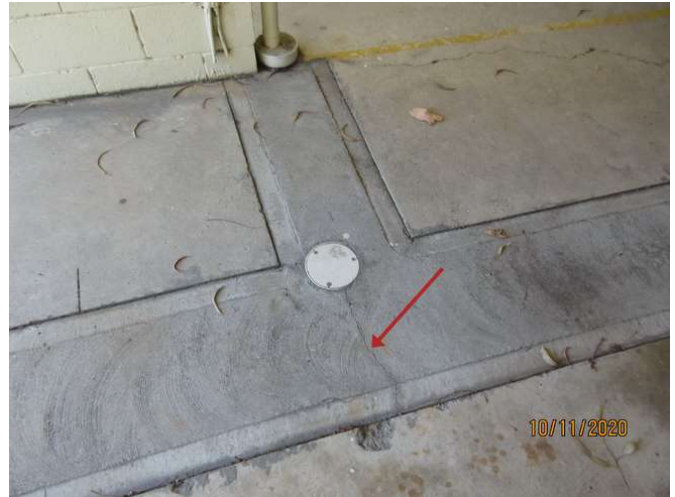
No 1-3_206_Note the cracking damage

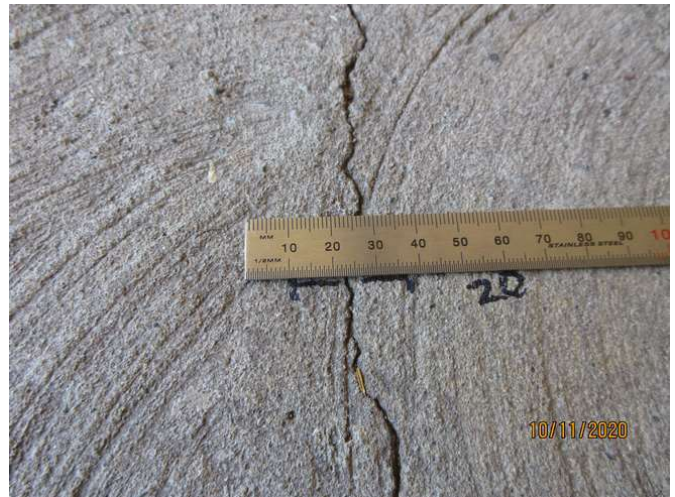
No 1-3_208_Note an estimated 1.5mm cracking width at representative location

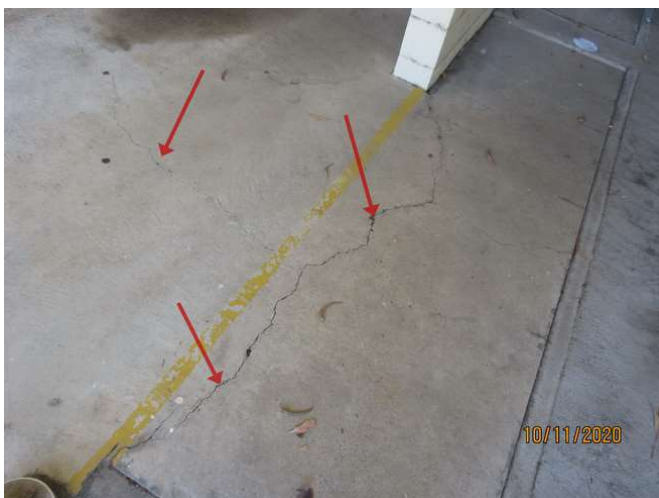
No 1-3_209_Note the cracking damage

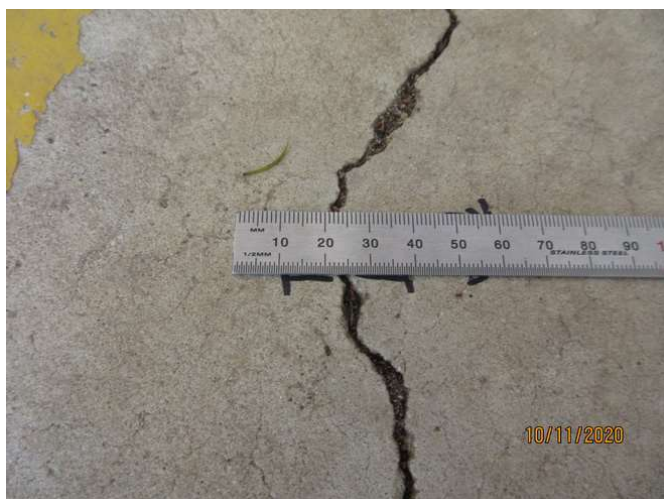
No 1-3_211_Note an estimated 2.0mm cracking width at representative location

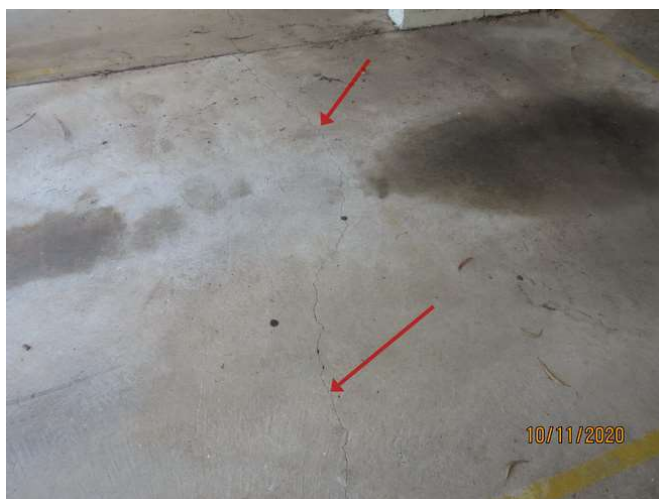
No 1-3_212_Note the cracking damage

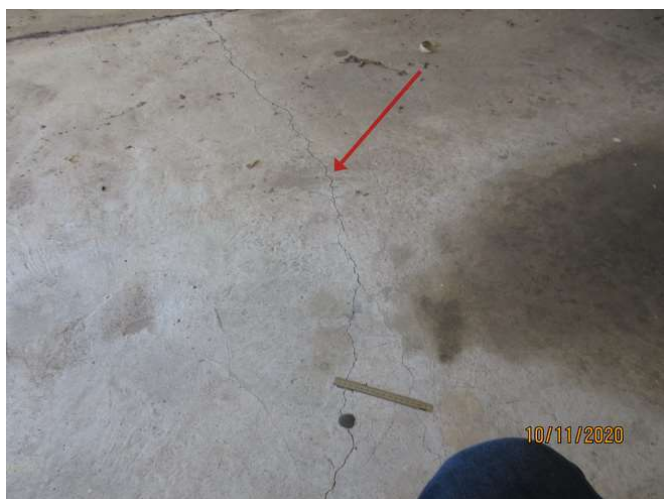
No 1-3_213_Note the cracking damage

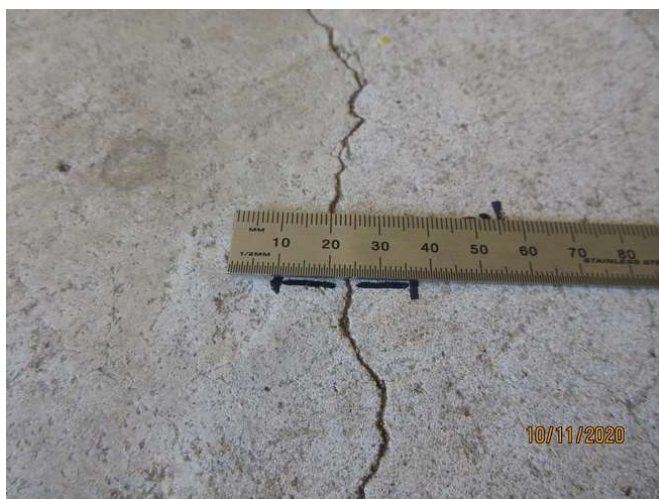
No 1-3_214_Note an estimated 1.0mm cracking width at representative location

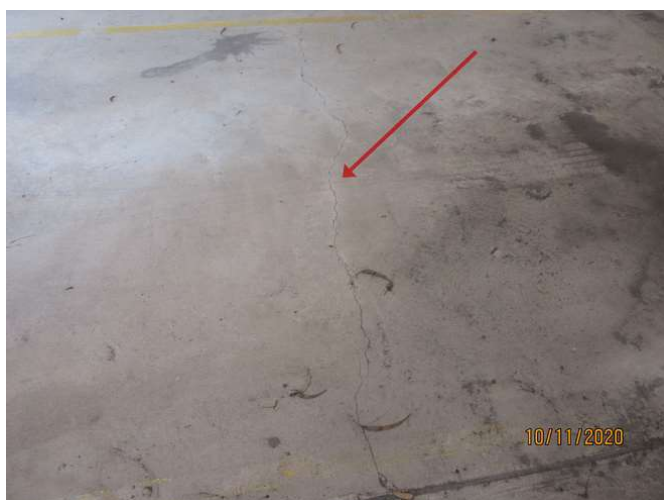
No 1-3_215_Note the cracking damage

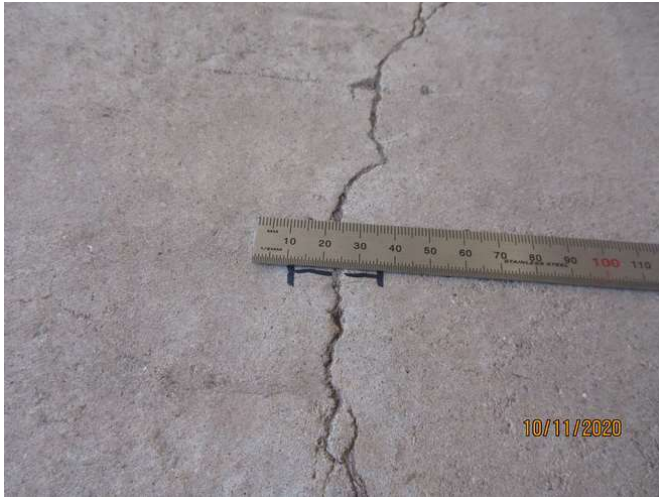
No 1-3_217_Note an estimated 3.0mm cracking width at representative location

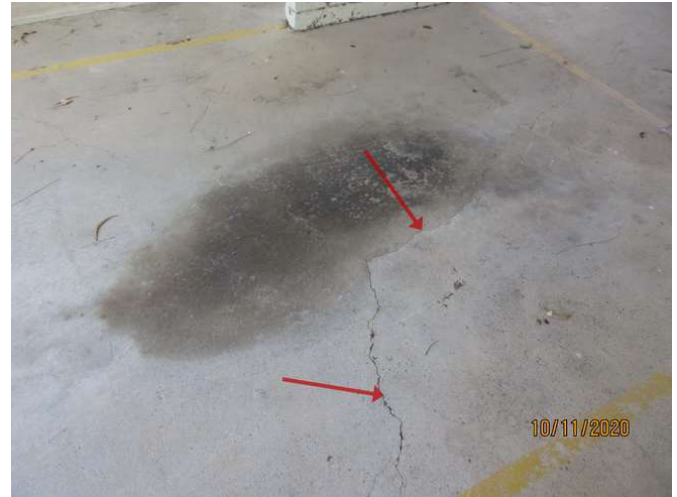
No 1-3_218_Note the cracking damage

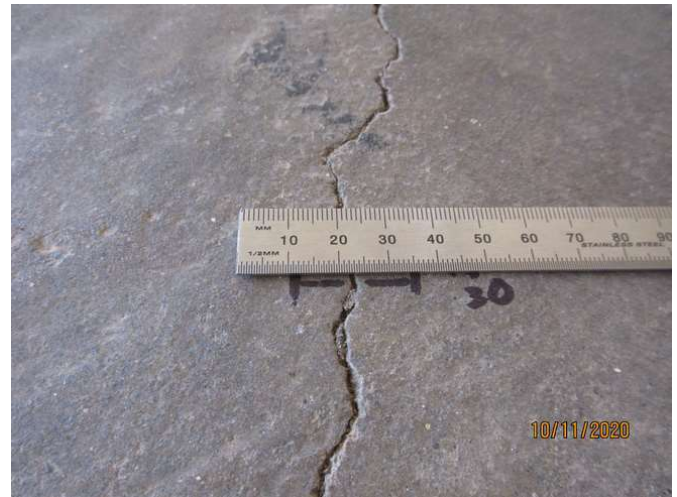
No 1-3_220_Note an estimated 1.0mm cracking width at representative location

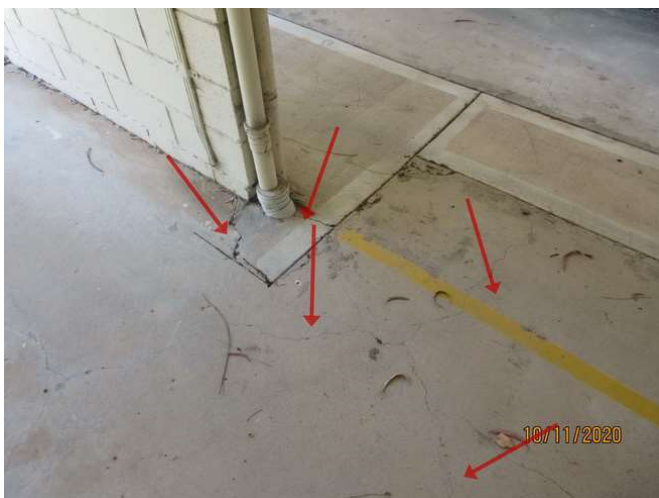
No 1-3_221_Note the cracking damage

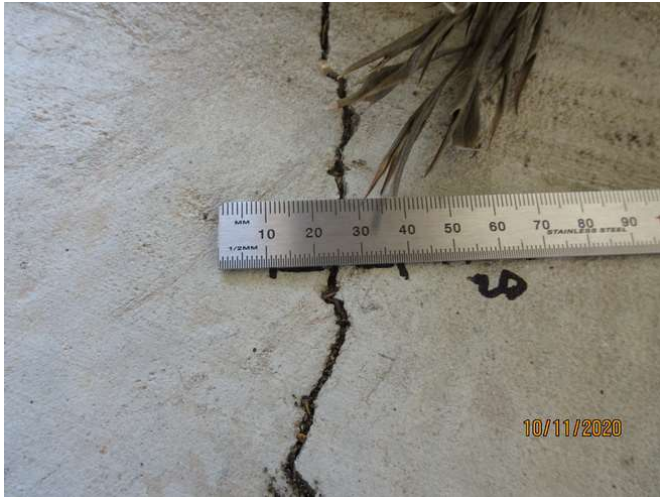
No 1-3_223_Note an estimated 2.0mm cracking width at representative location

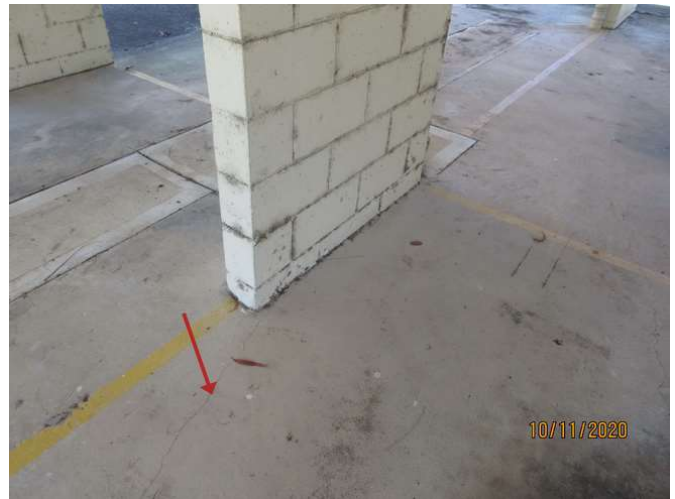
No 1-3_232_Note the cracking damage

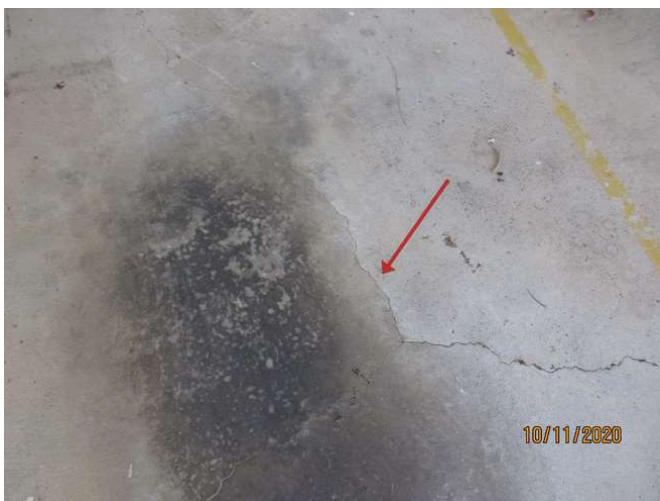
No 1-3_233_Note the cracking damage

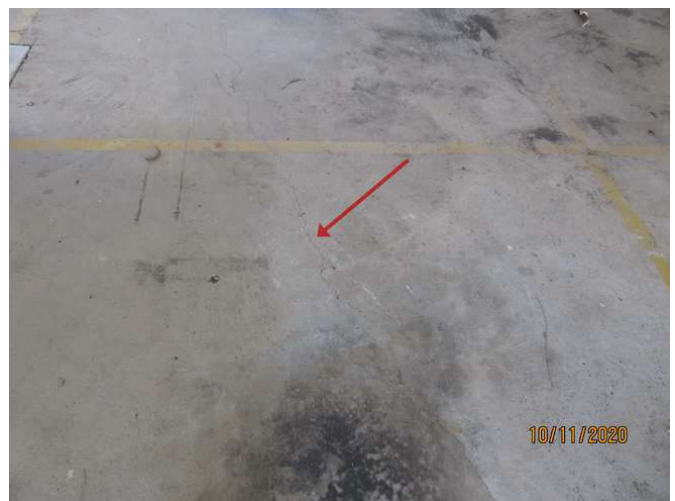
No 1-3_234_Note the cracking damage

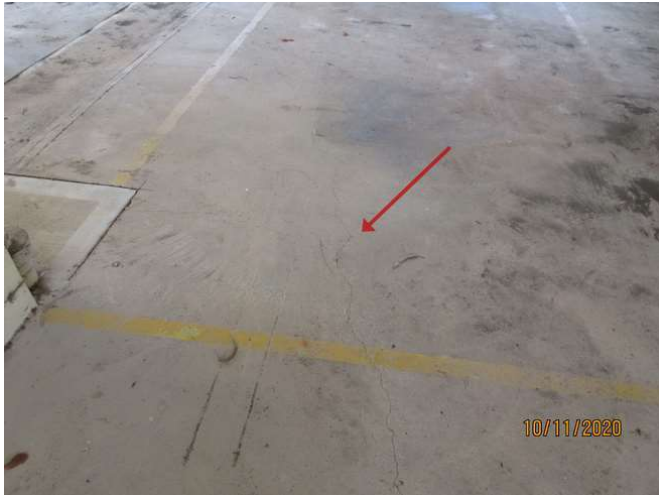
No 1-3_235_Note the cracking damage

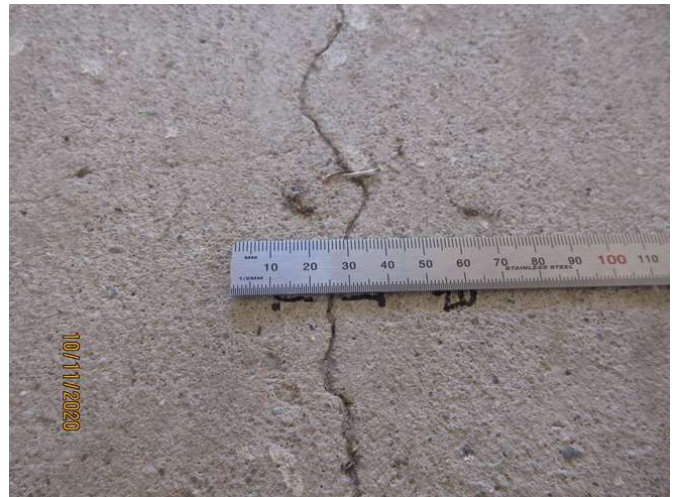
No 1-3_238_Note an estimated 1.0mm cracking width at representative location

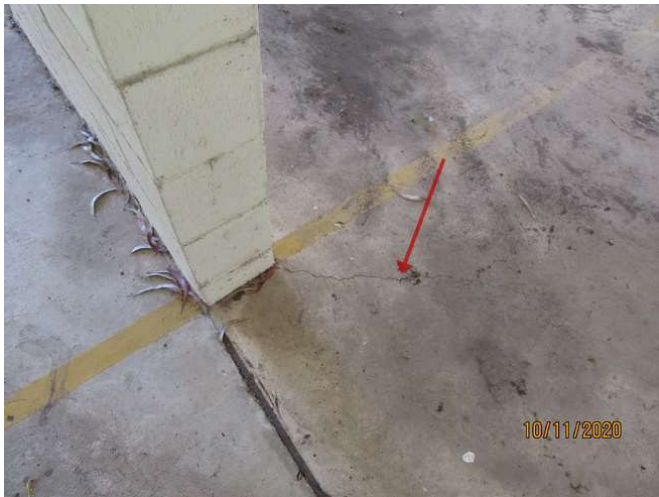
No 1-3_243_Note the cracking damage

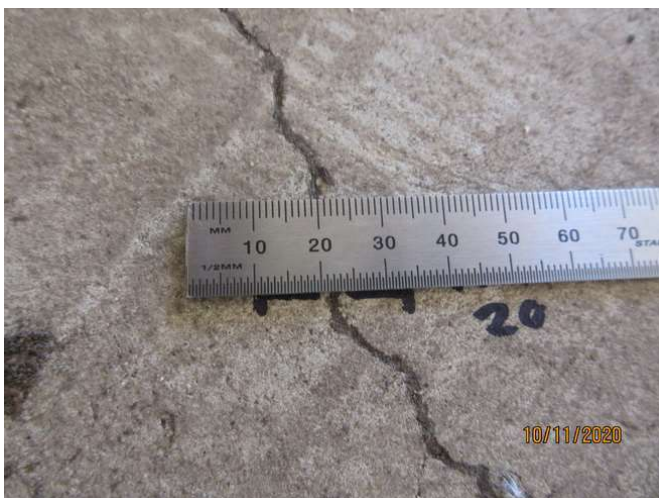
No 1-3_245_Note an estimated 2.0mm cracking width at representative location

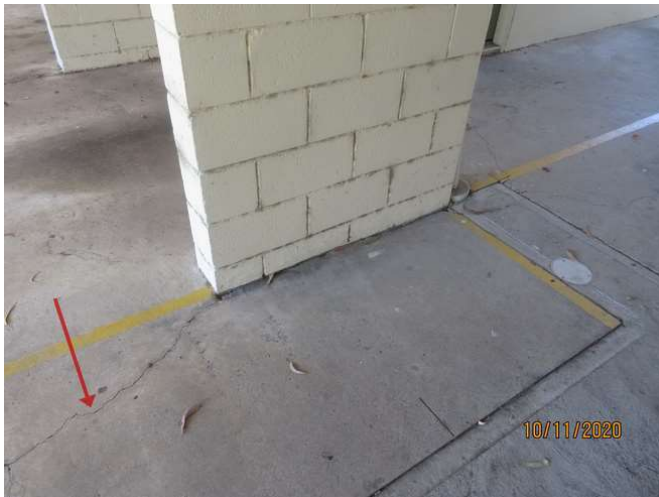
No 1-3_249_Note the cracking damage

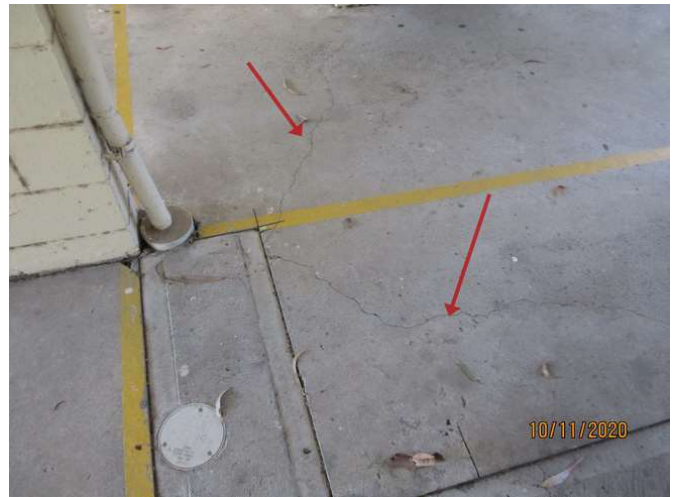
No 1-3_250_Note the cracking damage

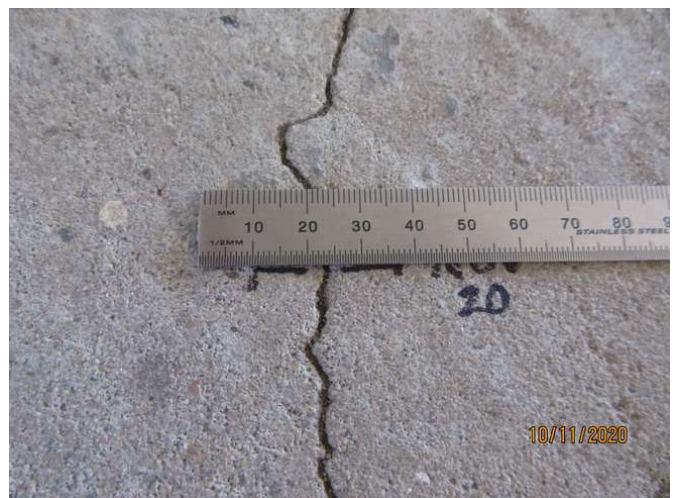
No 1-3_252_Note an estimated 1.0mm cracking width at representative location

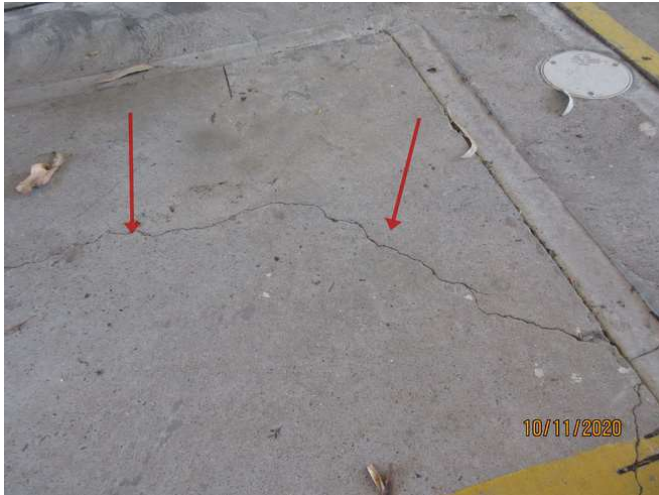
No 1-3_253_Note the cracking damage

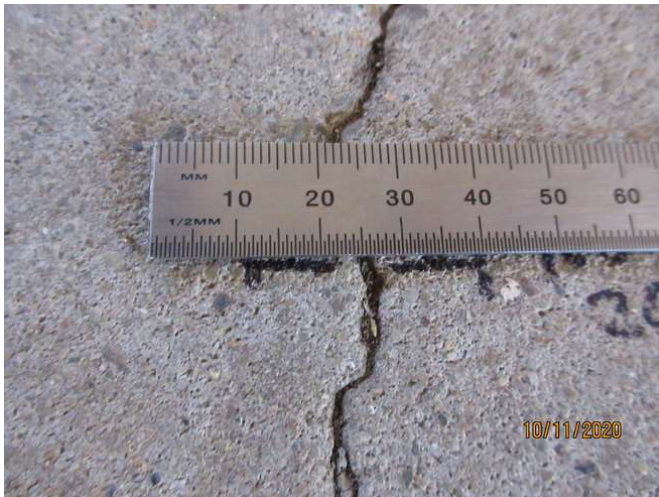
No 1-3_255_Note an estimated 2.0mm cracking width at representative location

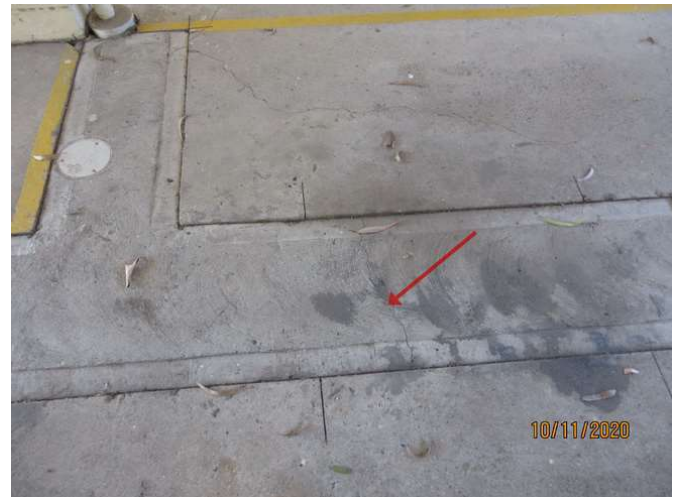
No 1-3_256_Note the cracking damage

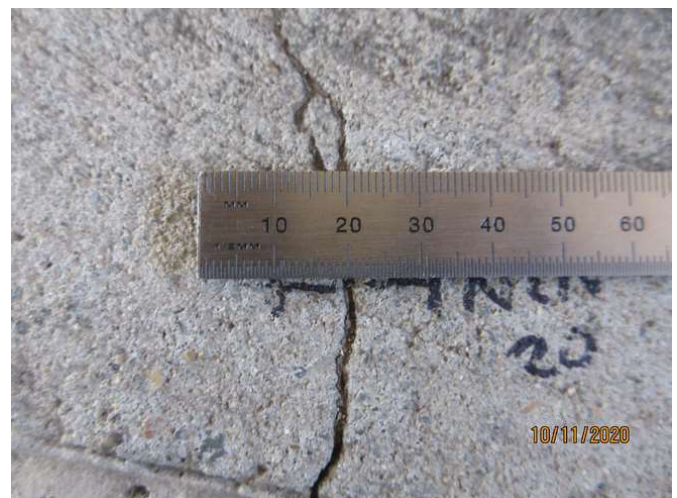
No 1-3_258_Note an estimated 1.5mm cracking width at representative location

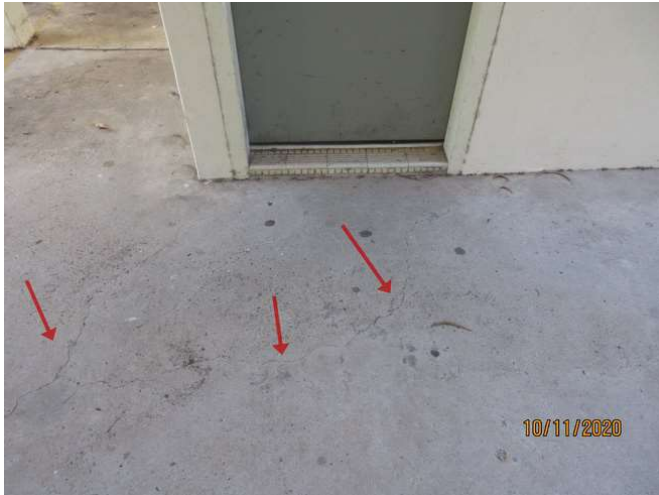
No 1-3_259_Note the cracking damage

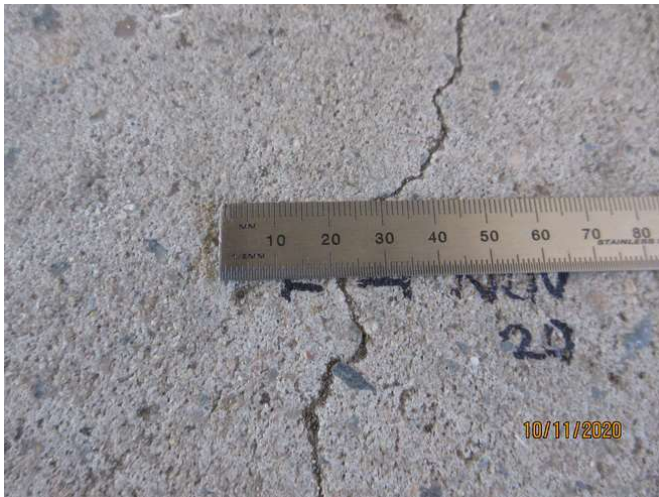
No 1-3_261_Note an estimated 1.5mm cracking width at representative location

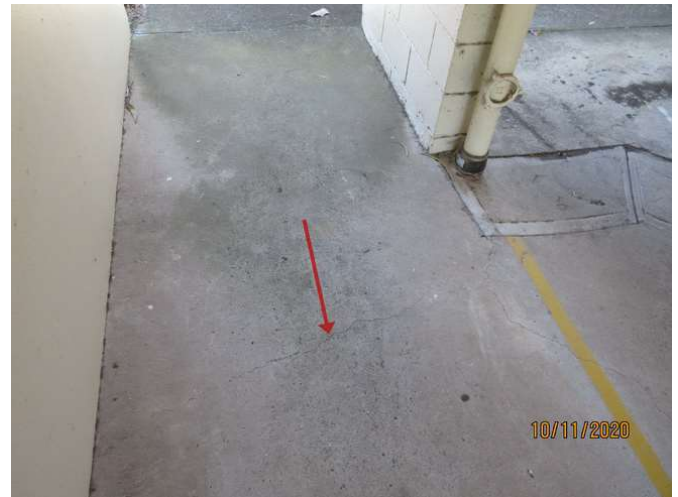
No 1-3_262_Note the cracking damage

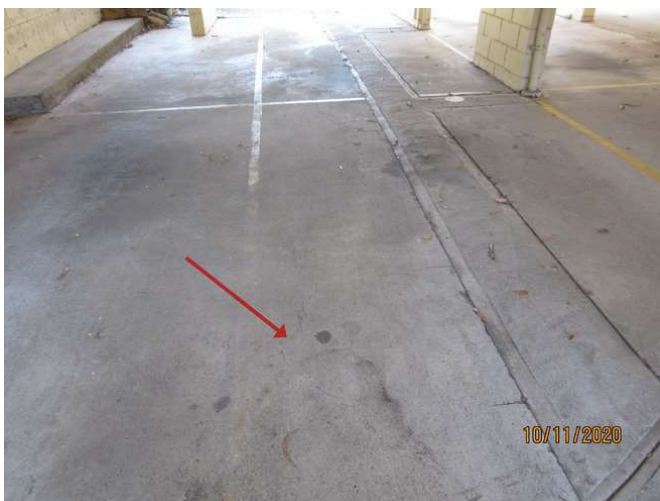
No 1-3_269_Note the cracking damage

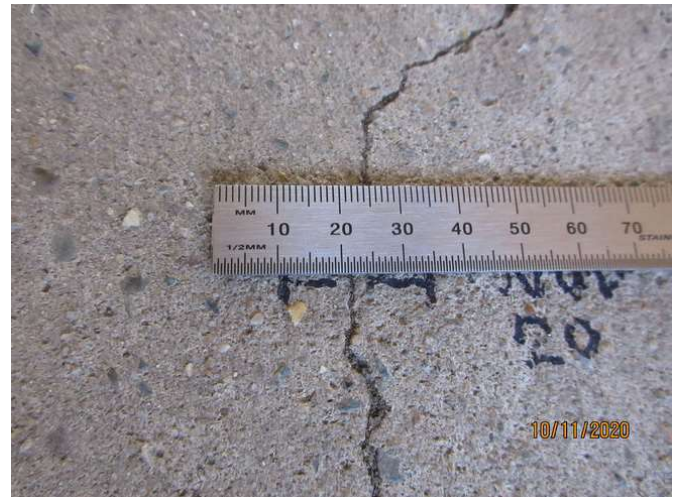
No 1-3_272_Note an estimated 1.0mm cracking width at representative location

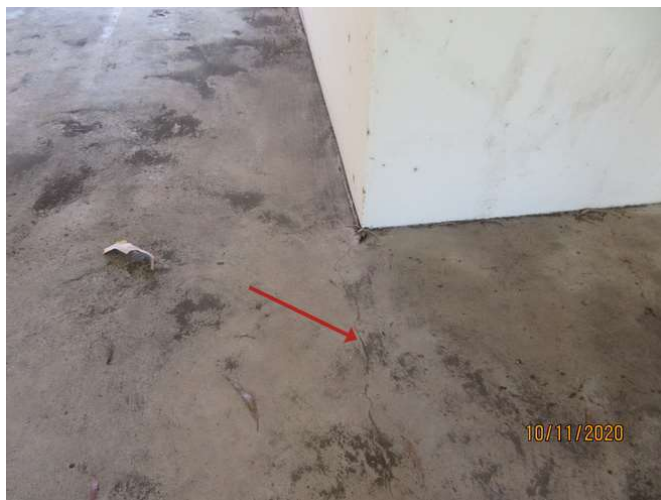
No 1-3_273_Note the cracking damage

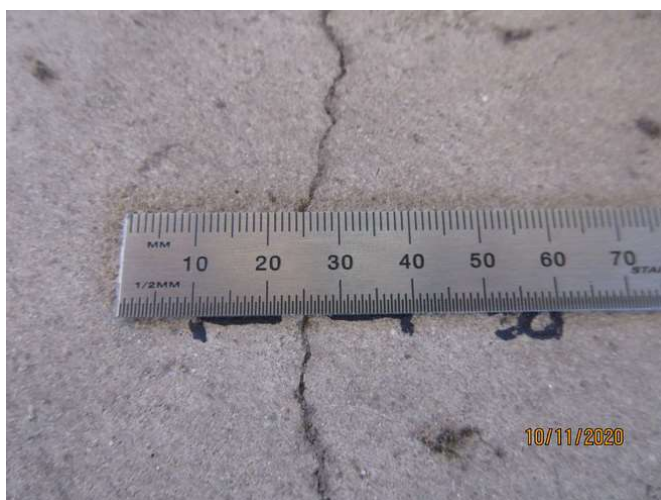
No 1-3_275_Note an estimated 0.5mm cracking width at representative location

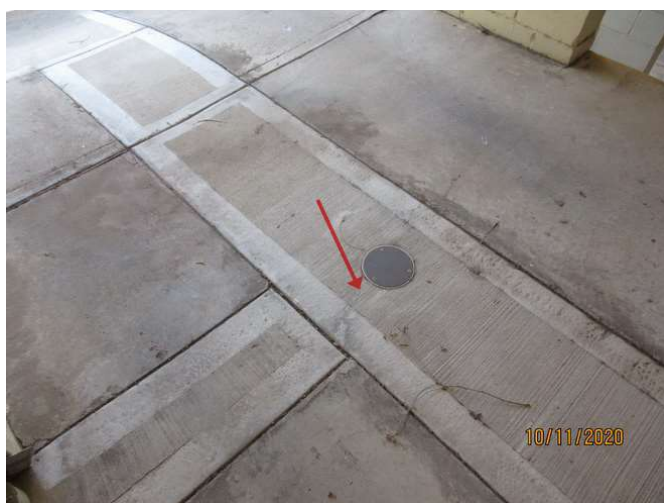
No 1-3_299_Note the cracking damage

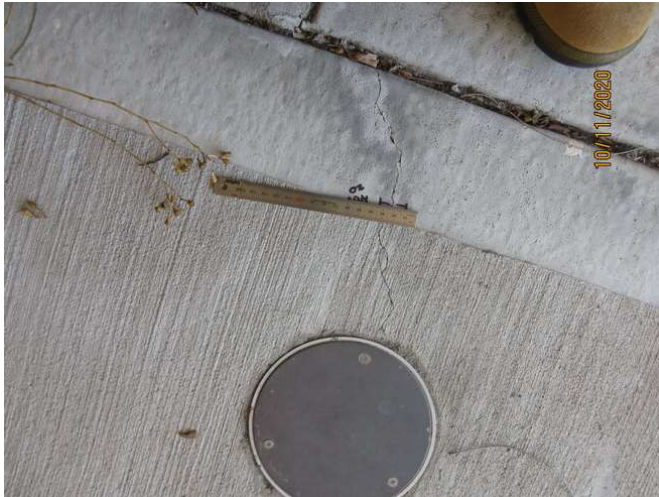
No 1-3_301_Note the cracking damage

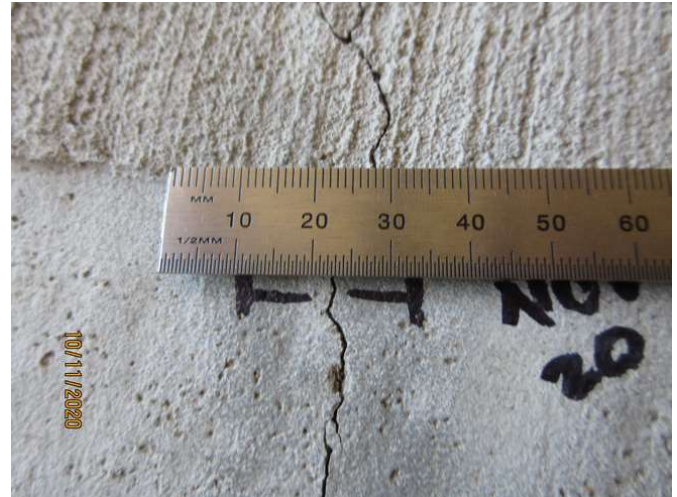
No 1-3_302_Note an estimated 0.5mm cracking width at representative location

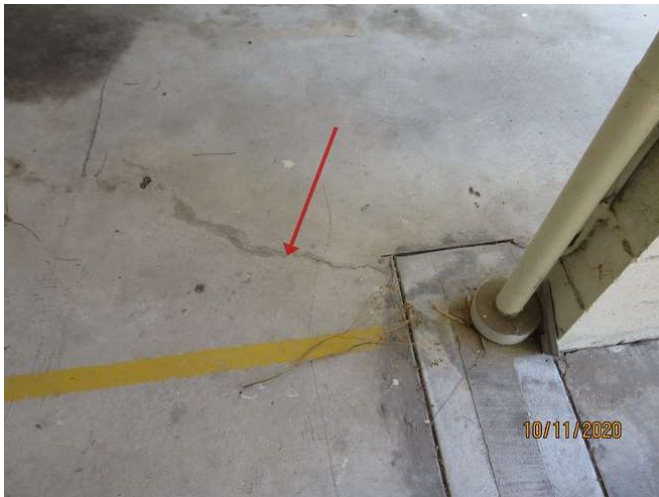
No 1-3_303_Note the cracking damage

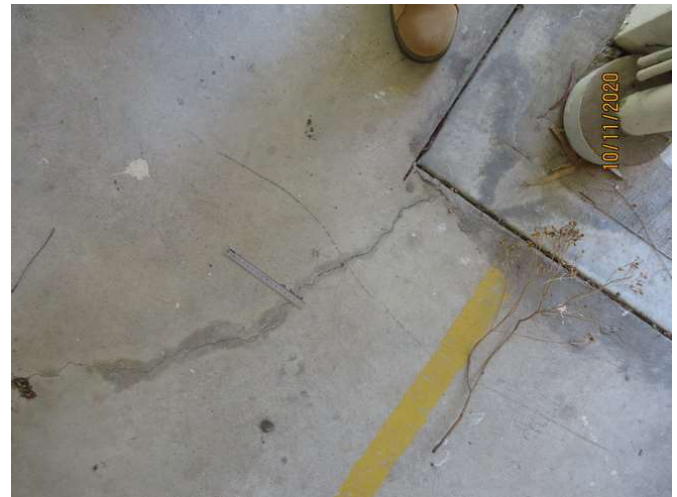
No 1-3_304_Note the cracking damage

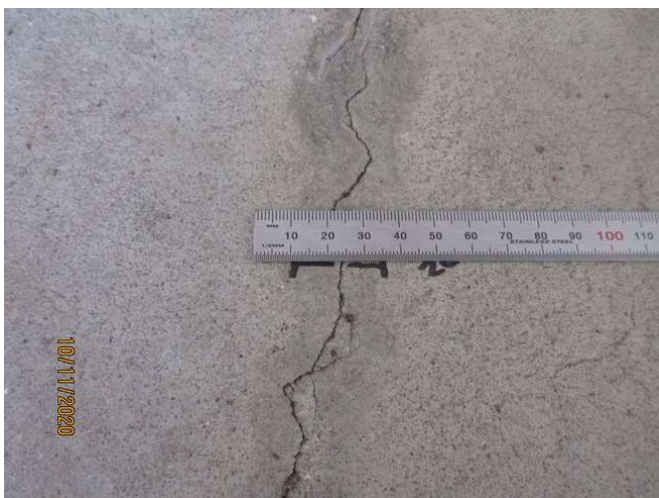
No 1-3_305_Note an estimated 0.5mm cracking width at representative location

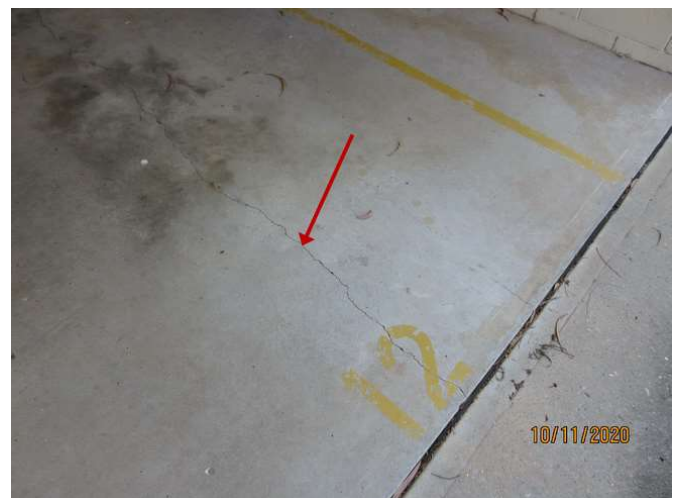
No 1-3_306_Note the cracking damage

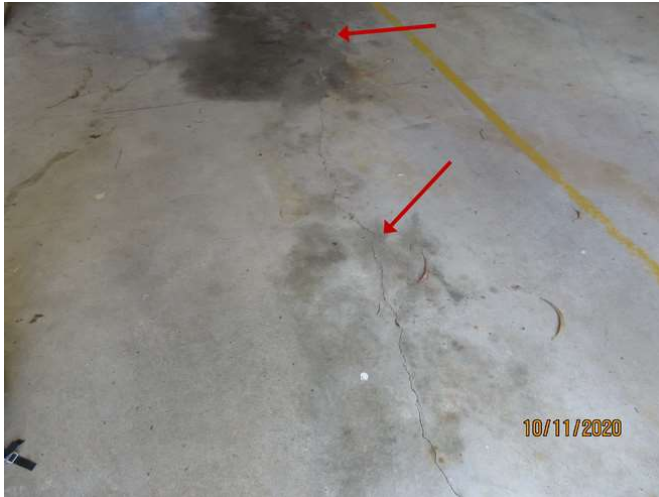
No 1-3_307_Note the cracking damage

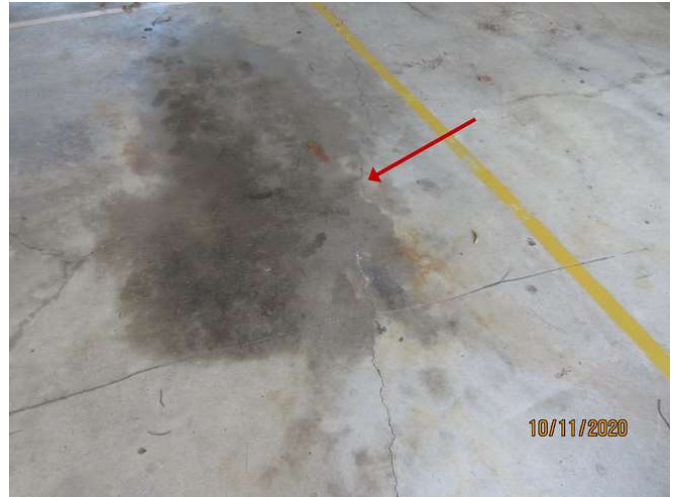
No 1-3_308_Note the cracking damage

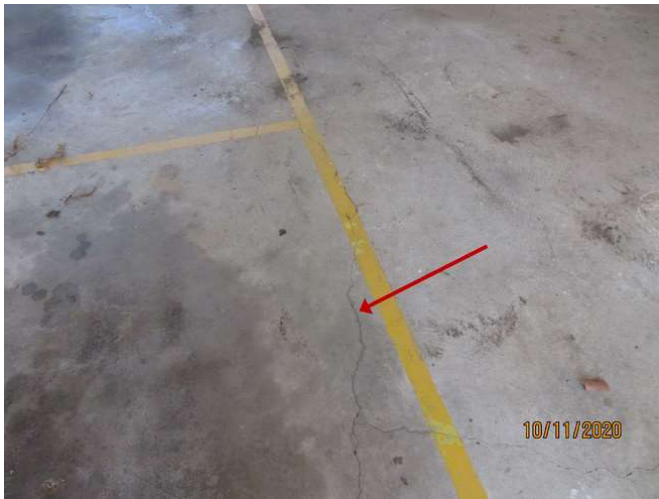
No 1-3_309_Note the cracking damage

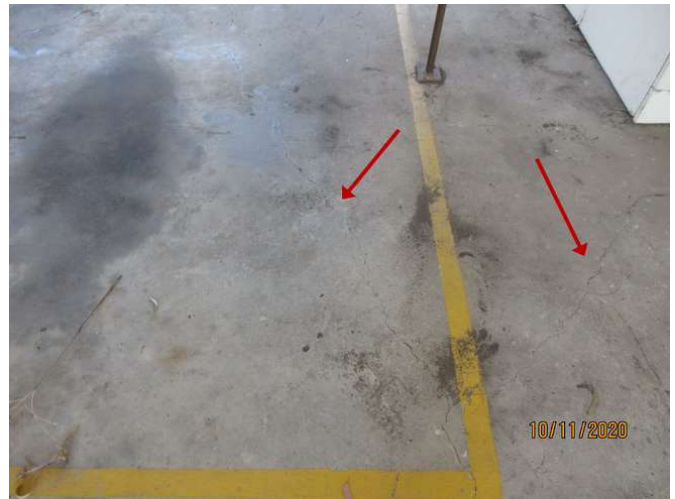
No 1-3_310_Note the cracking damage

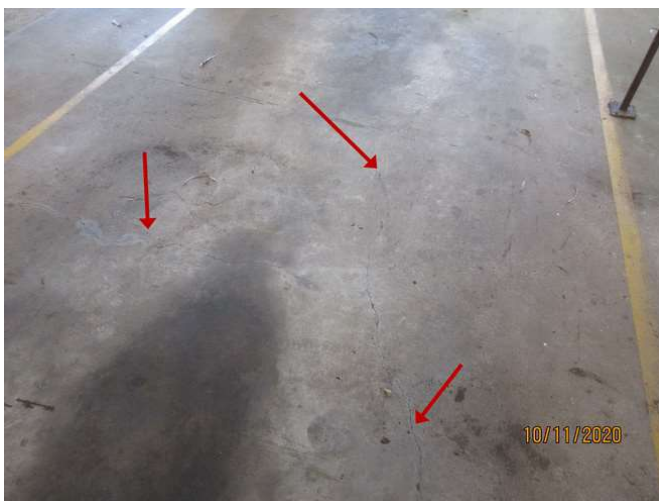
No 1-3_311_Note the cracking damage

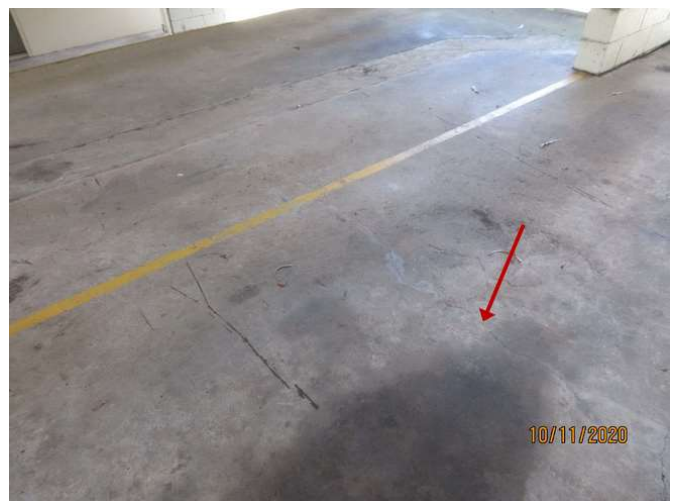
No 1-3_312_Note the cracking damage

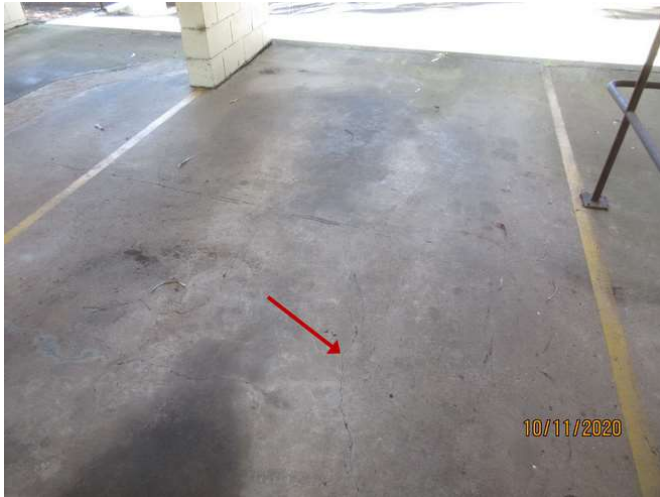
No 1-3_313_Note the cracking damage
