CONSTRUCTION CERTIFICATE No. J/74556/01

Issued under the Environmental Planning and Assessment Act 1979 Sections 6.4 and 6.7

Address: Ivanhoe Estate comprising Ivanhoe Place, Wilcannia Way, Nyngan Way, Narromine Way and Cobar Way, part of 2-4 Lyonpark Road and portions of Shrimptons Creek adjacent to the centre line of the creek, Macquarie Park

Description: Stage 1 development application for the redevelopment of the Ivanhoe Estate, including:

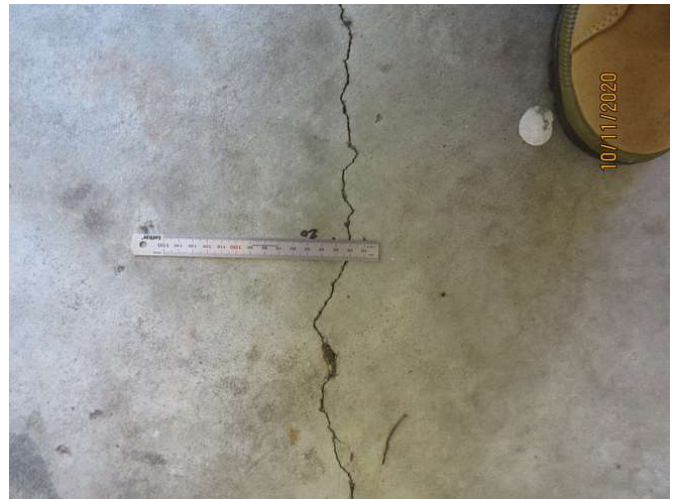
No 1-3_316_Note the cracking damage

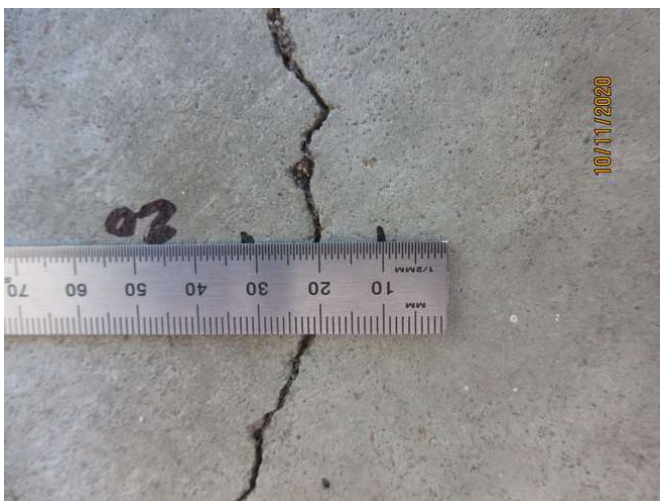
No 1-3_317_Note an estimated 2.0mm cracking width at representative location

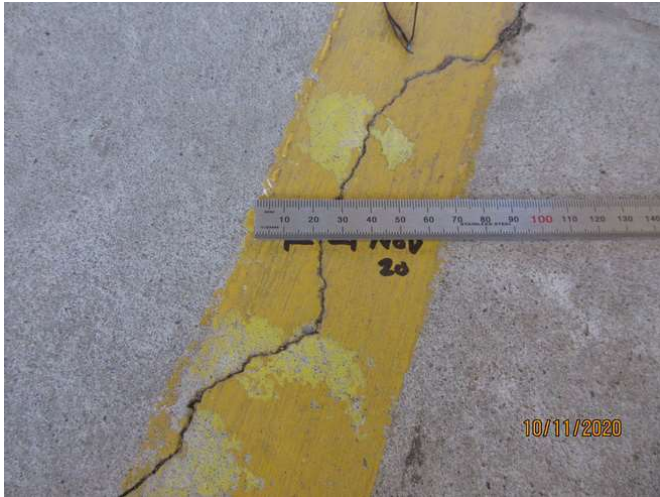
No 1-3_319_Note an estimated 1.5mm cracking width at representative location

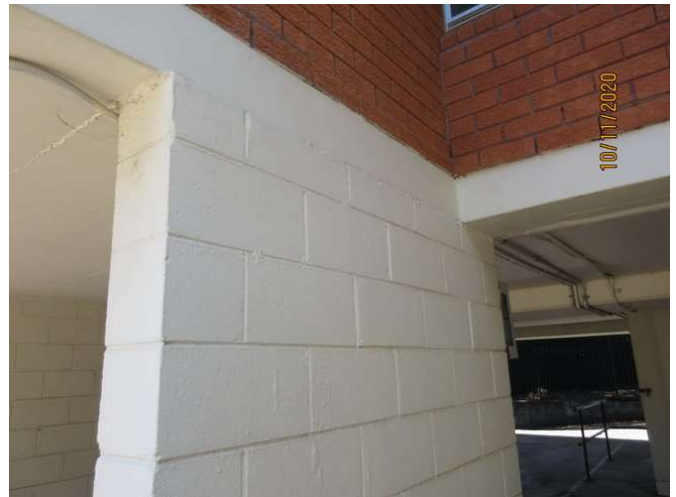
No 1-3_322_Note the cracking damage

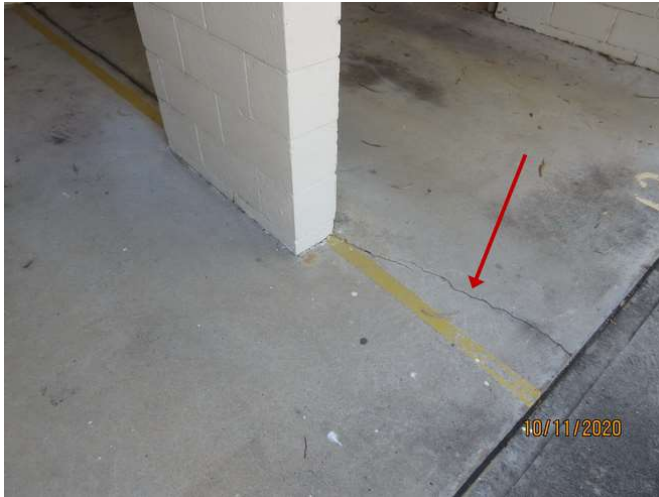
No 1-3_325_Note the cracking damage

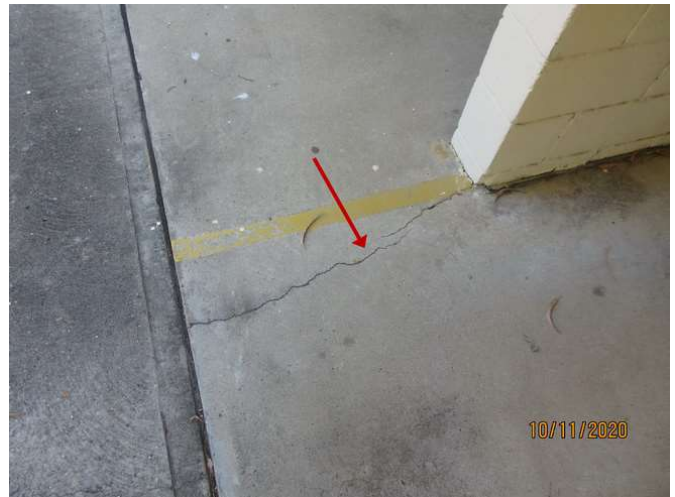
No 1-3_328_Note the cracking damage

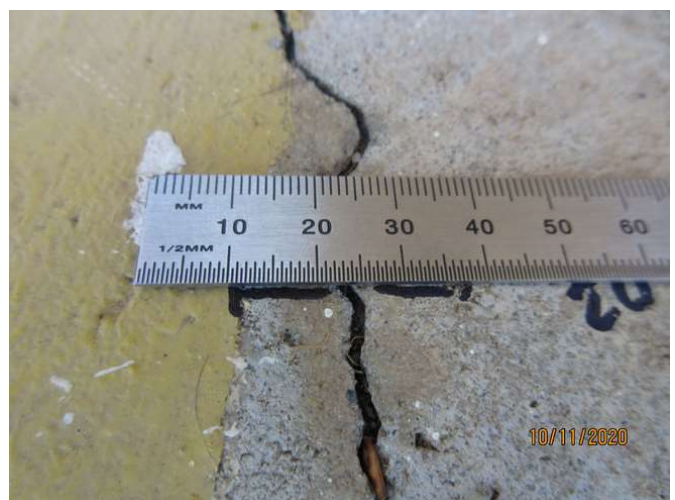
No 1-3_330_Note an estimated 1.5mm cracking width at representative location

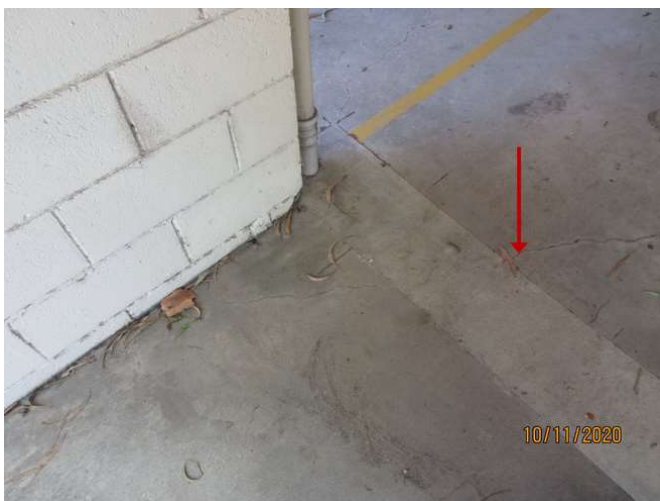
No 1-3_335_Note the cracking damage

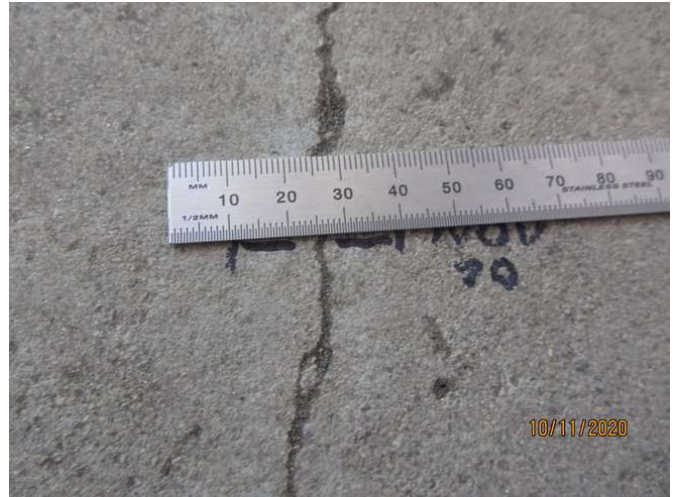
No 1-3_338_Note an estimated 2.0mm cracking width at representative location

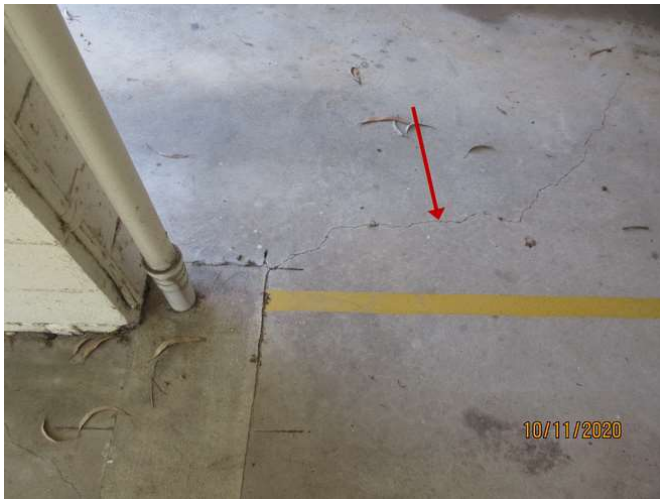
No 1-3_339_Note the cracking damage

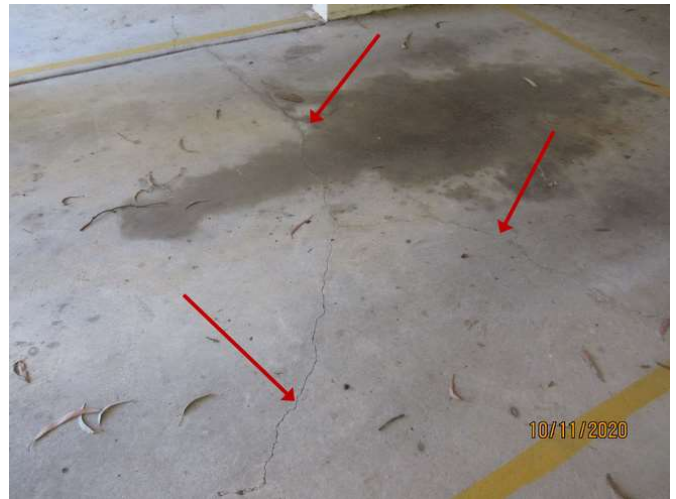
No 1-3_340_Note the cracking damage

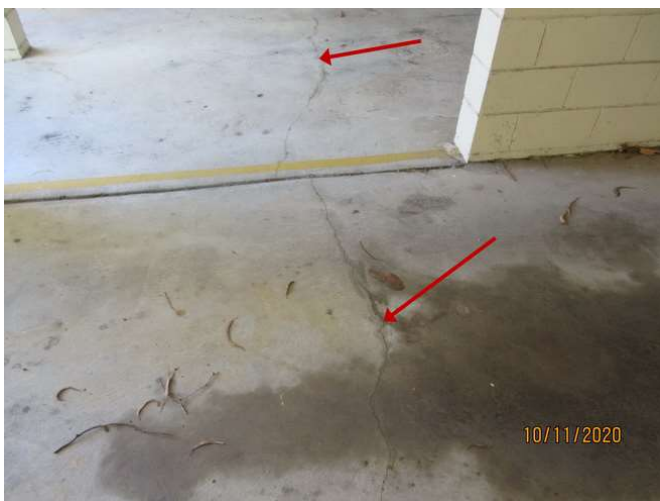
No 1-3_341_Note the cracking damage

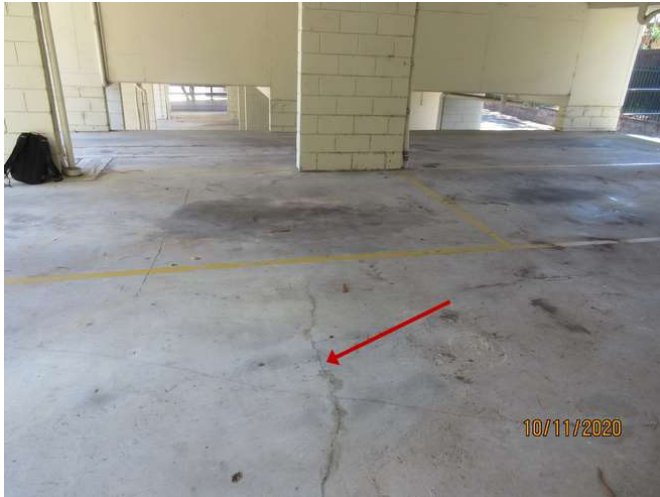
No 1-3_343_Note the cracking damage

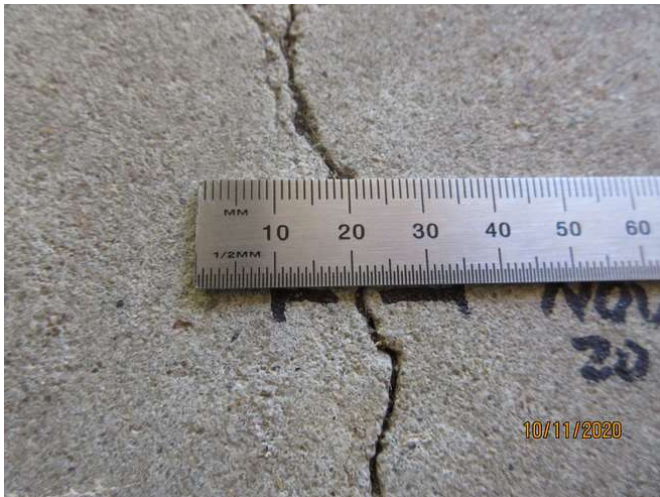
No 1-3_345_Note an estimated 1.0mm cracking width at representative location

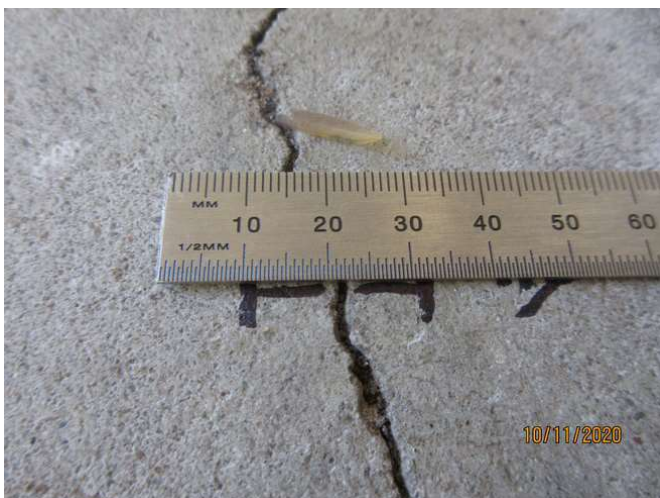
No 1-3_347_Note an estimated 1.0mm cracking width at representative location

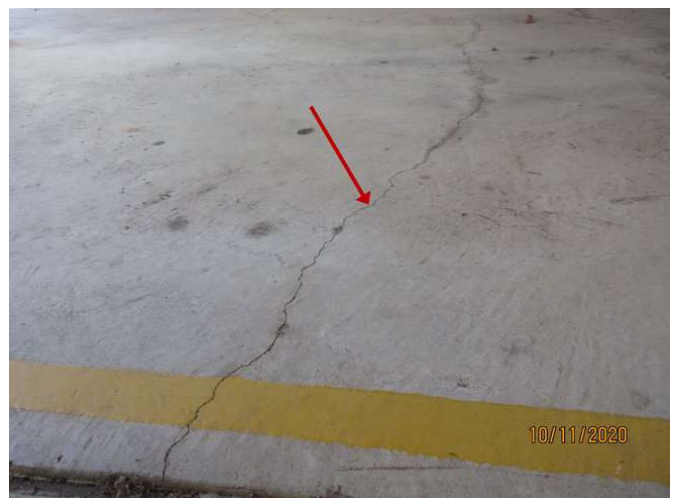
No 1-3_348_Note the cracking damage

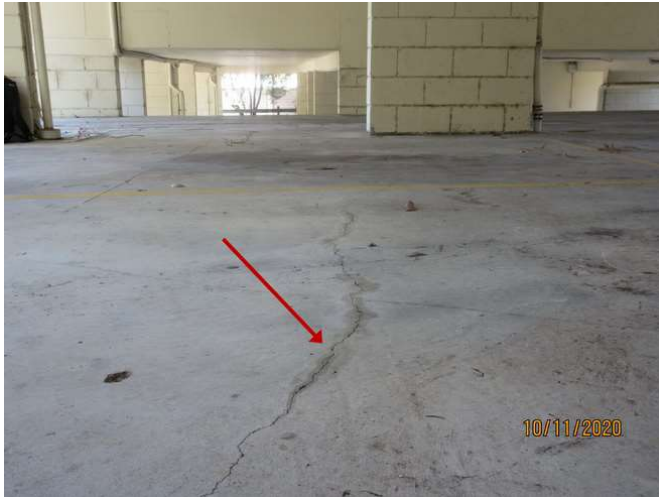
No 1-3_349_Note the cracking damage

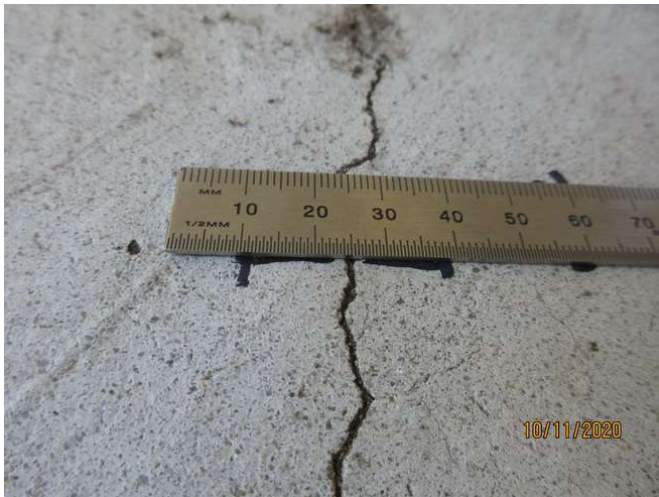
No 1-3_351_Note an estimated 1.5mm cracking width at representative location

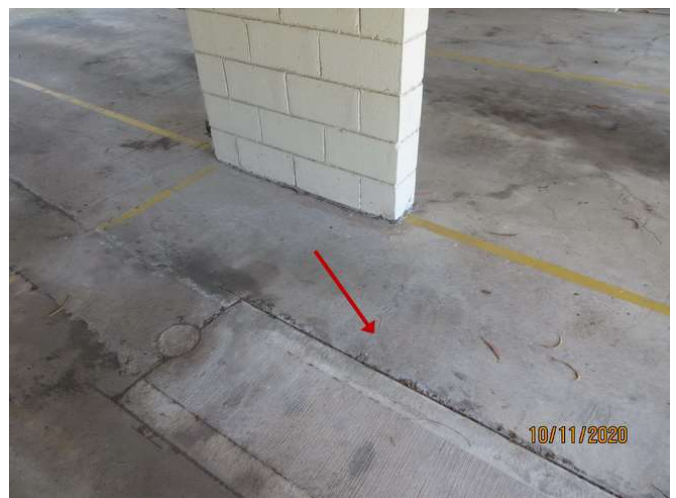
No 1-3_354_Note the cracking damage

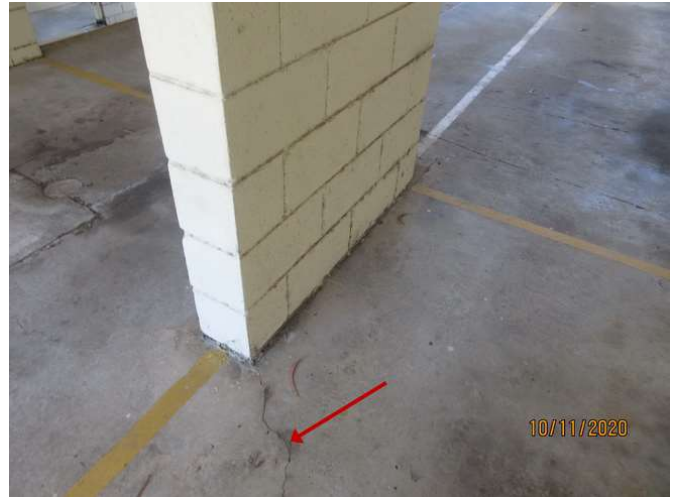
No 1-3_356_Note the cracking damage

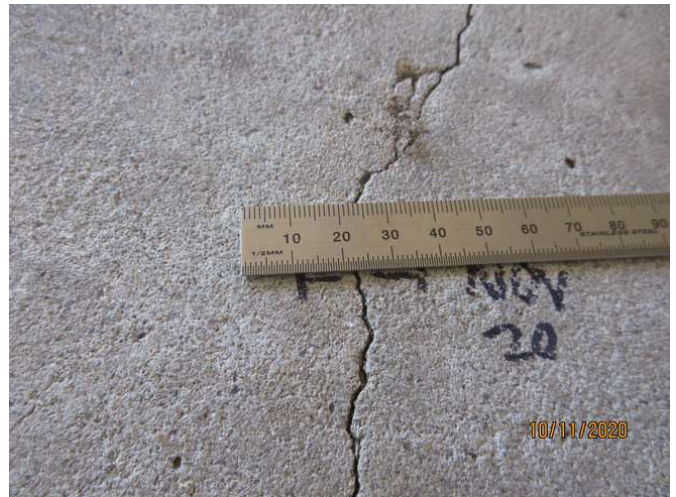
No 1-3_358_Note an estimated 1.0mm cracking width at representative location

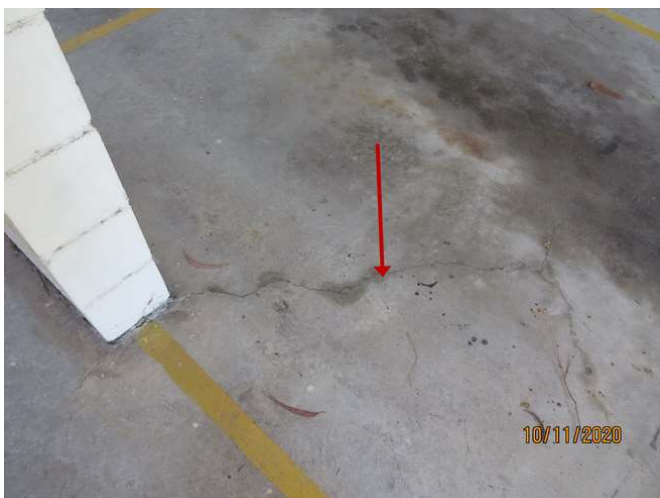
No 1-3_359_Note the cracking damage

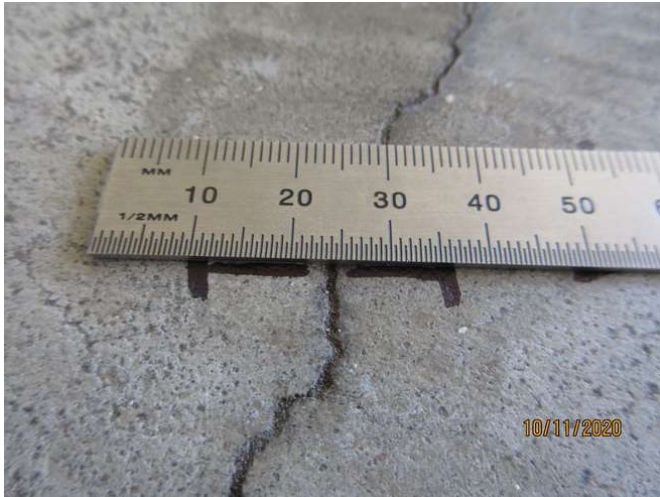
No 1-3_361_Note an estimated 1.0mm cracking width at representative location

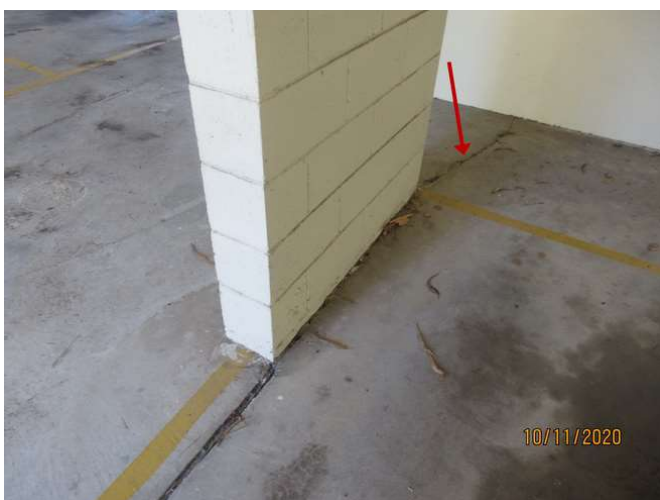
No 1-3_365_Note the cracking damage

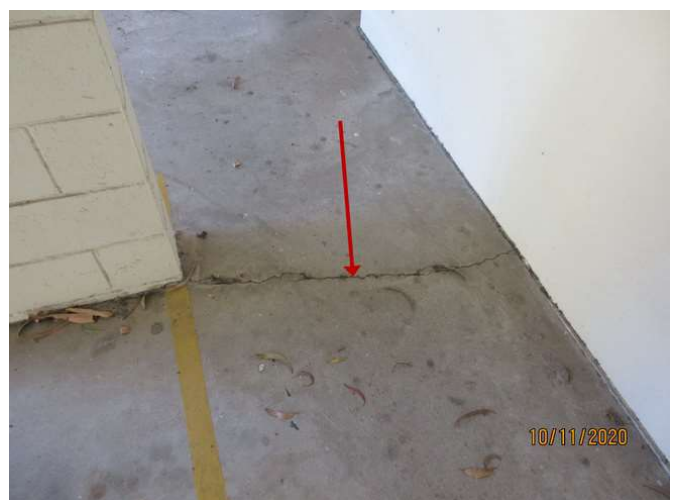
No 1-3_366_Note the cracking damage

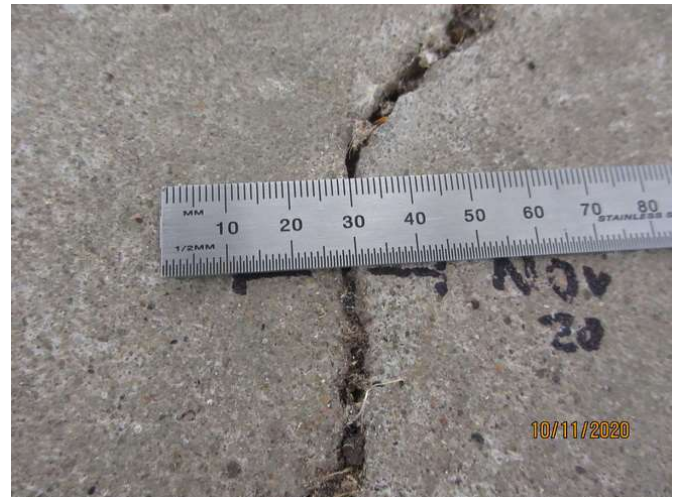
No 1-3_368_Note an estimated 2.0mm cracking width at representative location

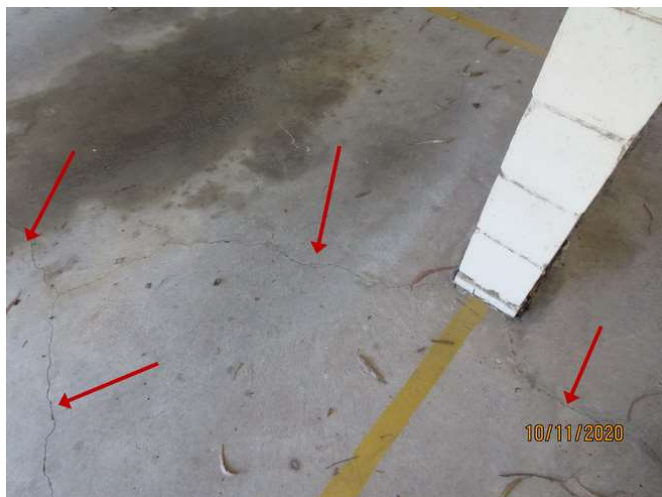
No 1-3_373_Note the cracking damage

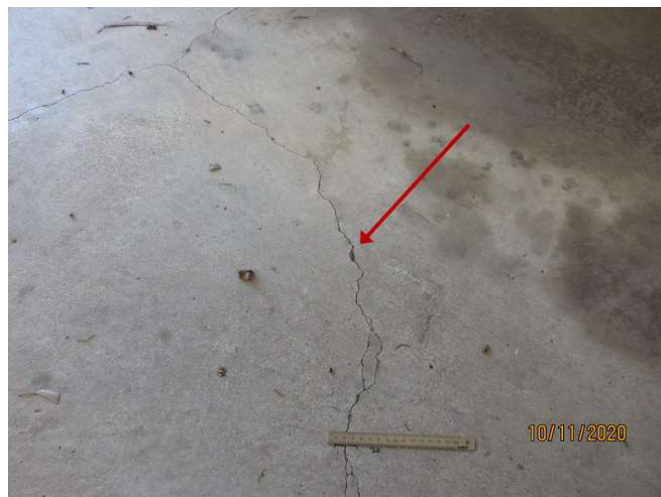
No 1-3_374_Note the cracking damage

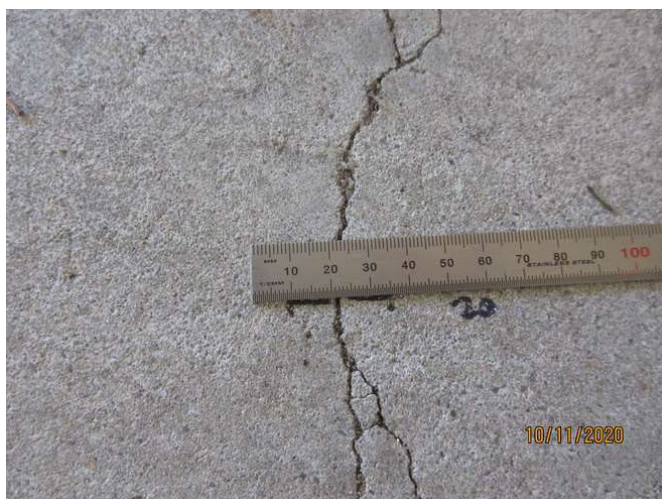
No 1-3_375_Note an estimated 1.0mm cracking width at representative location

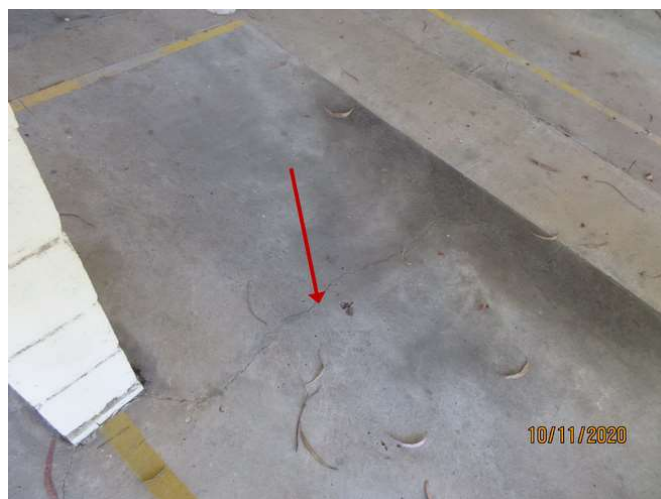
No 1-3_376_Note the cracking damage

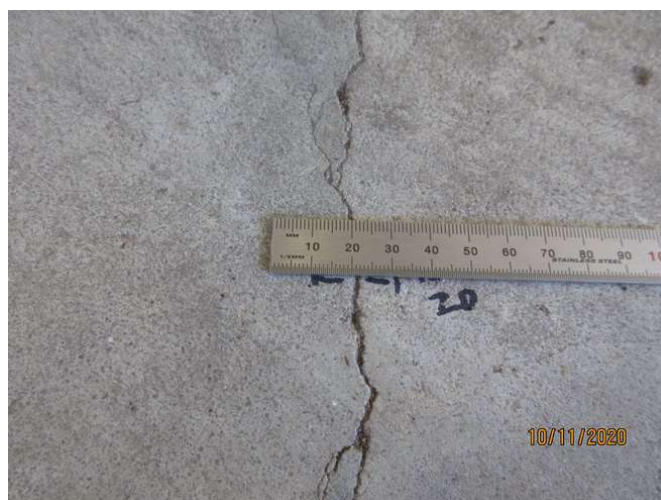
No 1-3_378_Note an estimated 1.0mm cracking width at representative location

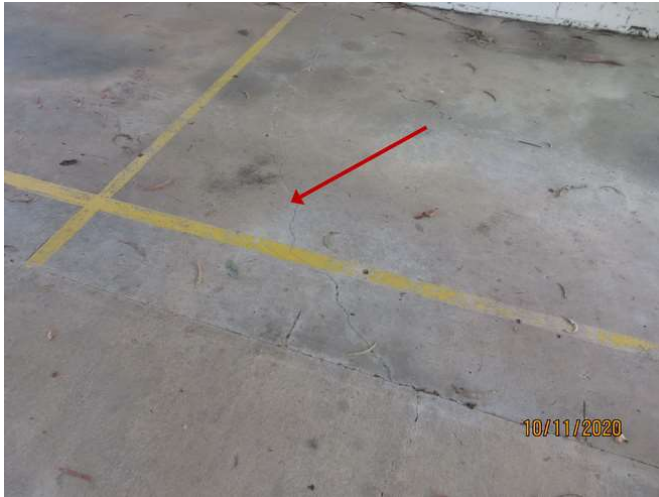
No 1-3_379_Note the cracking damage

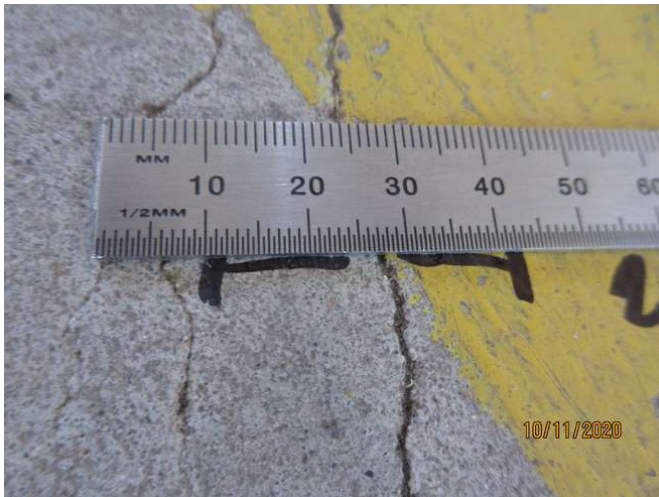
No 1-3_381_Note an estimated 1.0mm cracking width at representative location

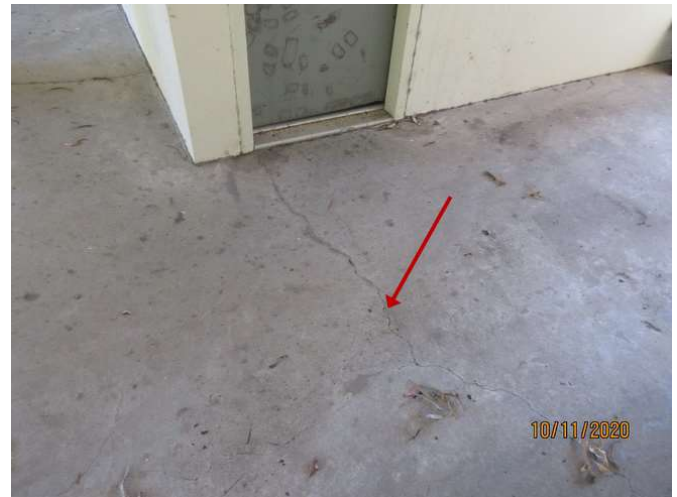
No 1-3_382_Note the cracking damage

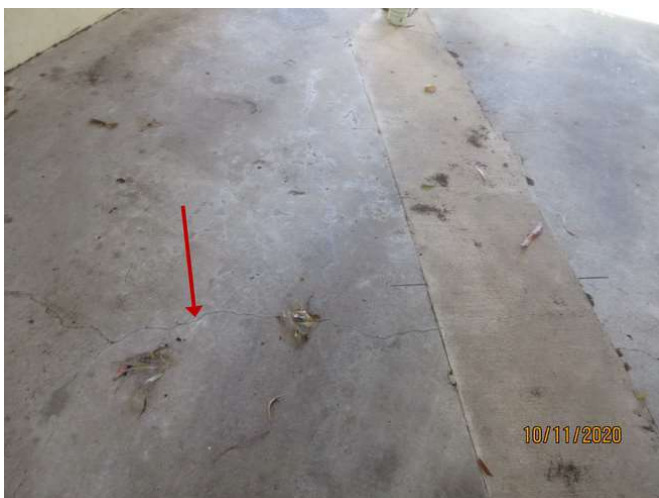
No 1-3_383_Note the cracking damage

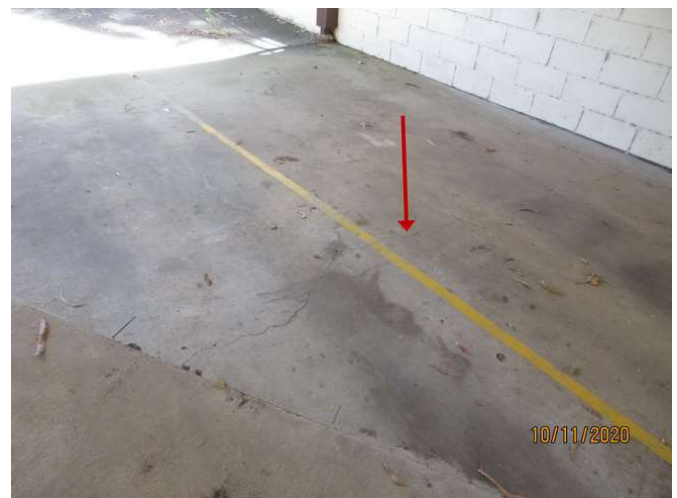
No 1-3_384_Note the cracking damage

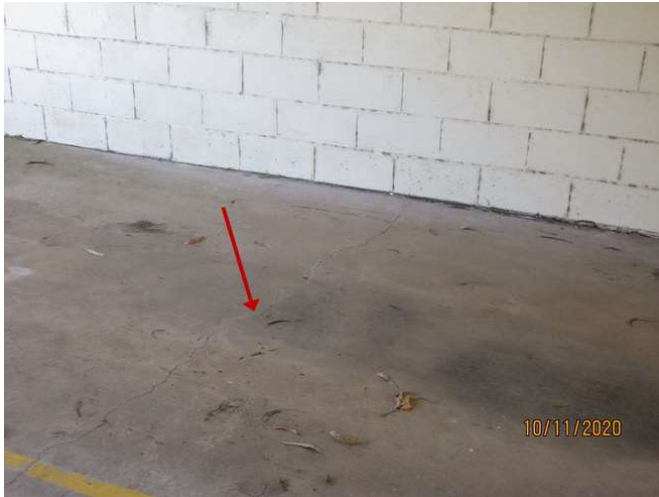
No 1-3_385_Note the cracking damage

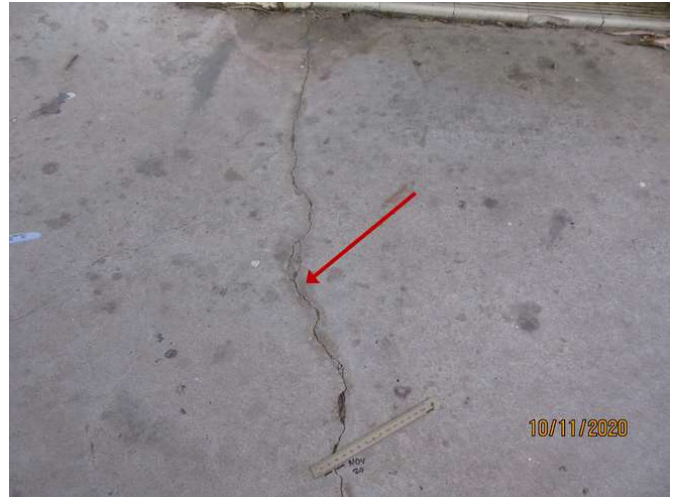
No 1-3_386_Note the cracking damage

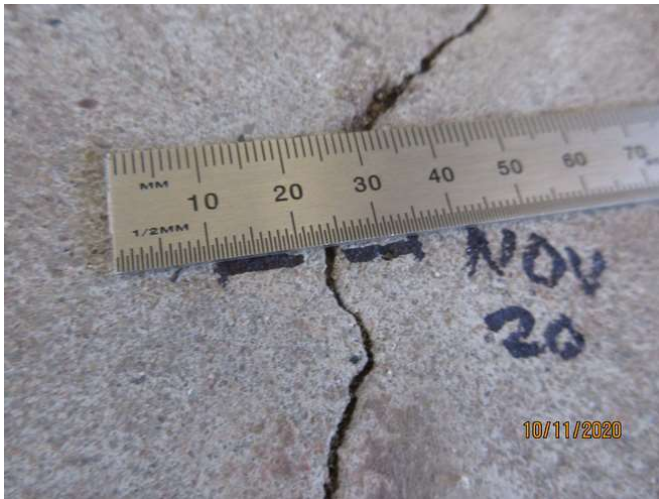
No 1-3_387_Note an estimated 1.5mm cracking width at representative location

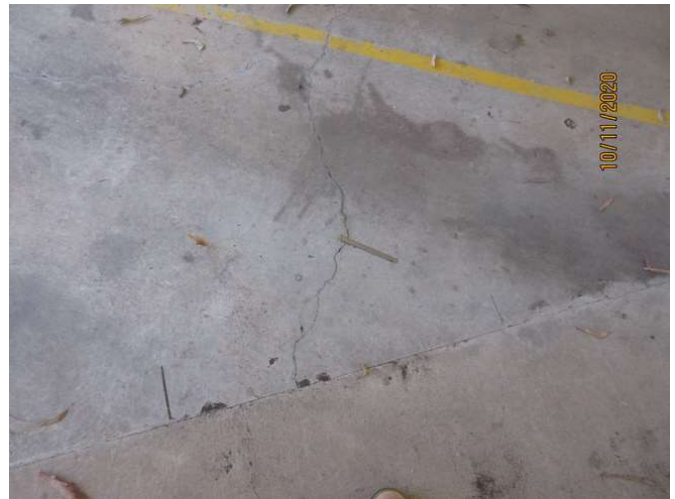
No 1-3_388_Note the cracking damage

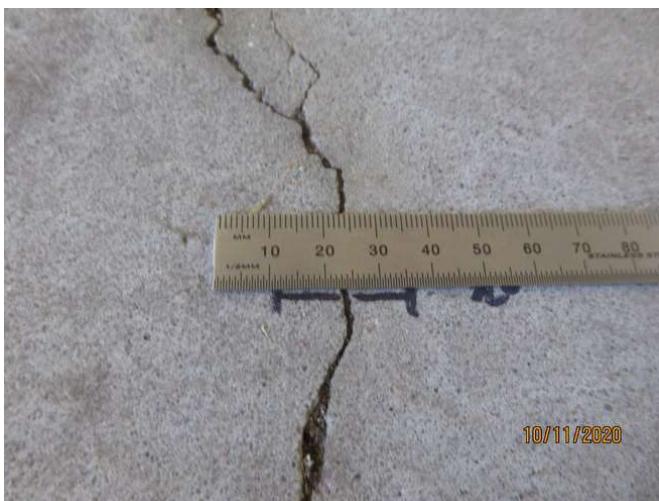
No 1-3_389_Note an estimated 1.5mm cracking width at representative location

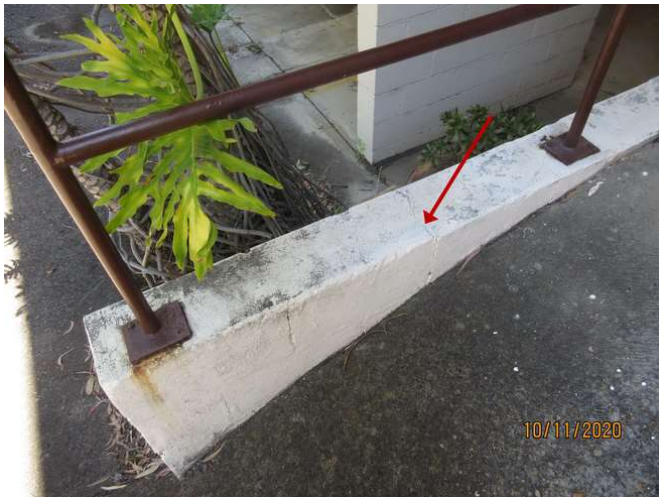
No 1-3_399_Note the cracking damage

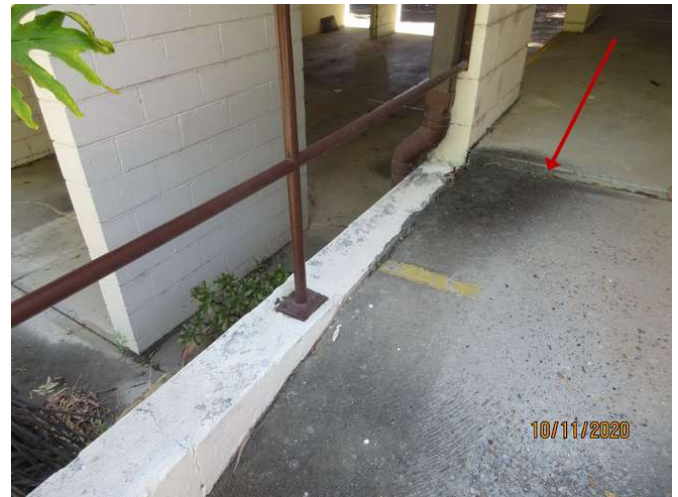
No 1-3_400_Note the dropping in level

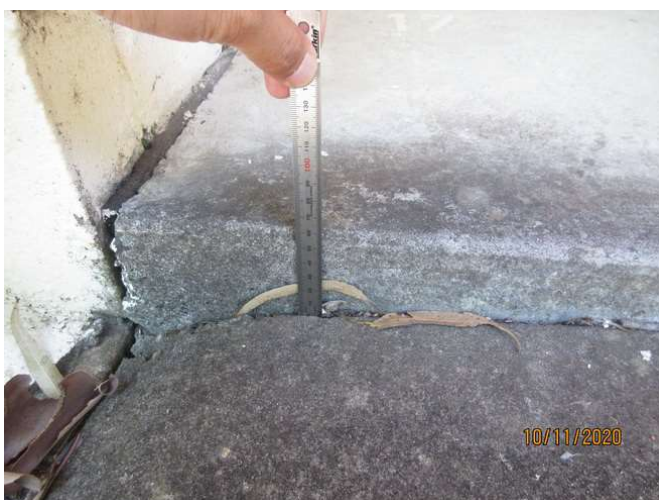
No 1-3_401_60mm dropping in level

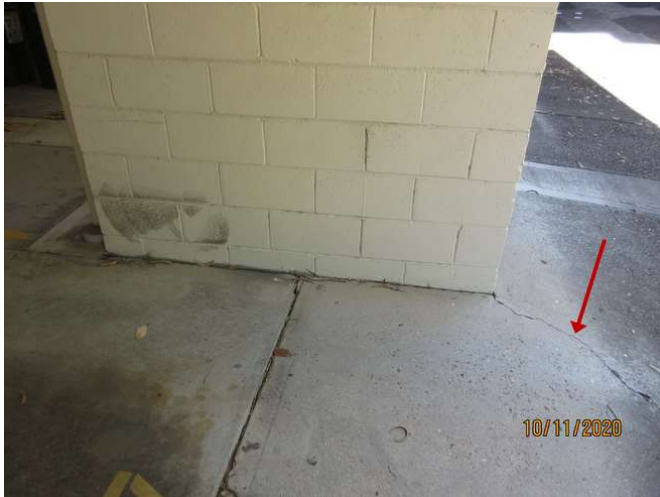
No 1-3_403_Note the cracking damage

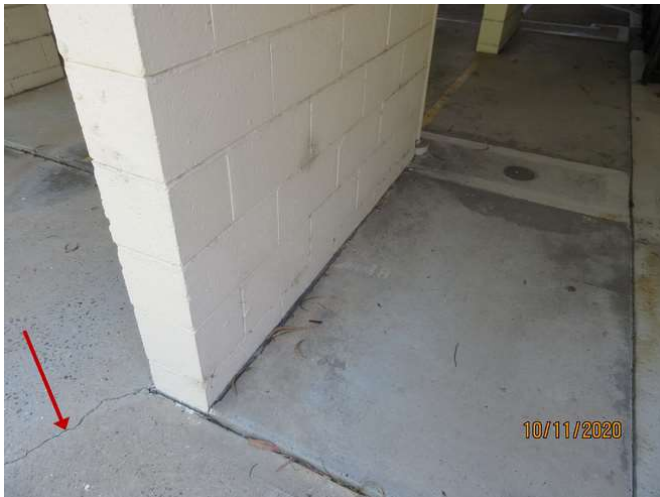
No 1-3_405_Note the cracking damage

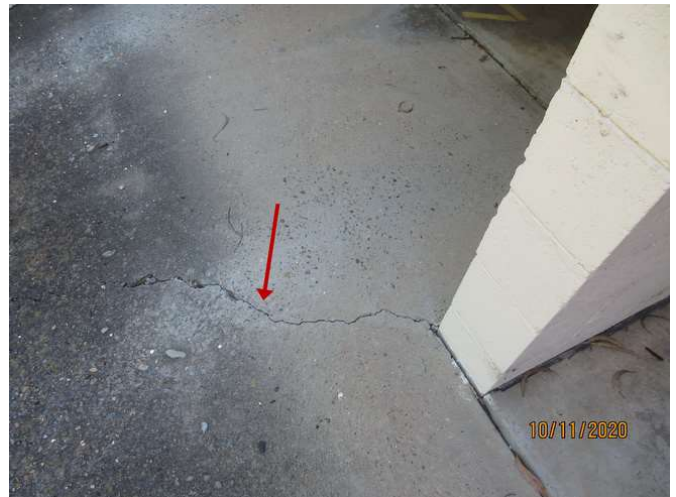
No 1-3_406_Note the cracking damage

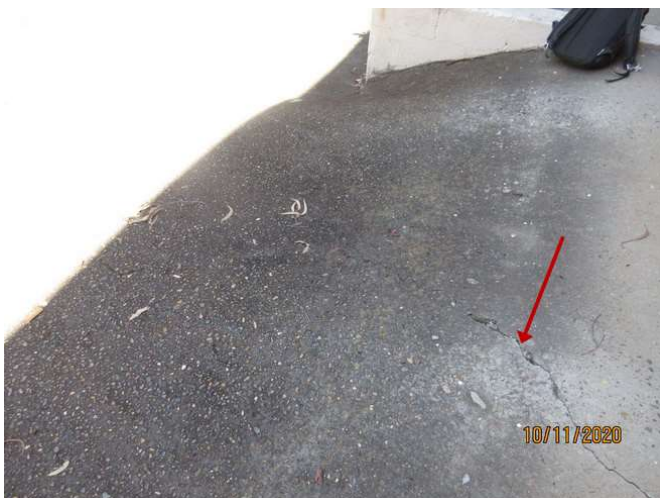
No 1-3_407_Note the cracking damage

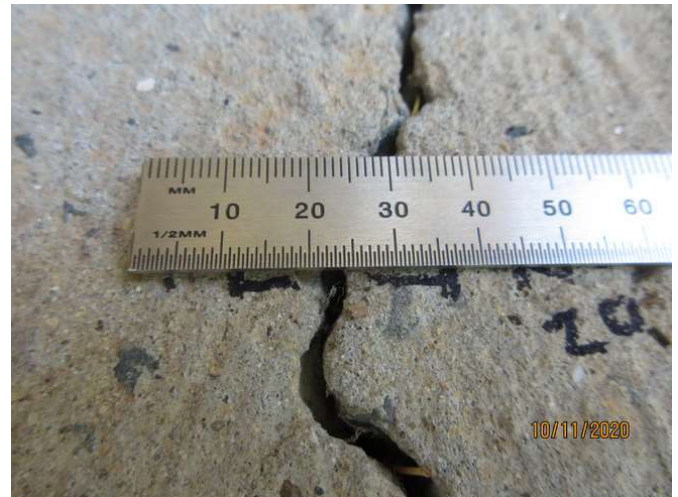
No 1-3_410_Note an estimated 3.0mm cracking width at representative location

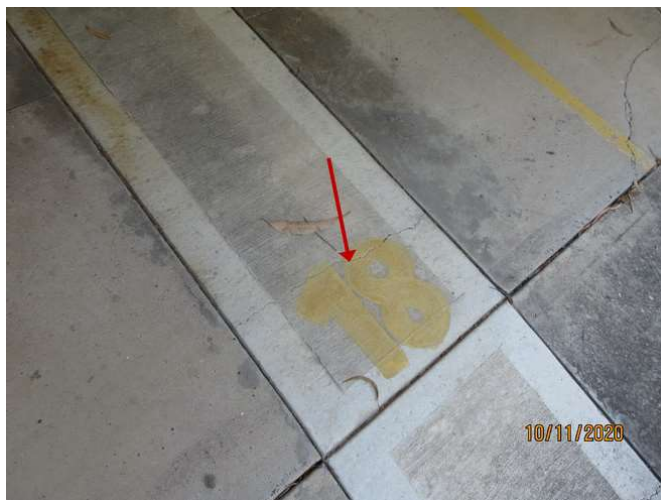
No 1-3_411_Note the cracking damage

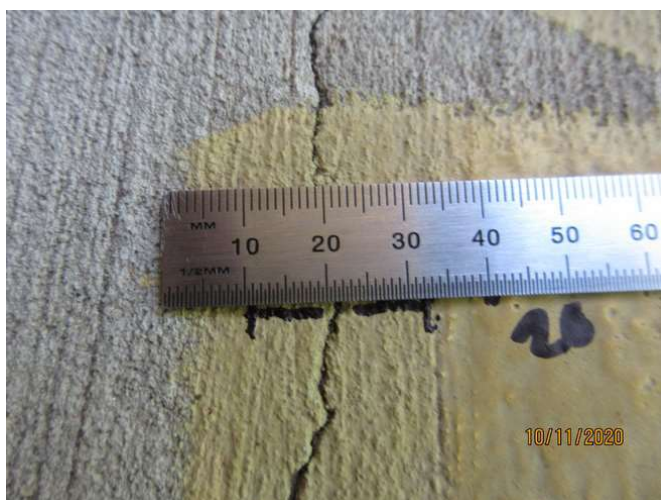
No 1-3_413_Note an estimated 0.5mm cracking width at representative location

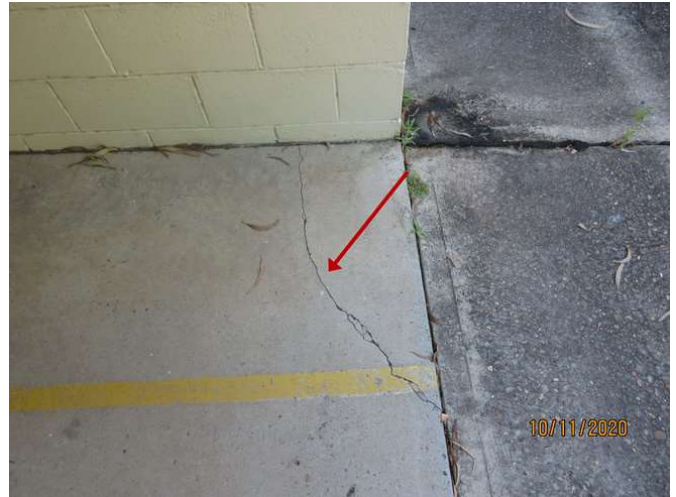
No 1-3_416_Note the cracking damage

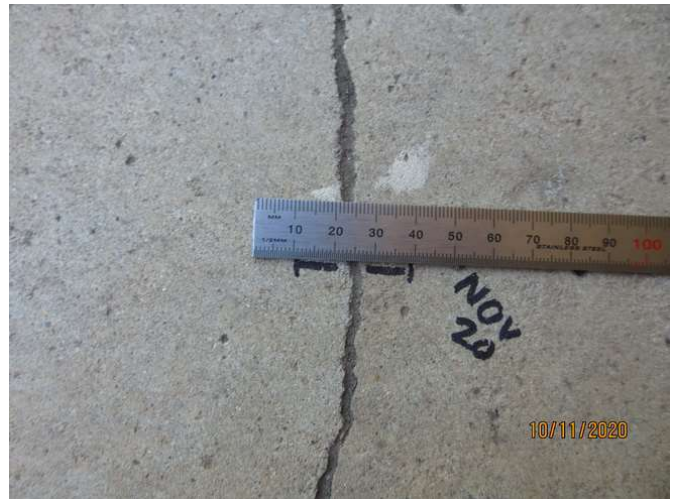
No 1-3_418_Note an estimated 3.5mm cracking width at representative location

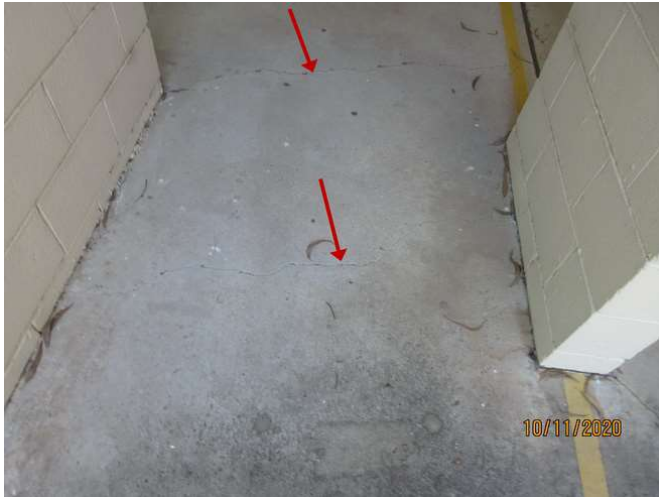
No 1-3_421_Note the cracking damage

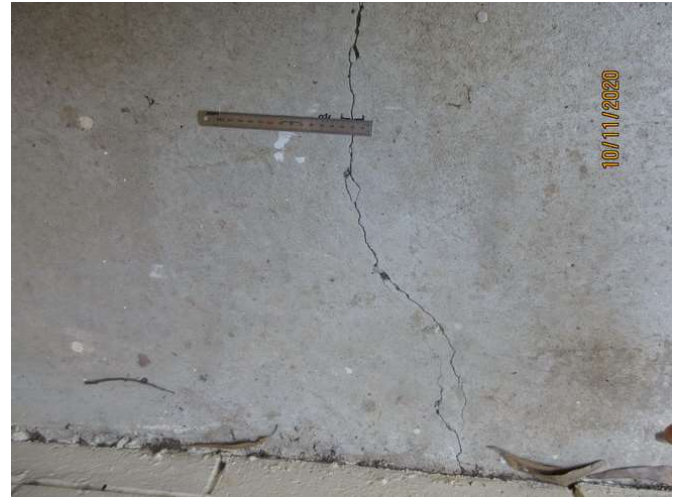
No 1-3_422_Note the cracking damage

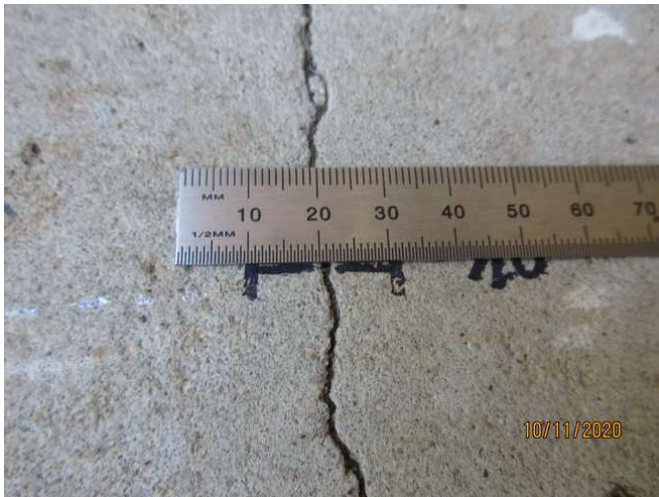
No 1-3_423_Note an estimated 1.5mm cracking width at representative location

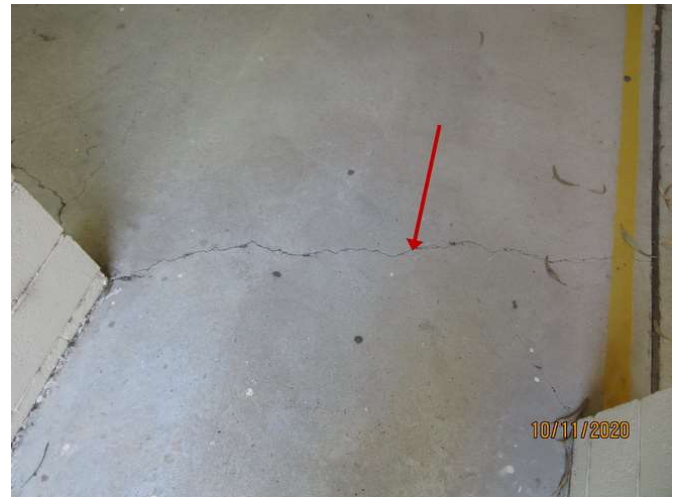
No 1-3_424_Note the cracking damage

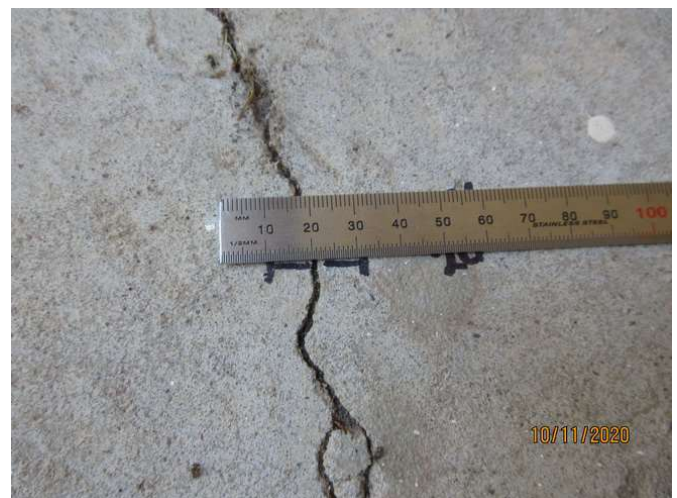
No 1-3_426_Note an estimated 1.0mm cracking width at representative location

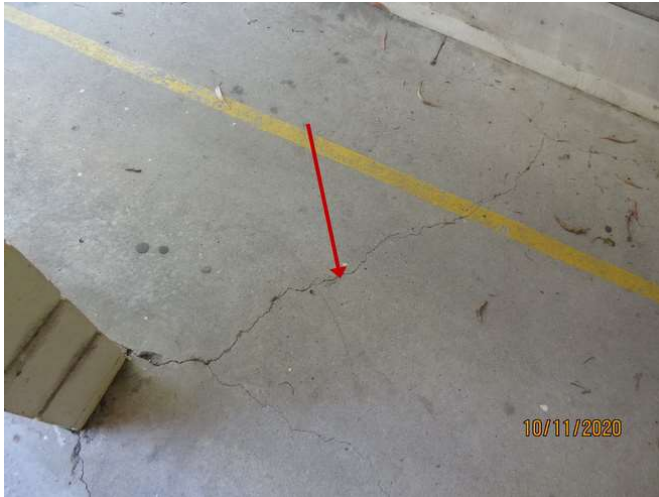
No 1-3_427_Note the cracking damage

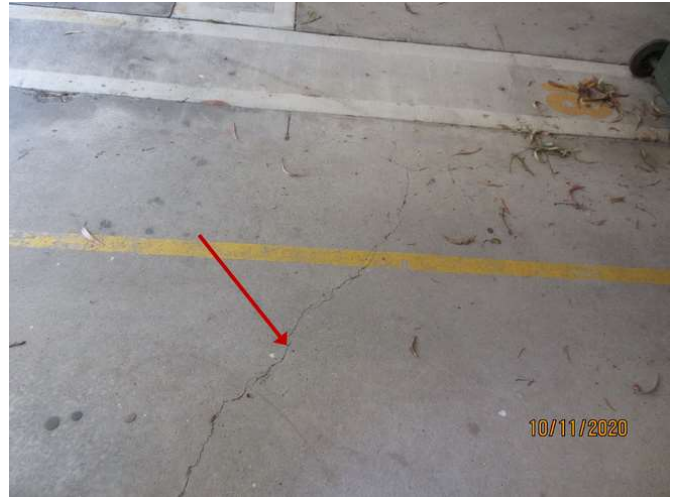
No 1-3_428_Note the cracking damage

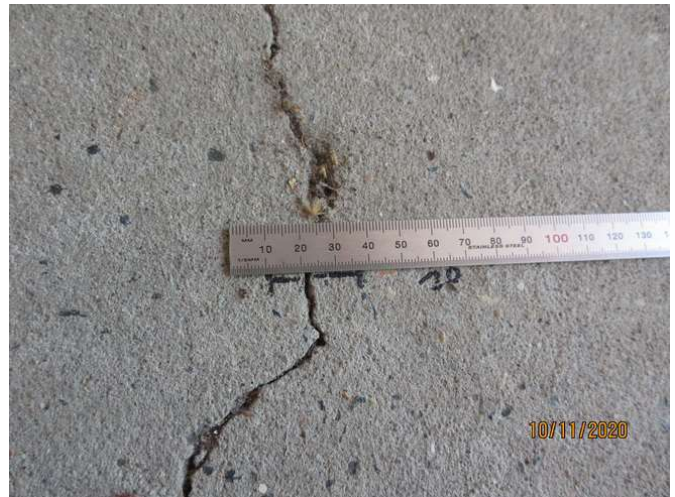
No 1-3_430_Note an estimated 2.0mm cracking width at representative location

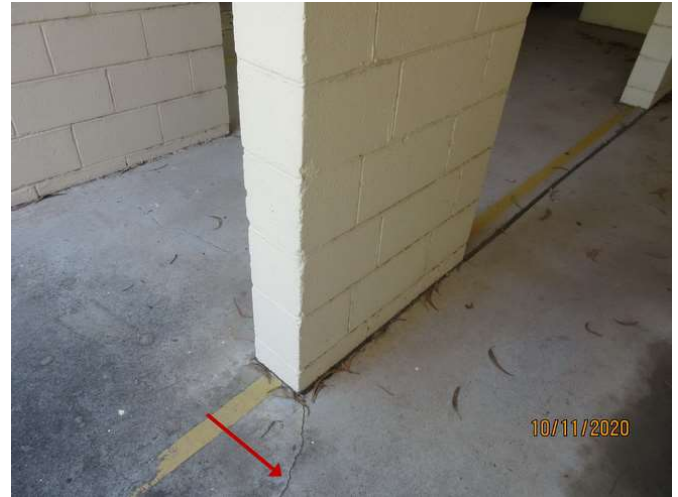
No 1-3_434_Note the cracking damage

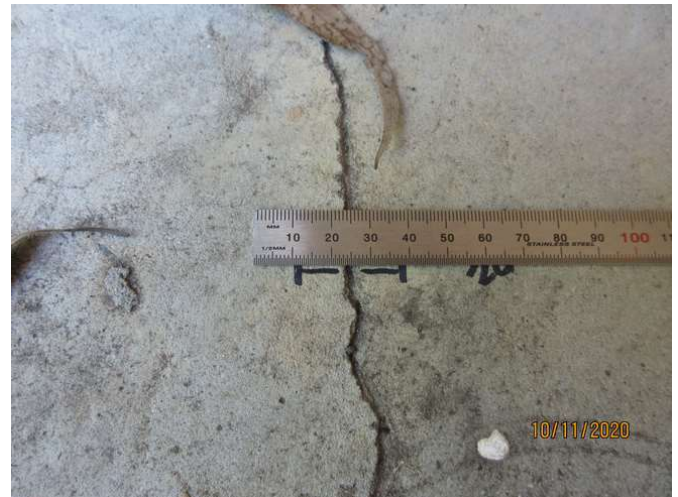
No 1-3_436_Note an estimated 1.5mm cracking width at representative location

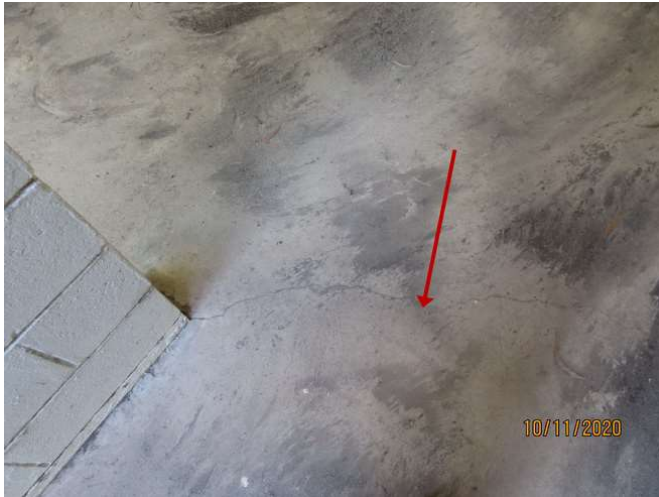
No 1-3_445_Note the cracking damage

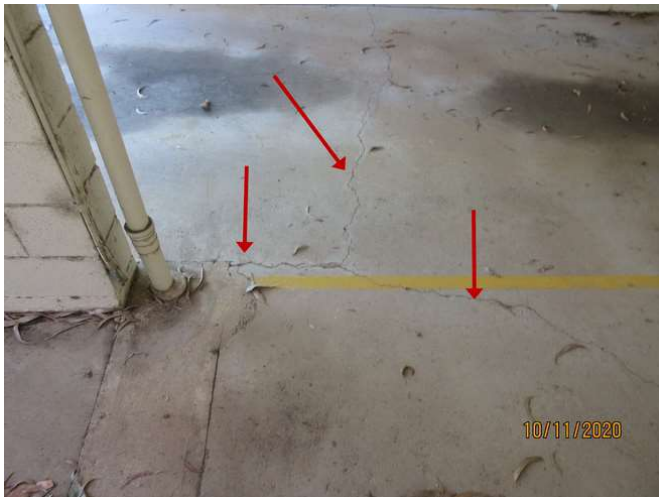
No 1-3_447_Note the cracking damage

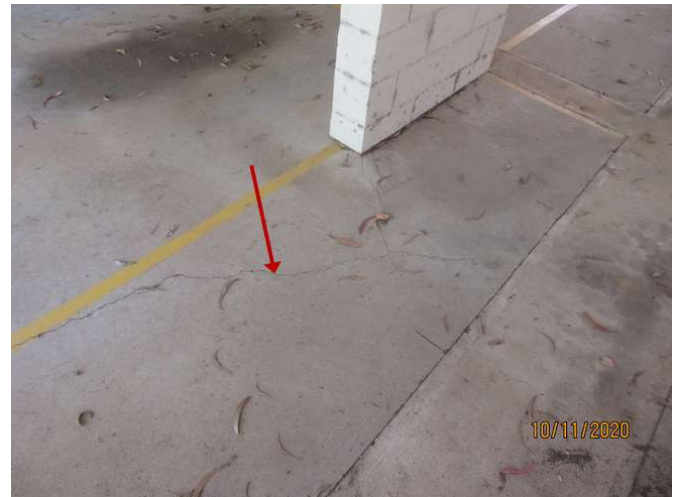
No 1-3_448_Note the cracking damage

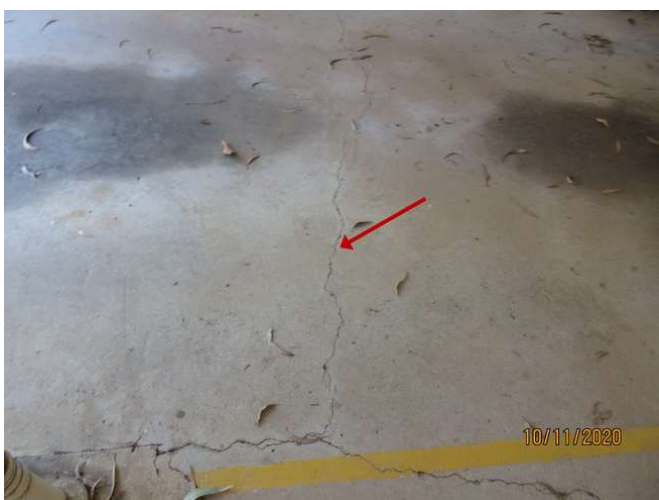
No 1-3_449_Note the cracking damage
