CONSTRUCTION CERTIFICATE No. J/74556/01

Issued under the Environmental Planning and Assessment Act 1979 Sections 6.4 and 6.7

Address: Ivanhoe Estate comprising Ivanhoe Place, Wilcannia Way, Nyngan Way, Narromine Way and Cobar Way, part of 2-4 Lyonpark Road and portions of Shrimptons Creek adjacent to the centre line of the creek, Macquarie Park

Description: Stage 1 development application for the redevelopment of the Ivanhoe Estate, including:

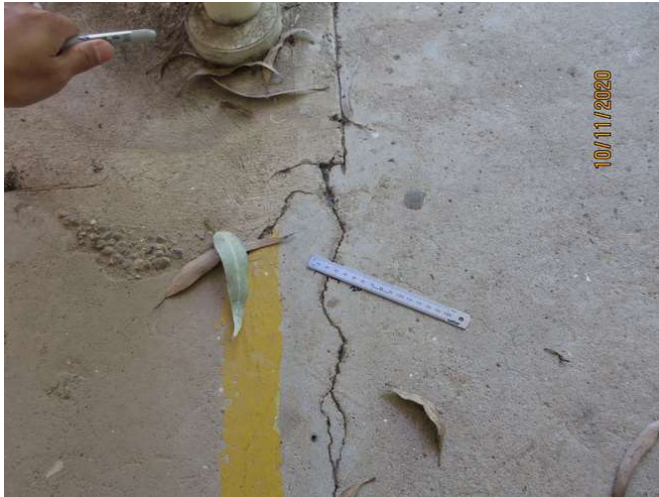
No 1-3_451_Note the cracking damage

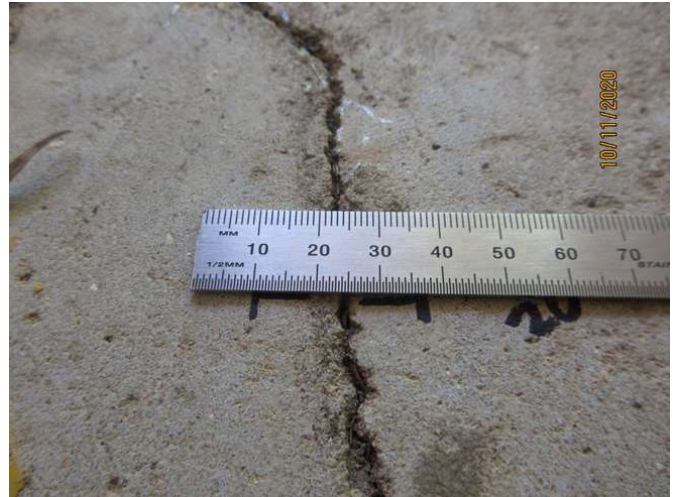
No 1-3_452_Note an estimated 1.5mm cracking width at representative location

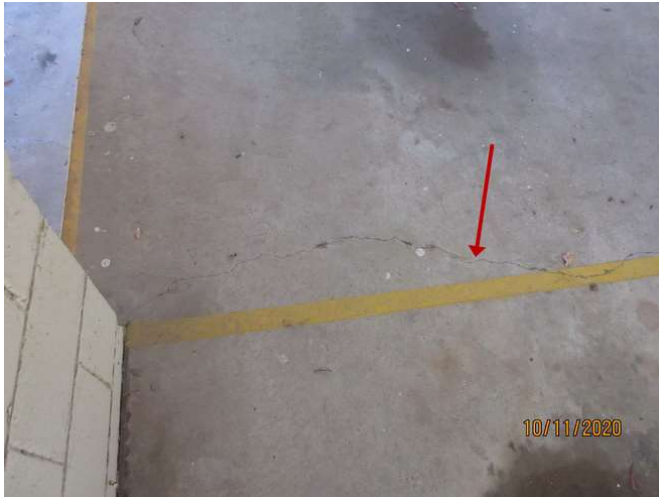
No 1-3_457_Note the cracking damage

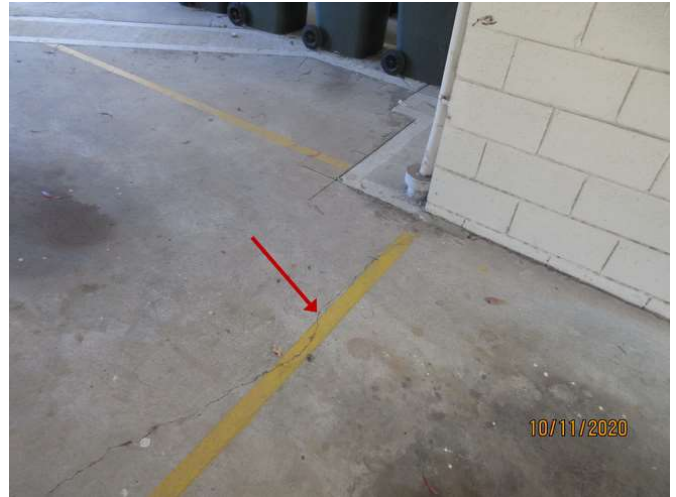
No 1-3_458_Note the cracking damage

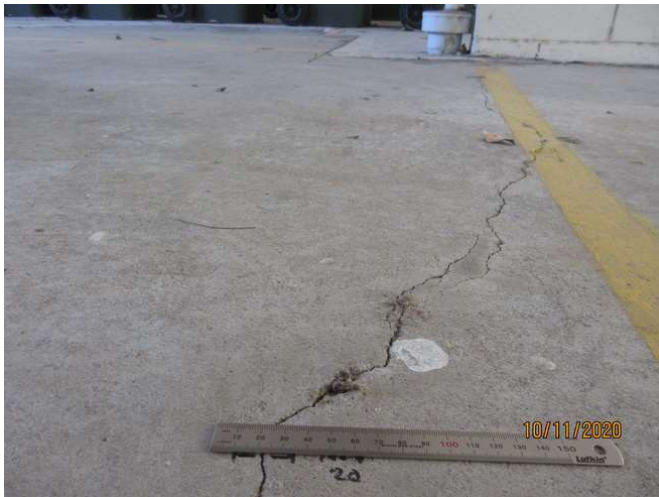
No 1-3_459

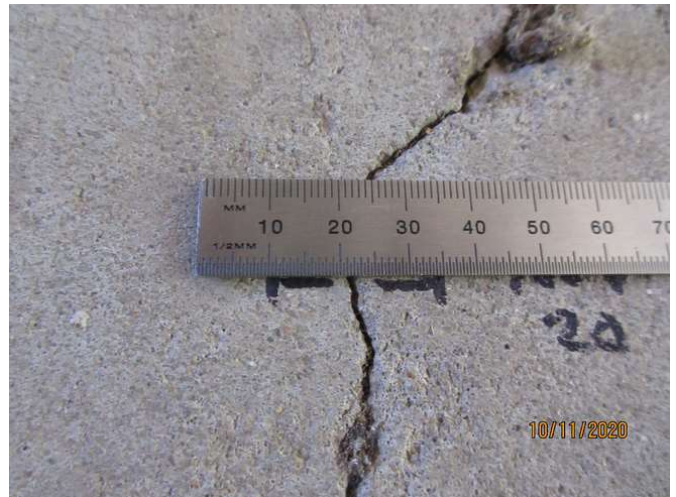
No 1-3_460_Note an estimated 1.5mm cracking width at representative location

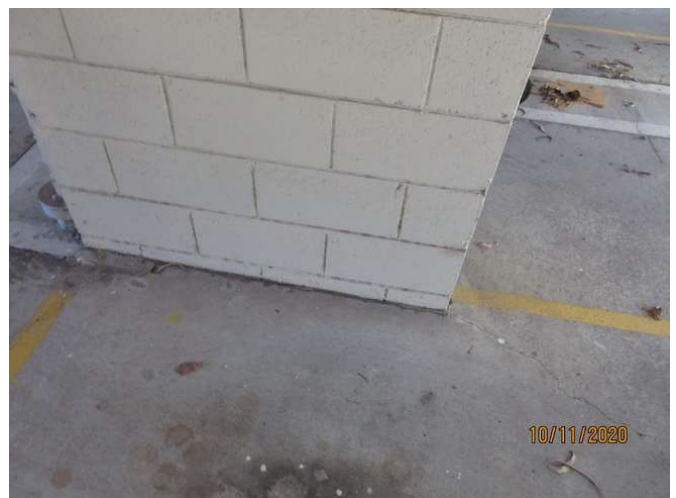
No 1-3_462

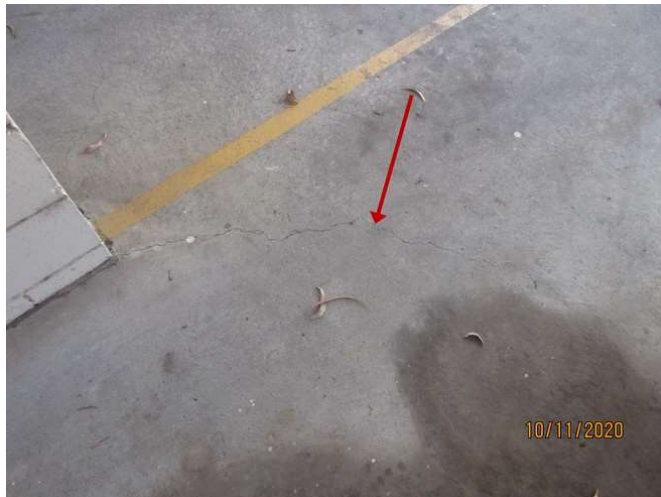
No 1-3_463_Note the cracking damage

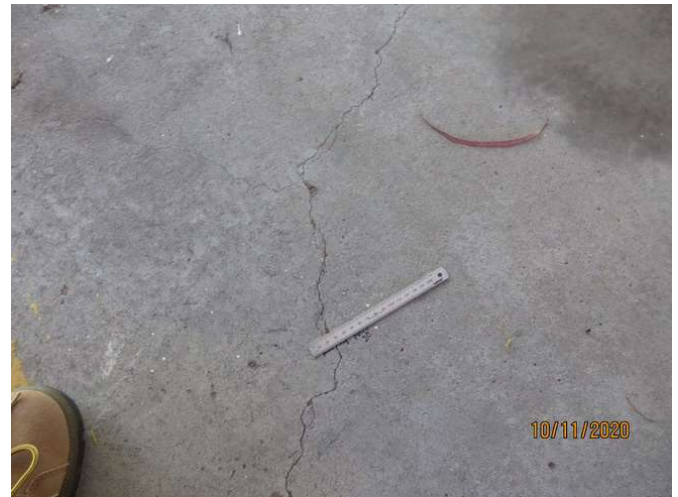
No 1-3_464

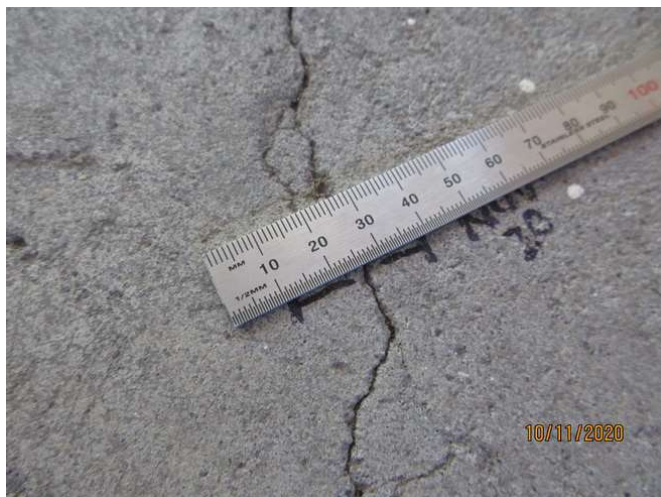
No 1-3_465_Note an estimated 1.0mm cracking width at representative location

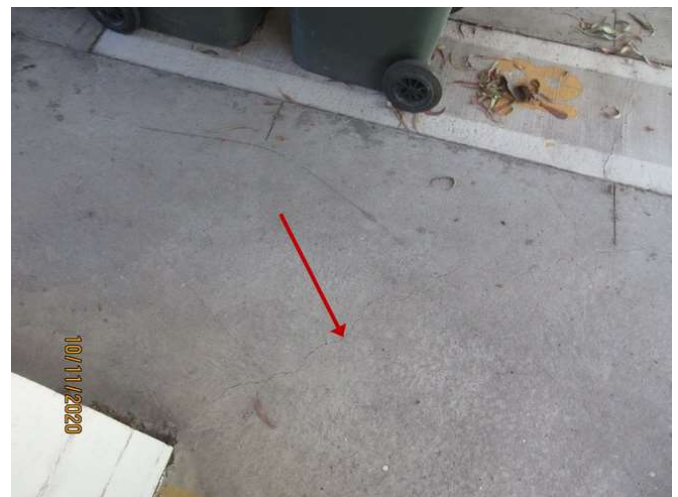
No 1-3_466_Note the cracking damage

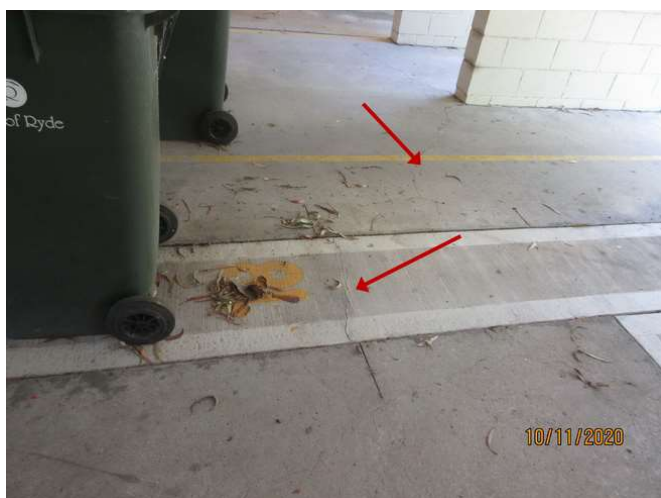
No 1-3_467_Note the cracking damage

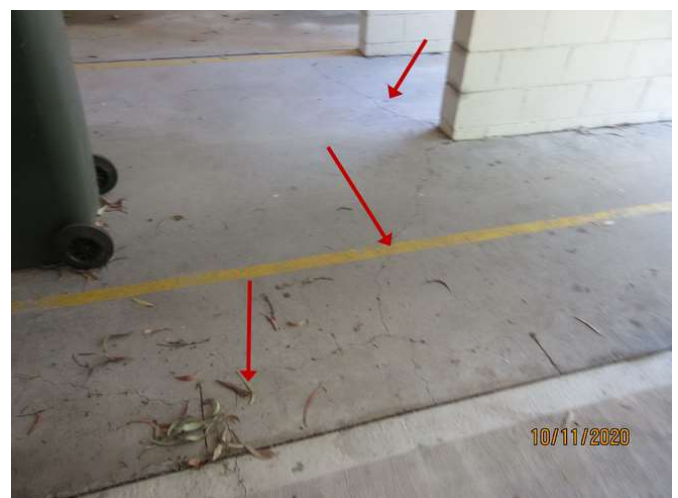
No 1-3_468_Note the cracking damage

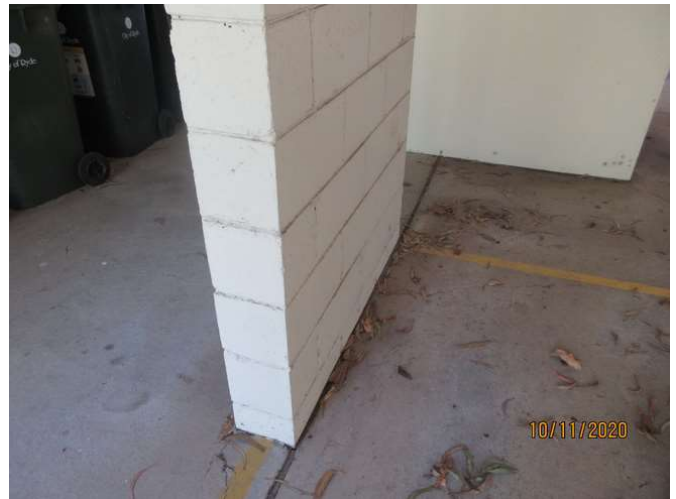
No 1-3_472

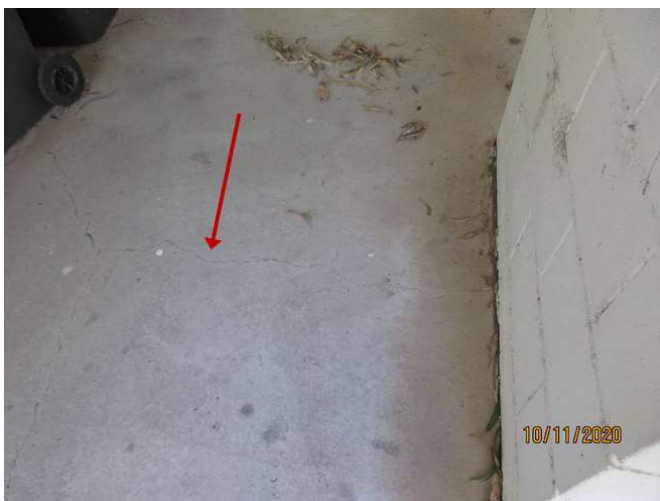
No 1-3_473_Note the cracking damage

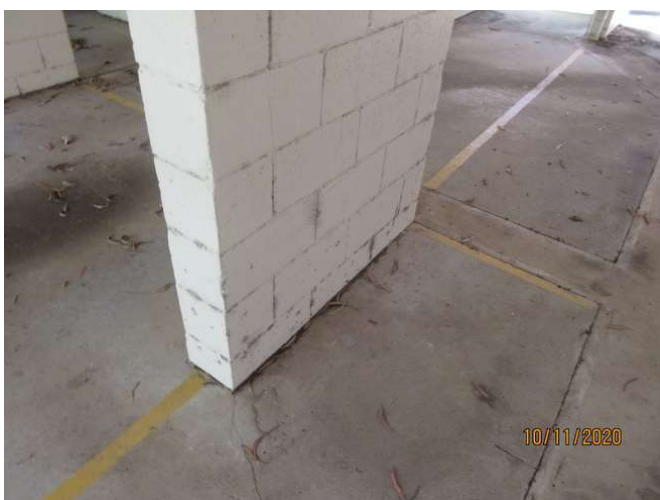
No 1-3_480_Note the cracking damage

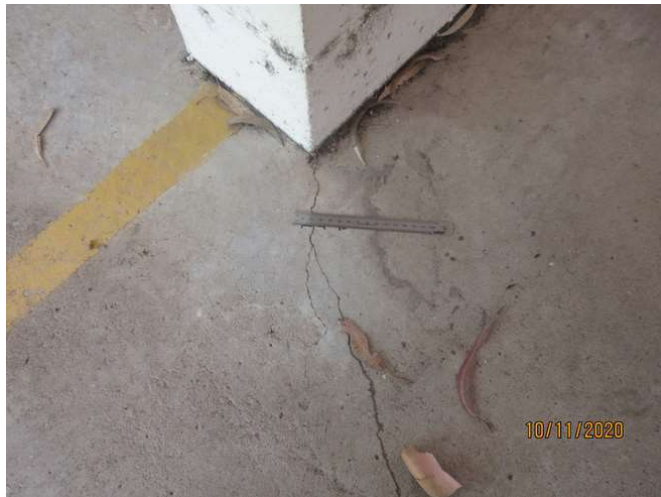
No 1-3_482_Note an estimated 1.0mm cracking width at representative location

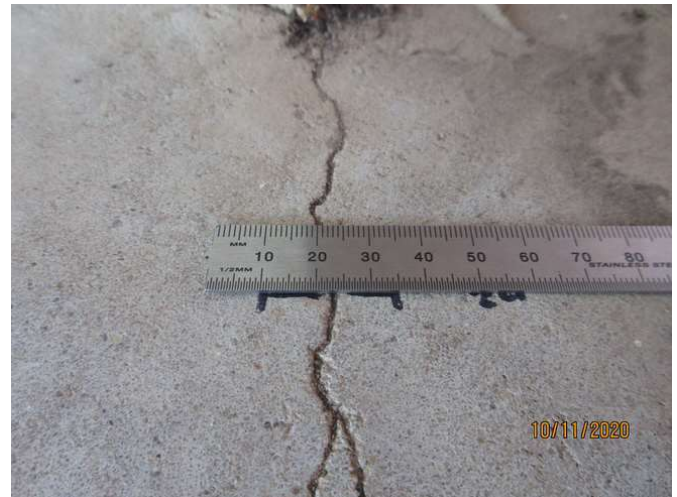
No 1-3_483_Note the cracking damage

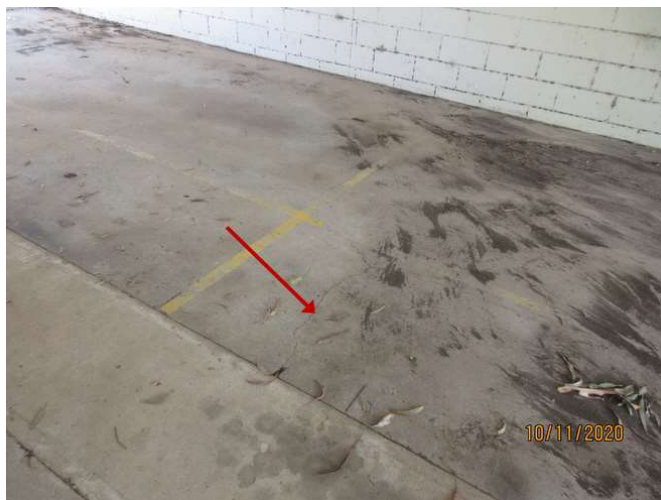
No 1-3_484_Note the cracking damage

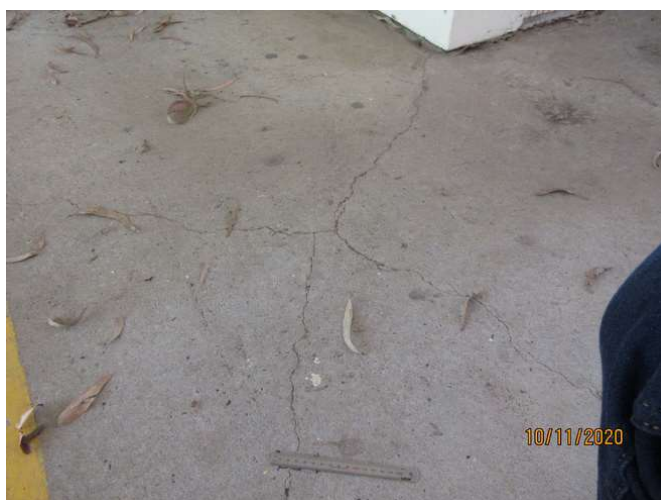
No 1-3_486_Note an estimated 1.0mm cracking width at representative location

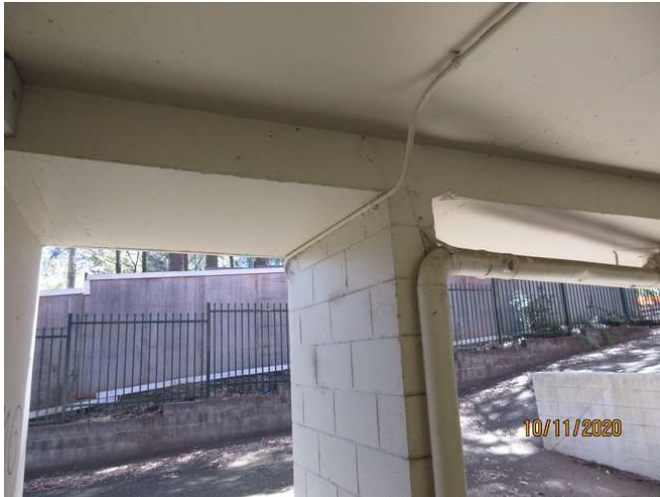
No 1-3_488_Note the cracking damage

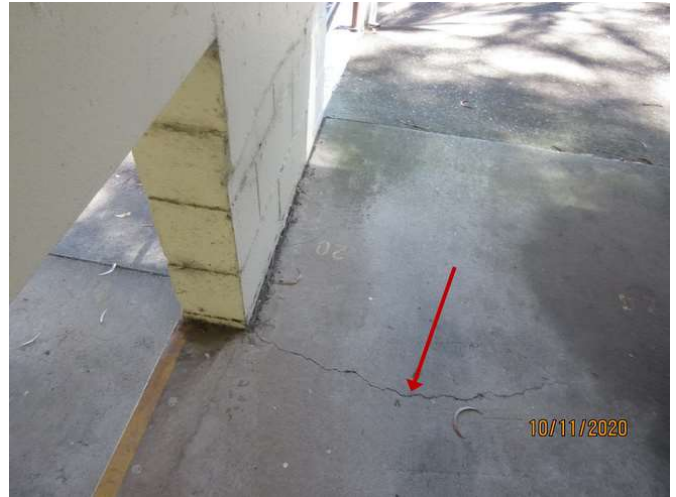
No 1-3_493_Note an estimated 1.5mm cracking width at representative location

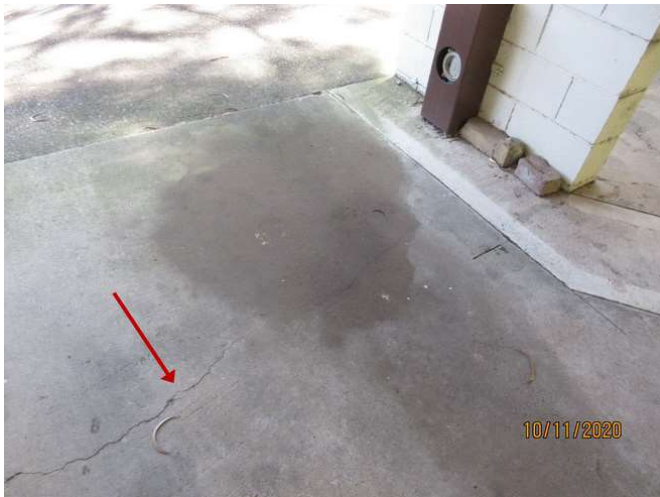
No 1-3_494_Note the cracking damage

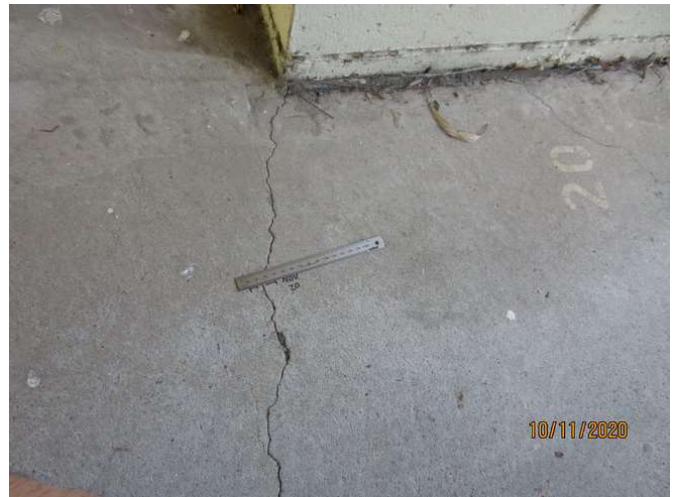
No 1-3_495_Note the cracking damage

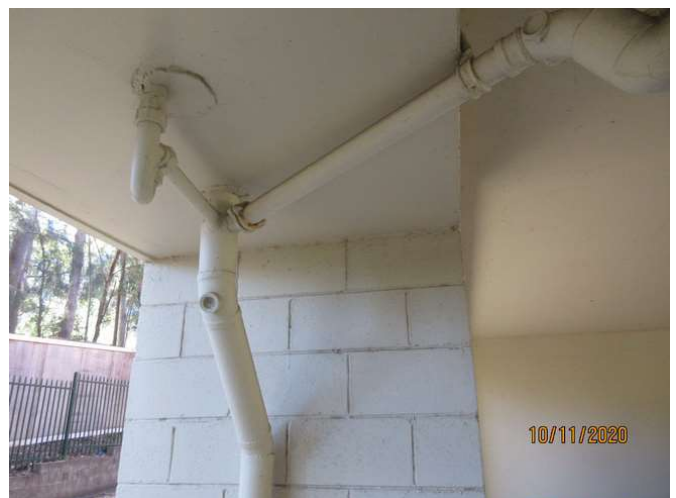
No 1-3_497_Note an estimated 2.0mm cracking width at representative location

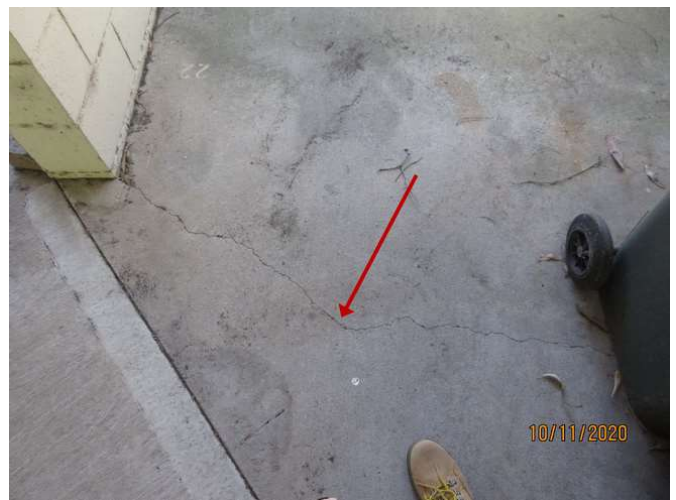
No 1-3_501_Note the cracking damage

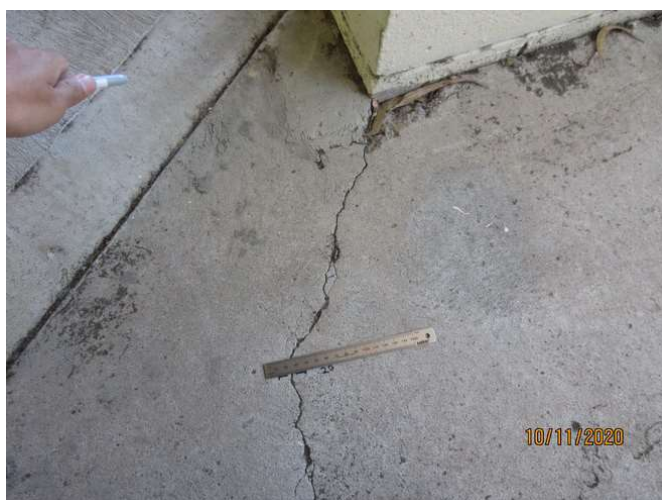
No 1-3_502_Note the cracking damage

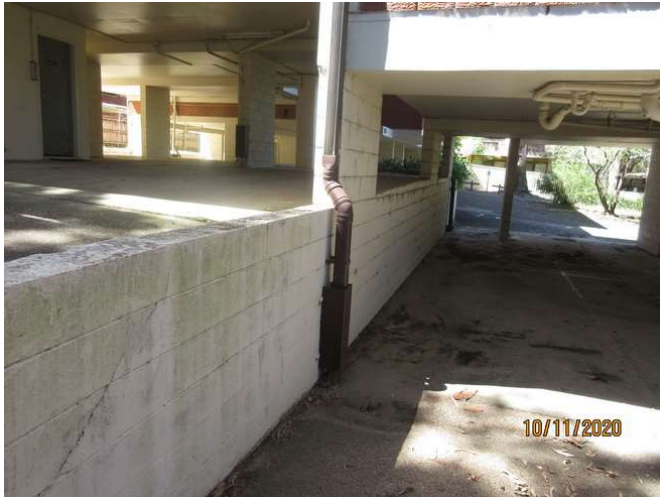
No 1-3_504_Note an estimated 1.5mm cracking width at representative location

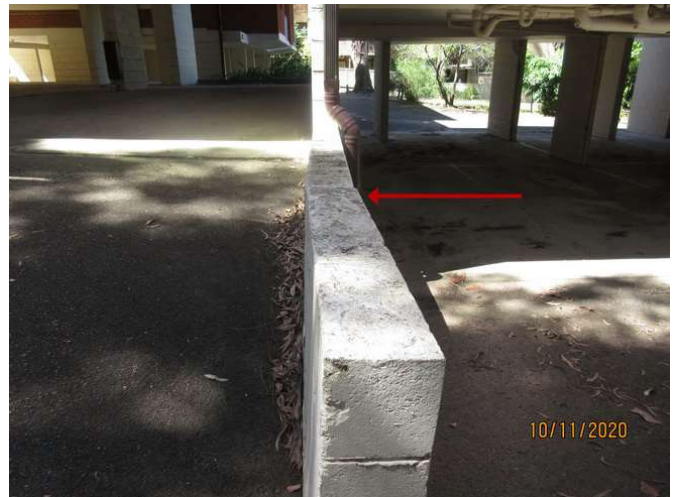
No 1-3_507_Note structual distress to block wall

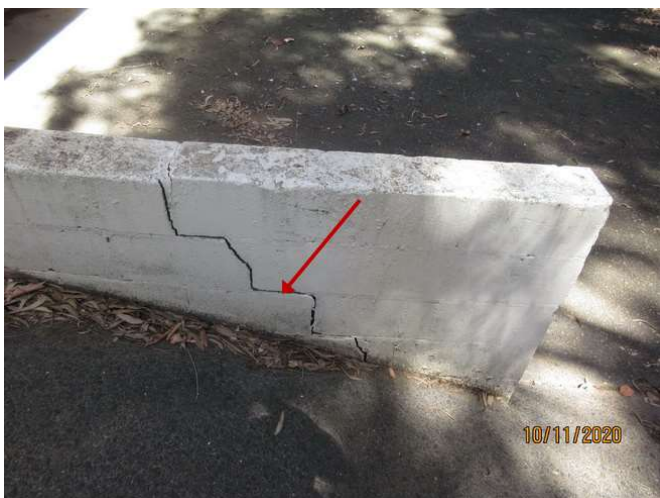
No 1-3_508_Note CAT-3 structual distress to block wall

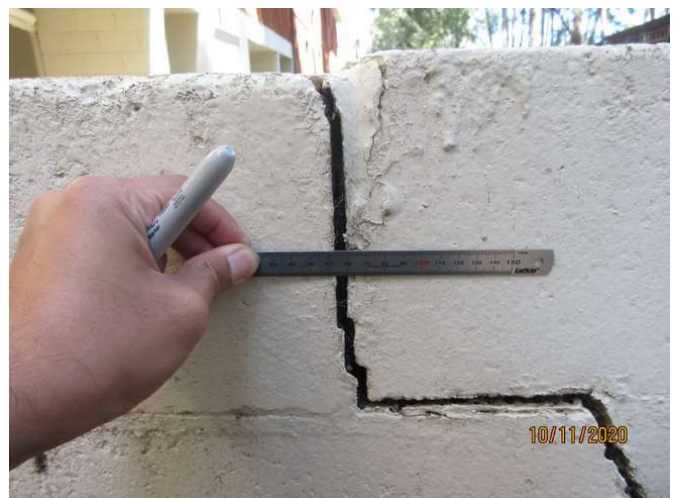
No 1-3_509_Note structual distress to block wall

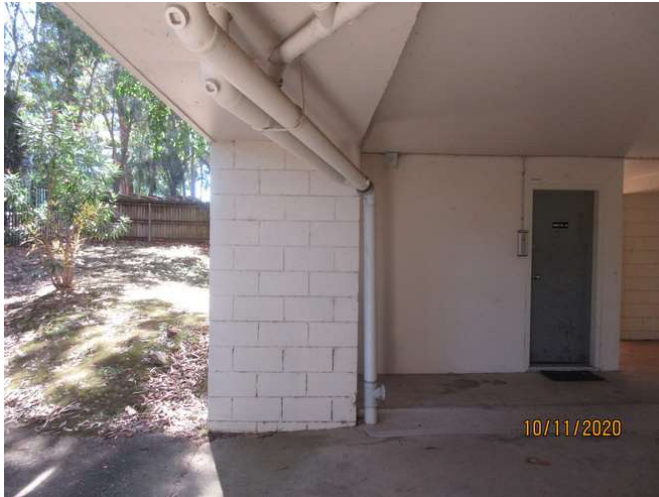
No 1-3_510_Note an estimated 5.5mm cracking width at representative location

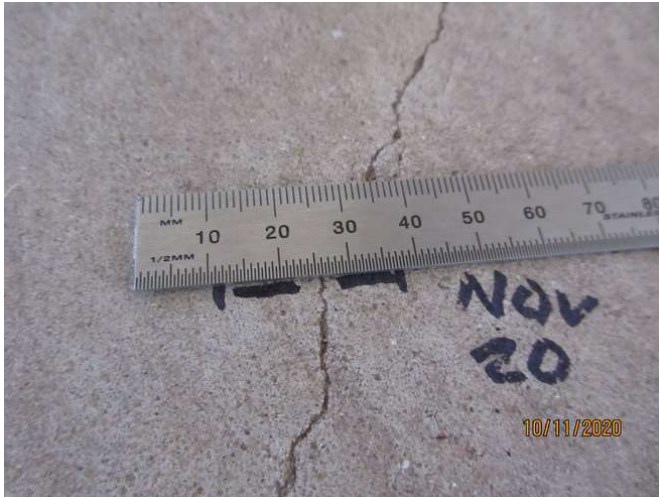
No 1-3_516_Note the cracking damage

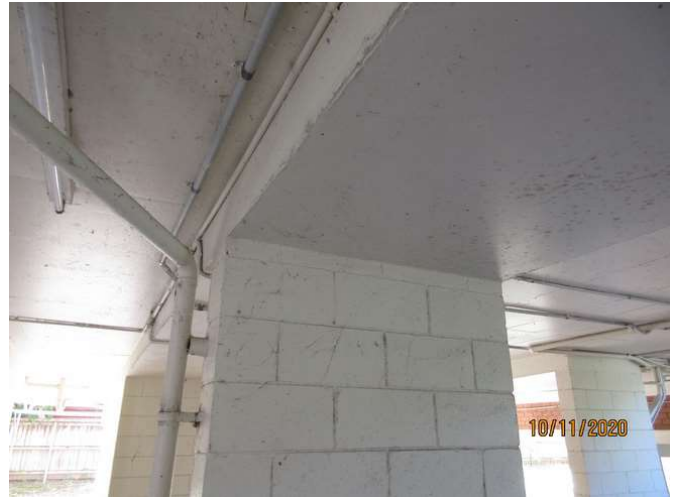
No 1-3_517_Note an estimated 0.5mm cracking width at representative location

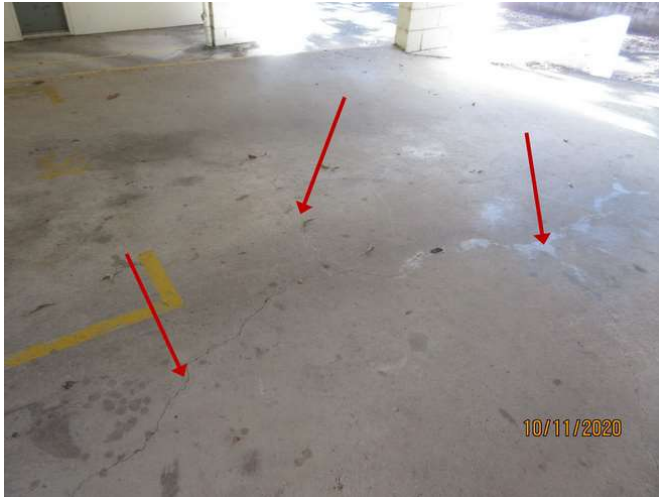
No 1-3_522_Note the cracking damage

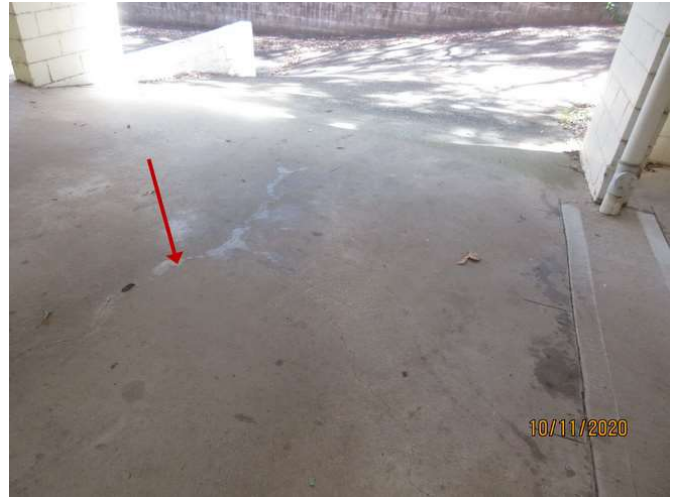
No 1-3_523_Note the cracking damage

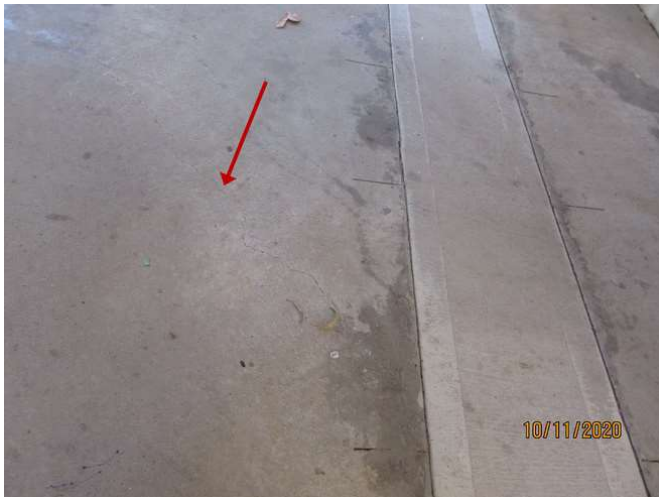
No 1-3_524_Note the cracking damage

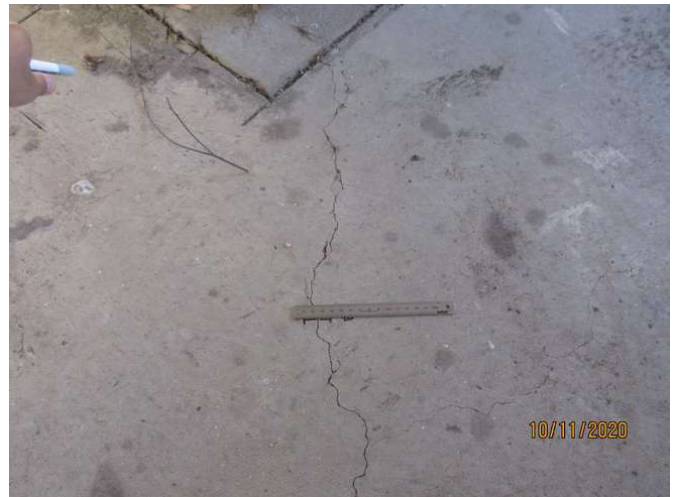
No 1-3_525_Note the cracking damage

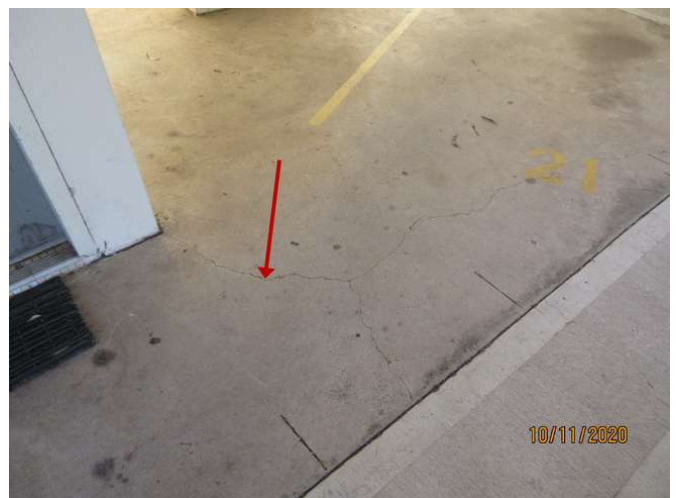
No 1-3_527_Note an estimated 1.0mm cracking width at representative location

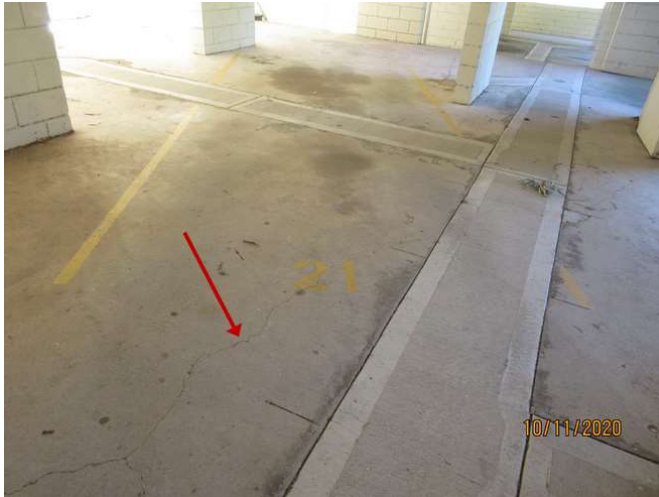
No 1-3_528_Note the cracking damage

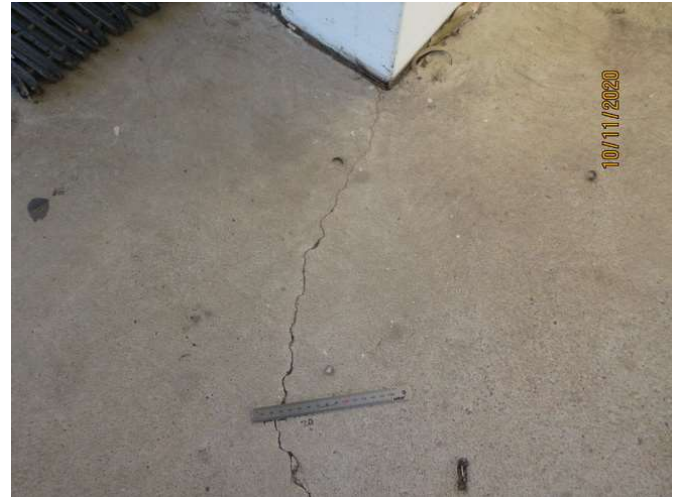
No 1-3_529_Note the cracking damage

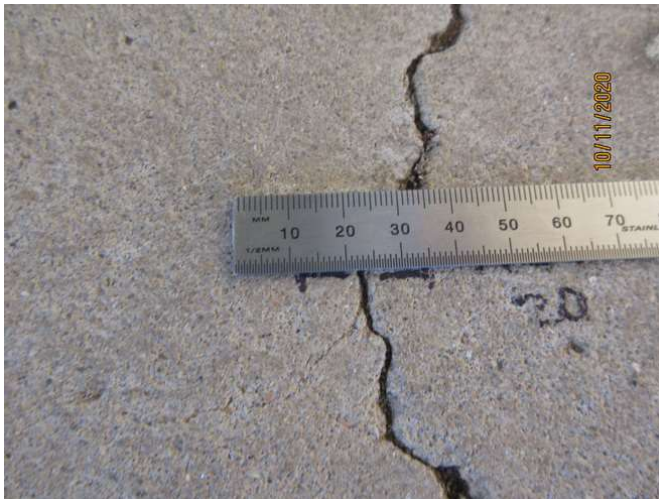
No 1-3_531_Note an estimated 1.0mm cracking width at representative location

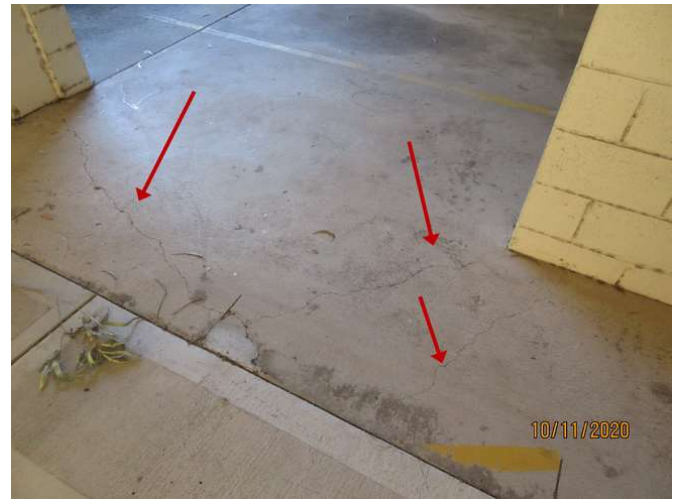
No 1-3_532_Note the cracking damage

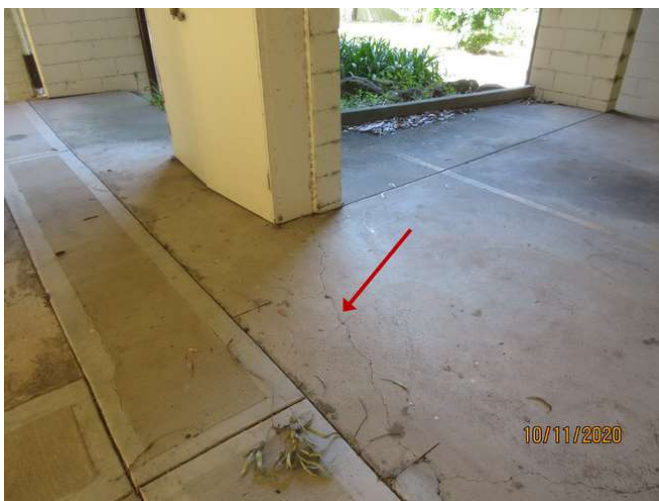
No 1-3_533_Note the cracking damage

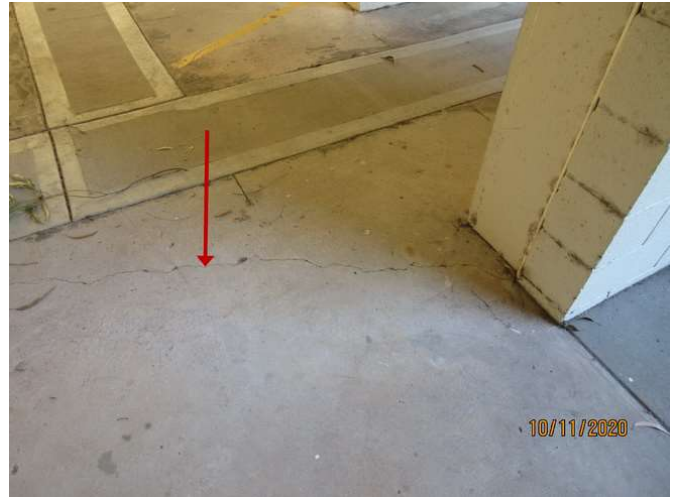
No 1-3_536_Note the cracking damage

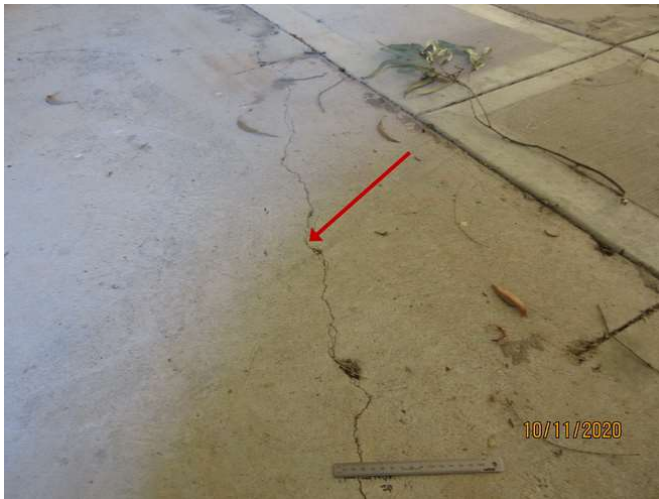
No 1-3_537_Note the cracking damage

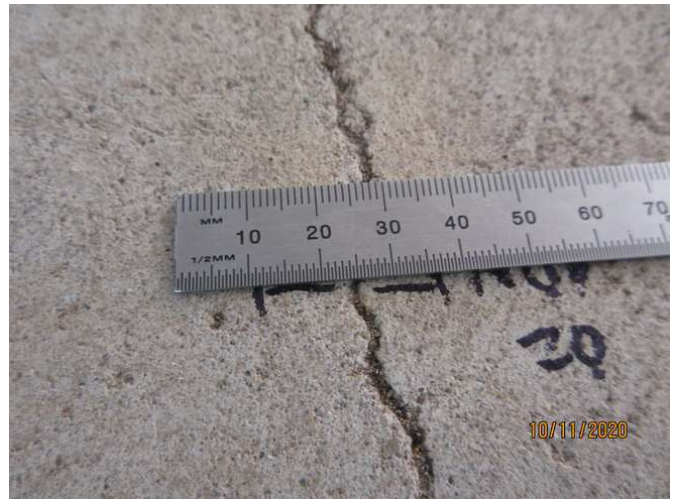
No 1-3_538_Note an estimated 1.0mm cracking width at representative location

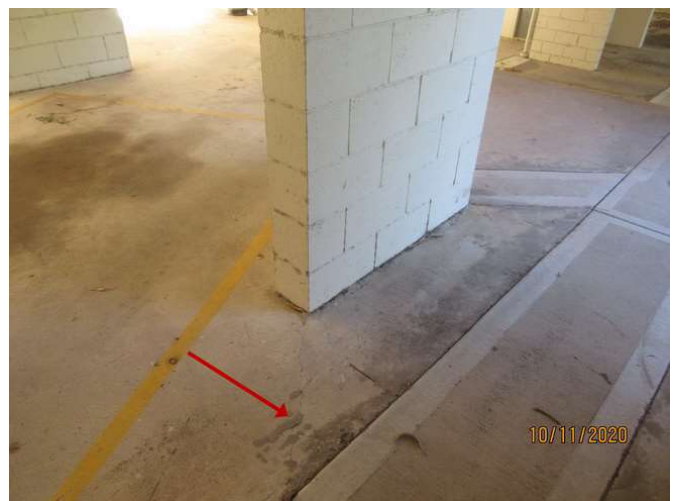
No 1-3_540_Note the cracking damage

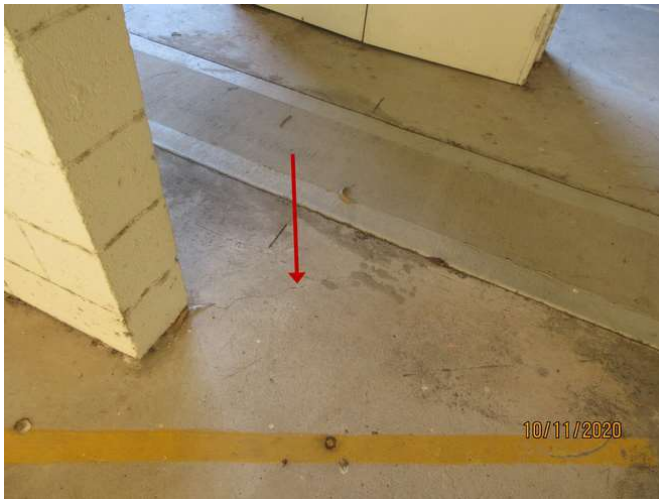
No 1-3_543_Note the cracking damage

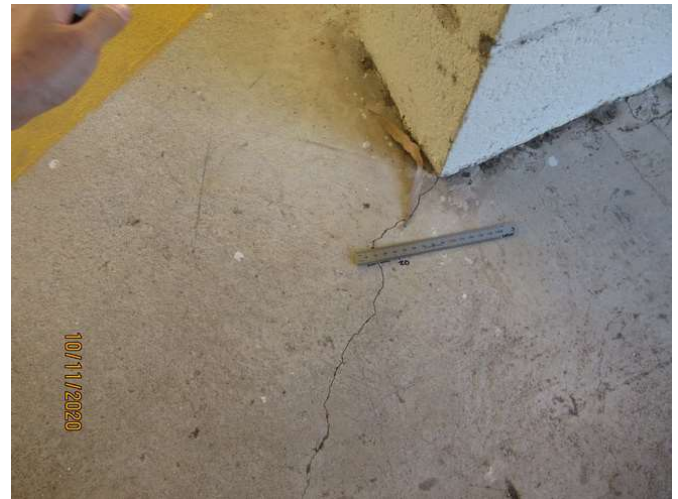
No 1-3_544_Note the cracking damage

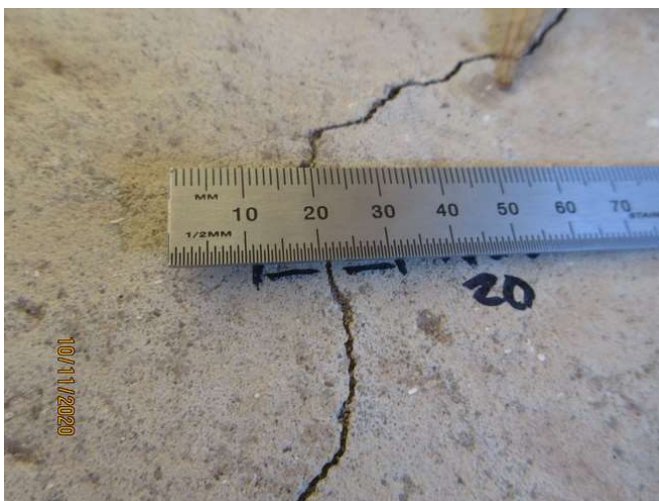
No 1-3_545_Note an estimated 0.75mm cracking width at representative location

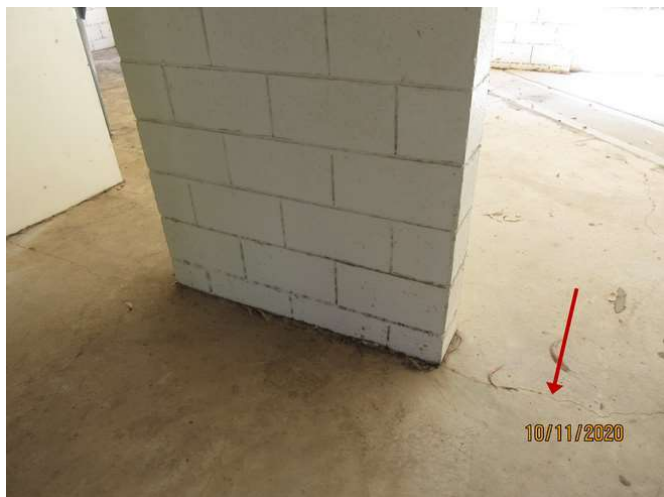
No 1-3_547_Note the cracking damage

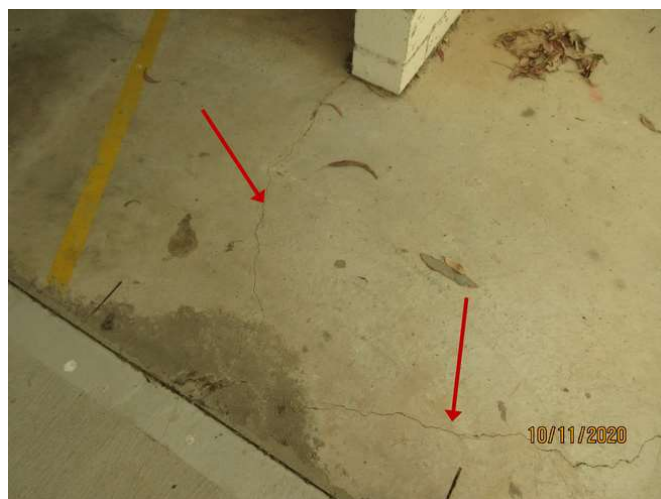
No 1-3_550_Note the cracking damage

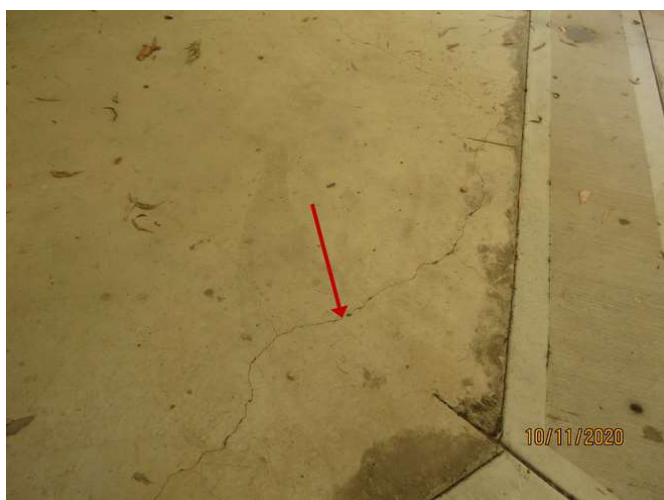
No 1-3_551_Note the cracking damage

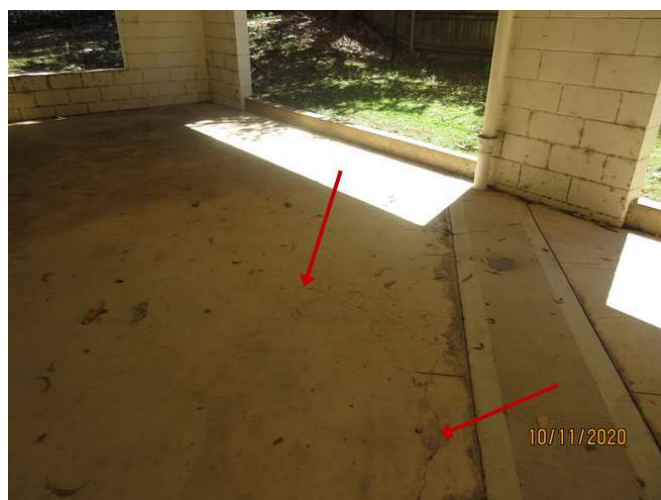
No 1-3_552_Note the cracking damage

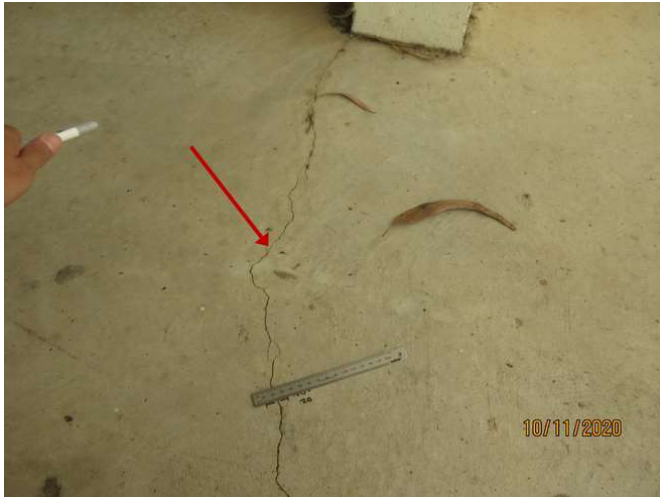
No 1-3_553_Note the cracking damage

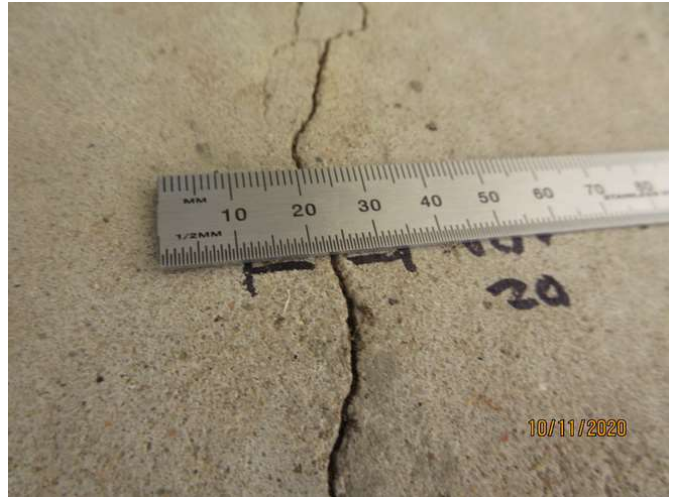
No 1-3_554_Note an estimated 1.0mm cracking width at representative location

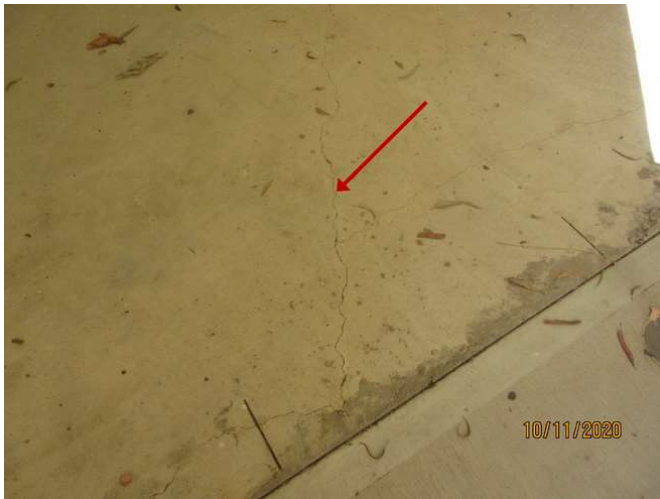
No 1-3_555_Note the cracking damage

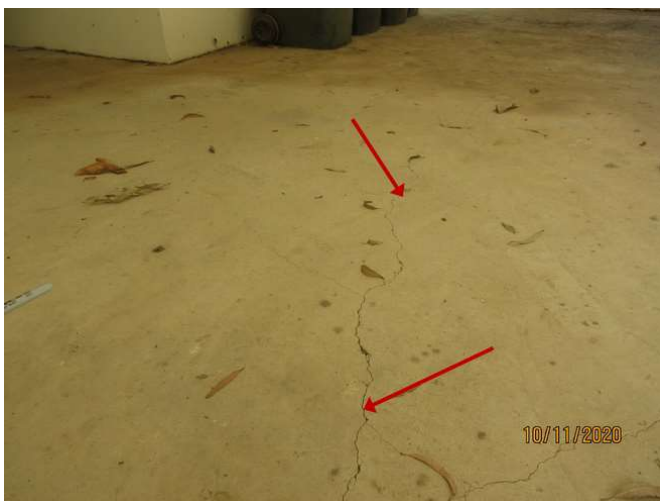
No 1-3_557_Note the cracking damage

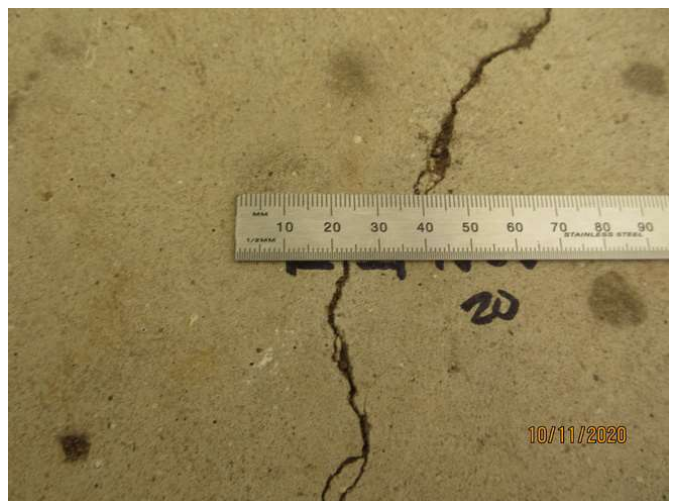
No 1-3_558_Note an estimated 1.0mm cracking width at representative location

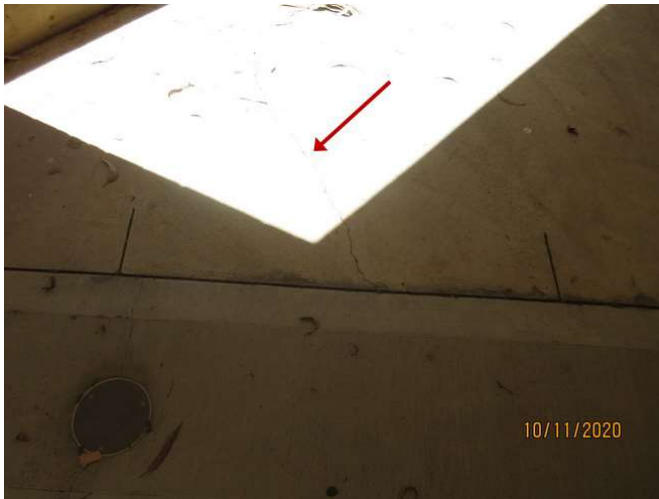
No 1-3_559_Note the cracking damage

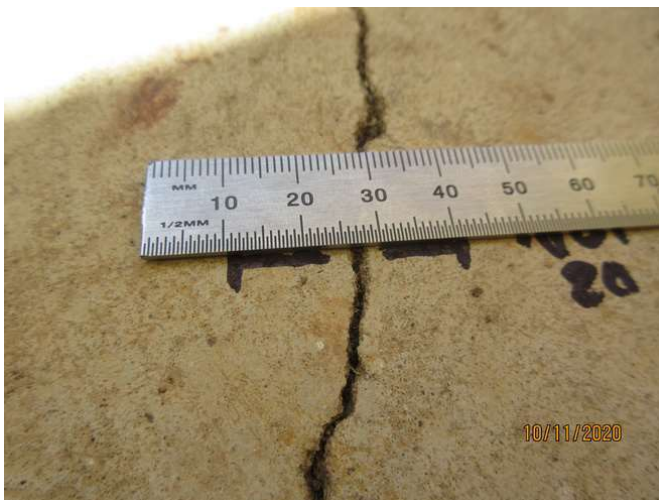
No 1-3_561_Note an estimated 2.0mm cracking width at representative location

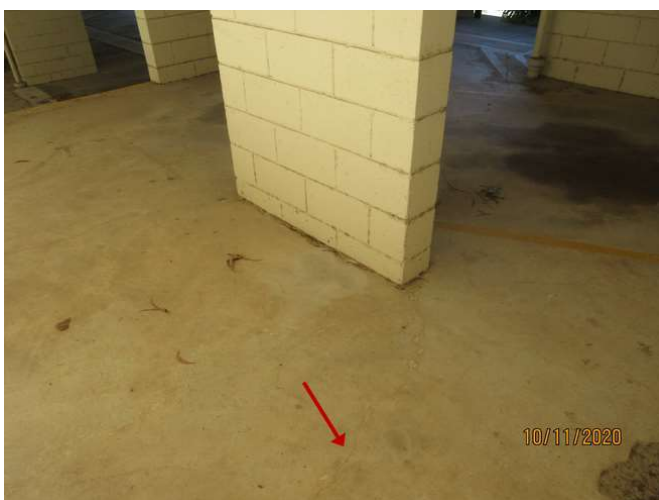
No 1-3_563_Note the cracking damage

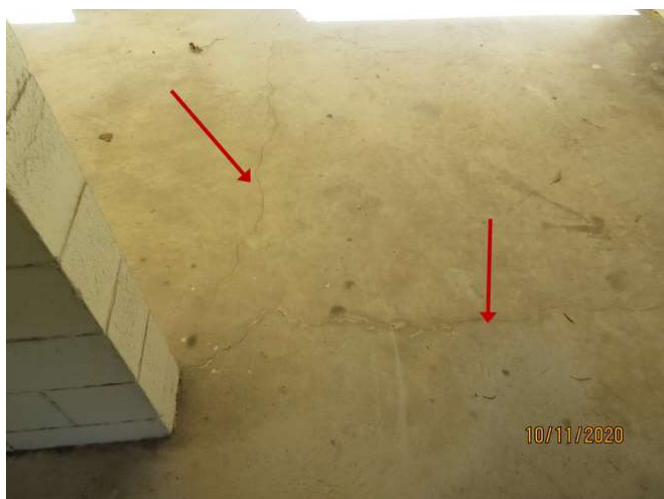
No 1-3_567_Note the cracking damage

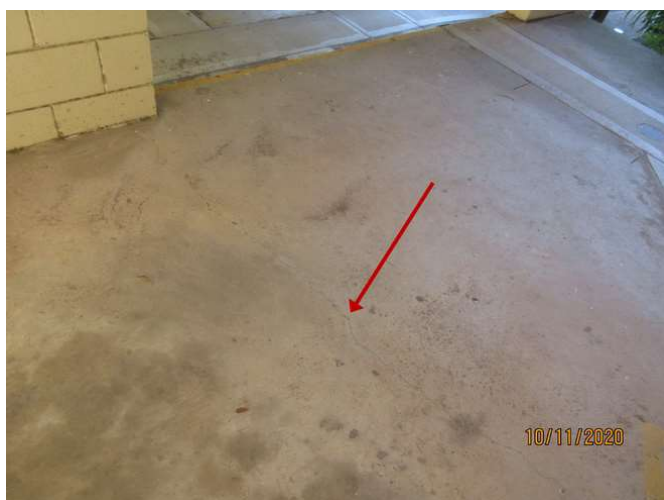
No 1-3_569_Note the cracking damage

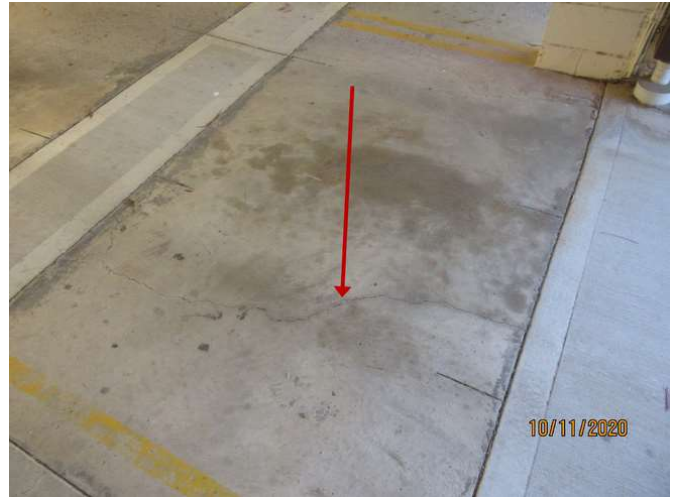
No 1-3_572_Note the cracking damage

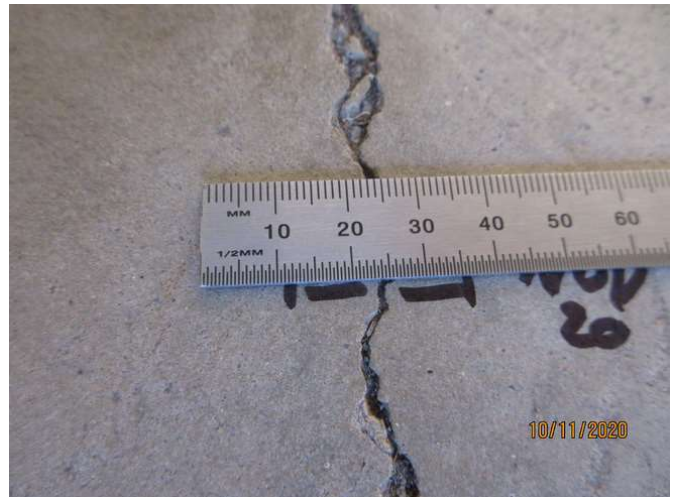
No 1-3_574_Note an estimated 1.0mm cracking width at representative location
