CONSTRUCTION CERTIFICATE No. J/74556/01

Issued under the Environmental Planning and Assessment Act 1979 Sections 6.4 and 6.7

Address: Ivanhoe Estate comprising Ivanhoe Place, Wilcannia Way, Nyngan Way, Narromine Way and Cobar Way, part of 2-4 Lyonpark Road and portions of Shrimptons Creek adjacent to the centre line of the creek, Macquarie Park

Description: Stage 1 development application for the redevelopment of the Ivanhoe Estate, including:

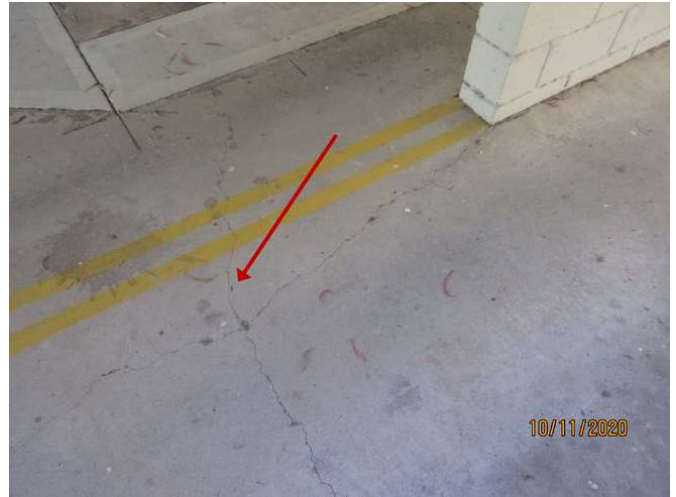
No 1-3_590_Note the cracking damage

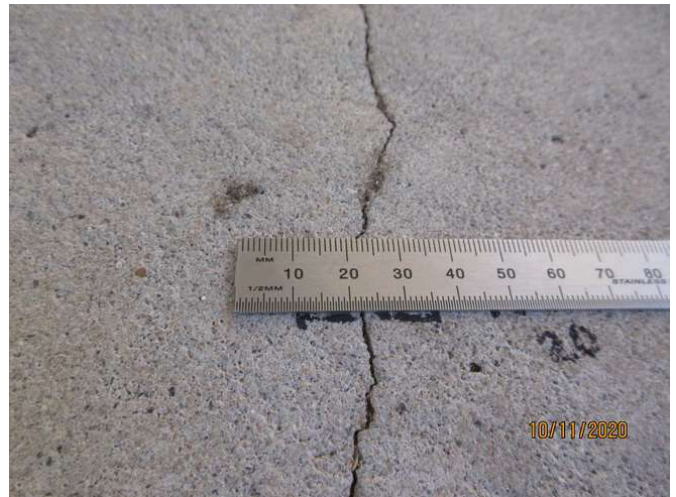
No 1-3_592_Note an estimated 0.5mm cracking width at representative location

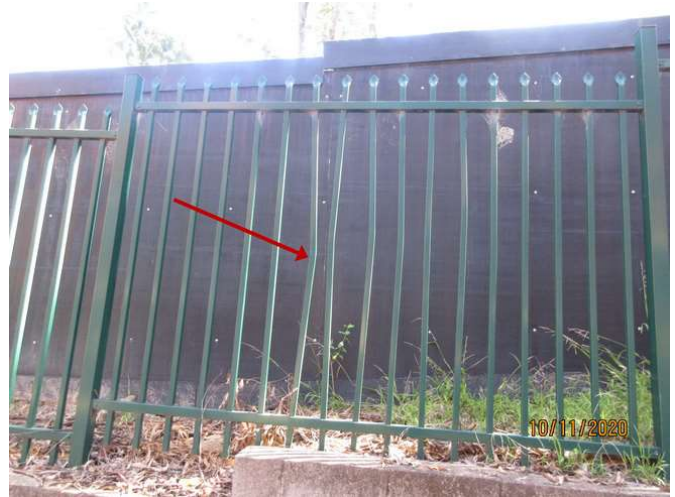
No 1-3_608_Note impact to metal railing fence

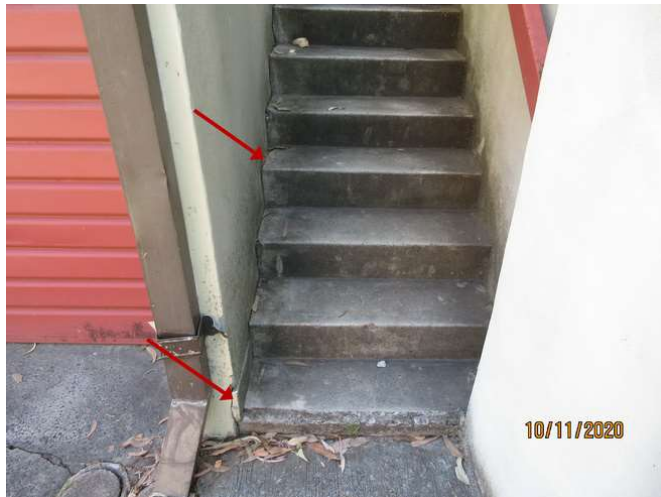
No 155_030_Note the opening to staircase edge

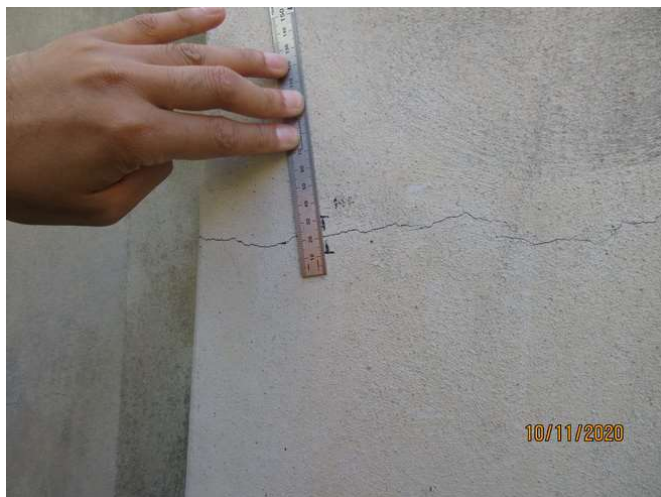
No 155_032_Note the cracking damage

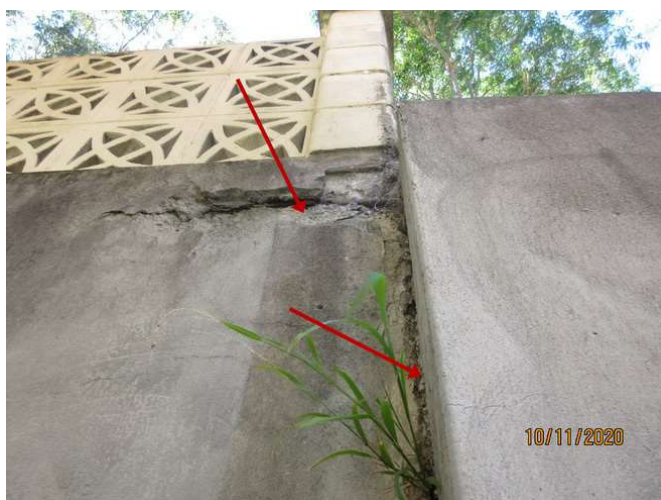
No 155_034_Note an estimated 0.5mm cracking width at representative location

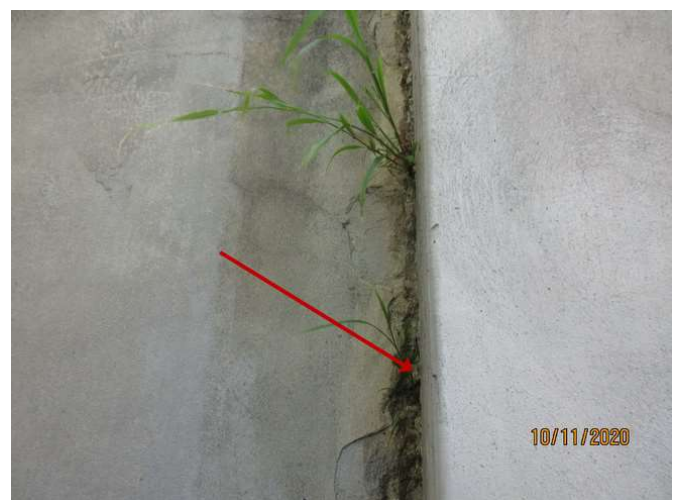
No 155_035_Spalling damage to concrete retaining wall

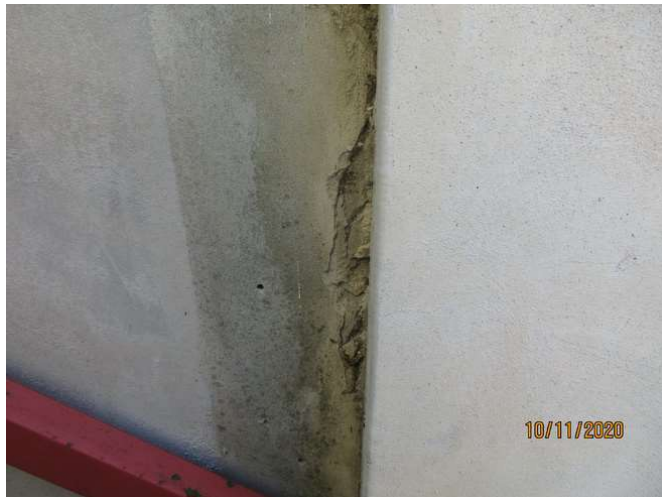
No 155_036_Spalling damage to concrete retaining wall

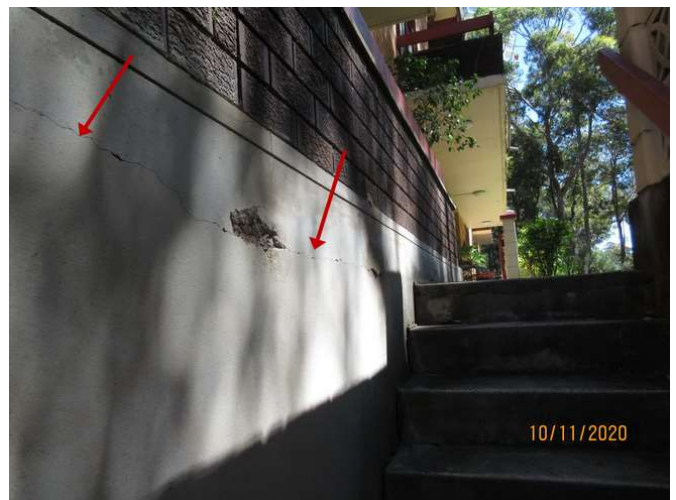
No 155_039_Note the cracking damage

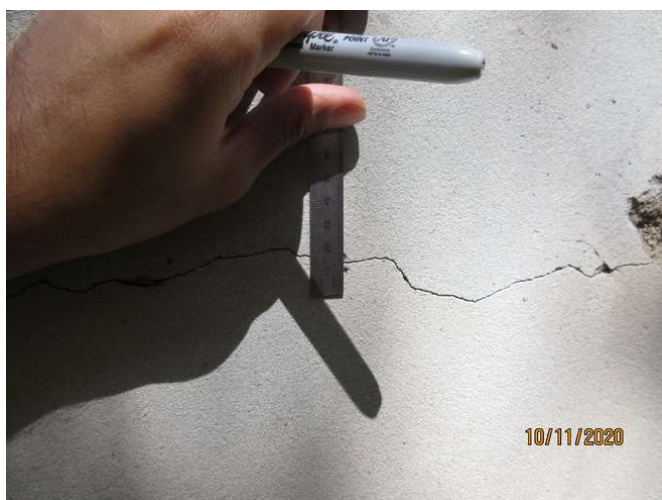
No 155_040_Note the cracking damage

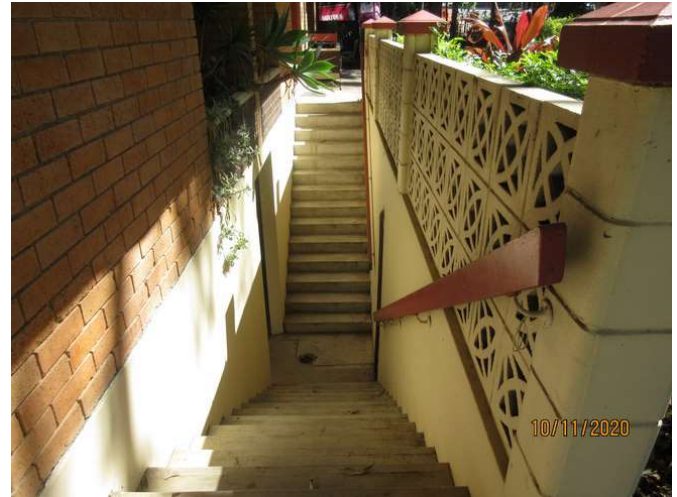
No 155_043_Note the cracking damage

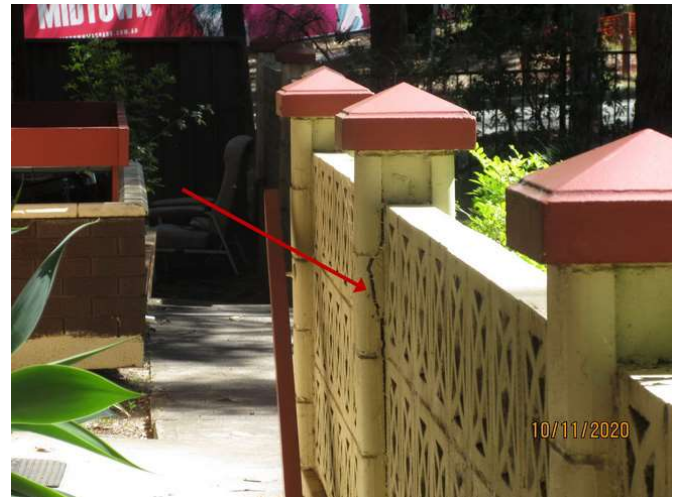
No 155_045_Note the cracking damage

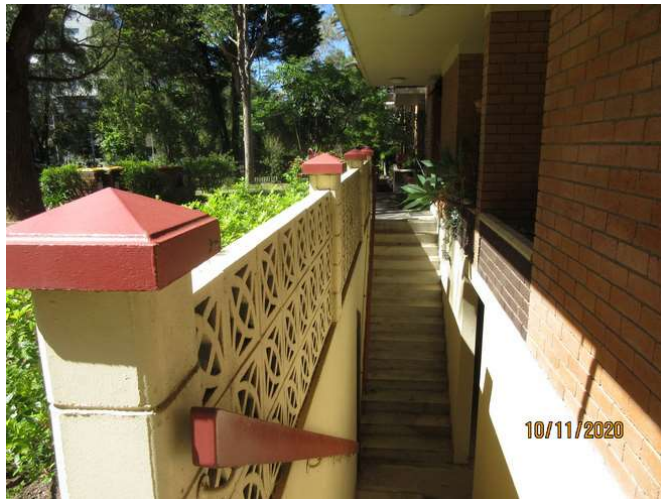
No 155_048_Note the cracking damage

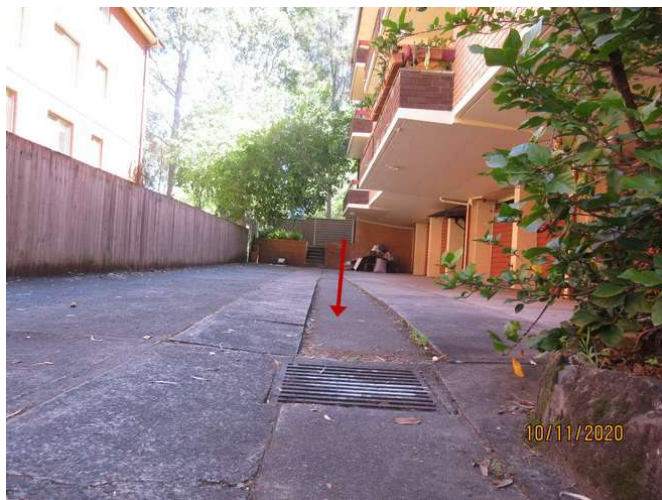
No 155_080_Subsidence along underground drain

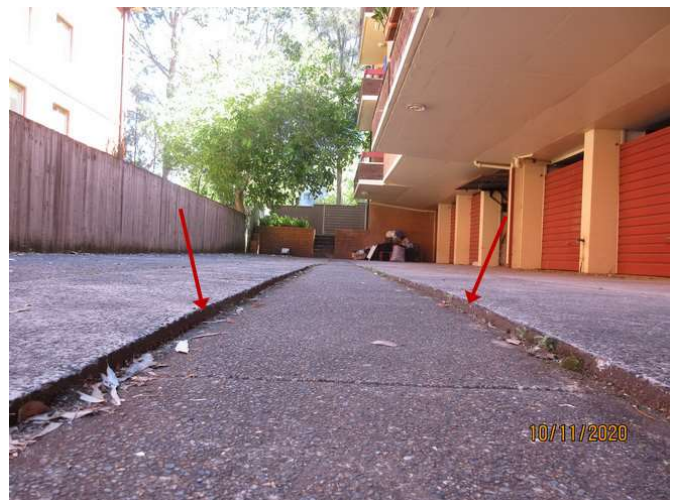
No 155_081_Subsidence along underground drain

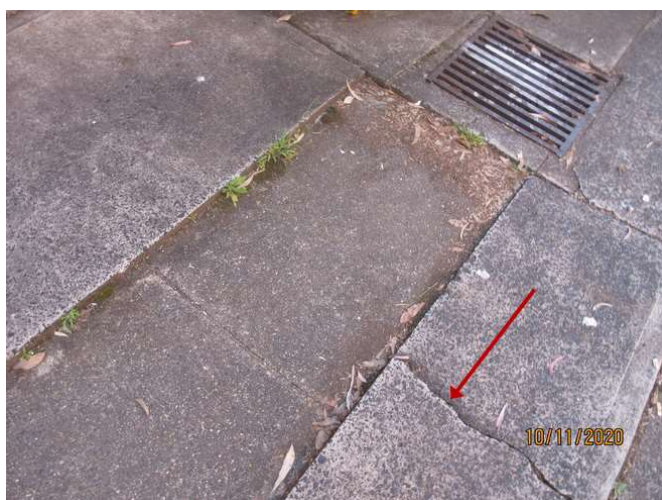
No 155_082_Subsidence along underground drain

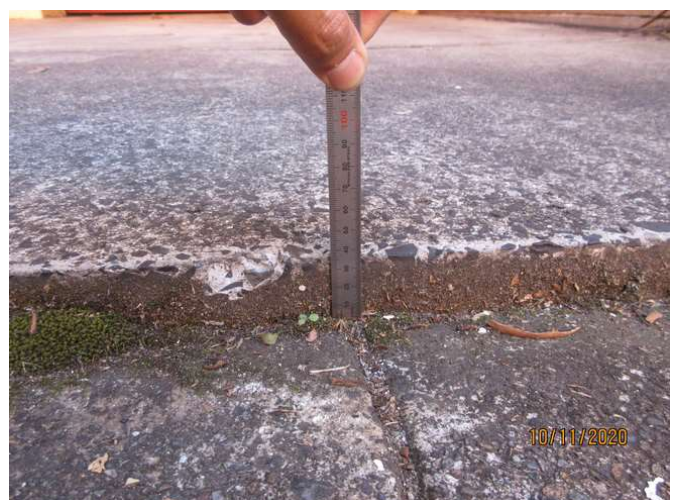
No 155_083_Note cracking damage

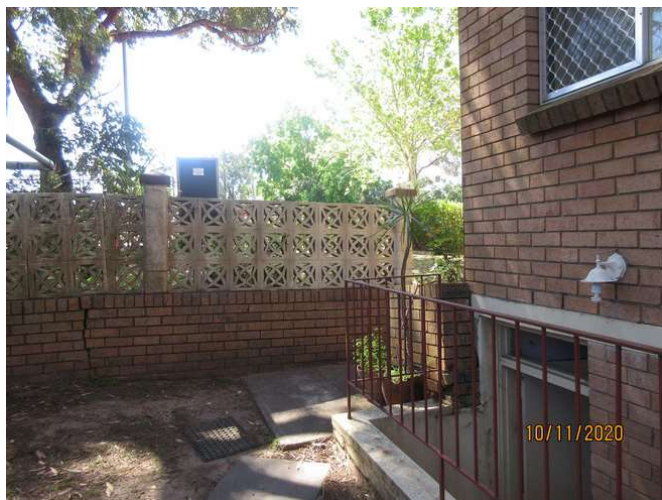
No 155_092_Distressed brick wall

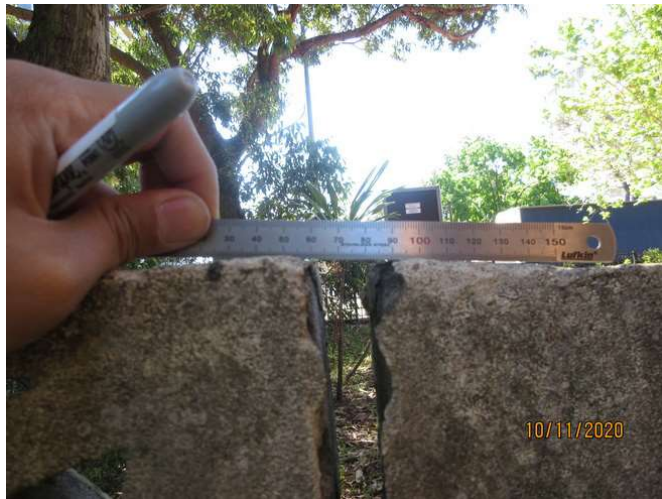
No 155_096_Note an estimated 28.0mm opening on top

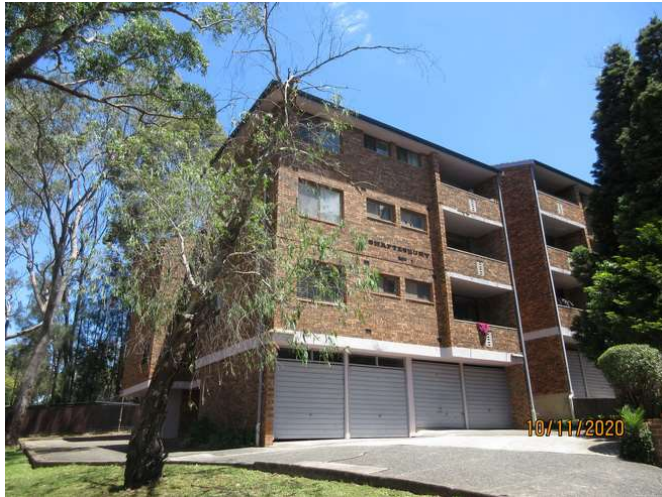
No 155_100_Distressed brick wall

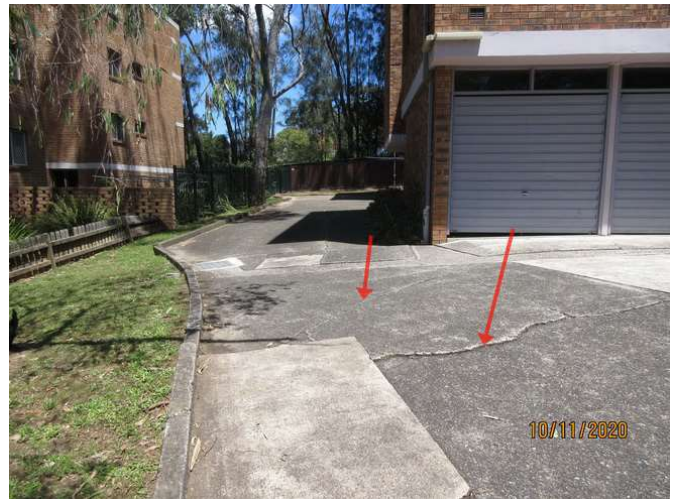
No1_003_Note evident cracking to concrete driveway

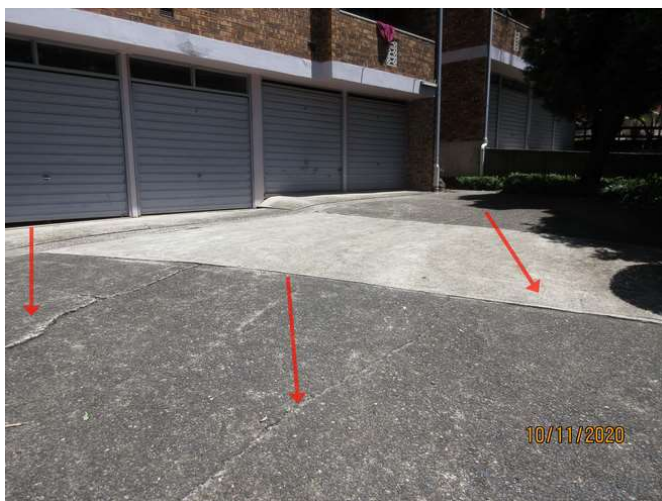
No1_004_Note evident cracking to concrete driveway

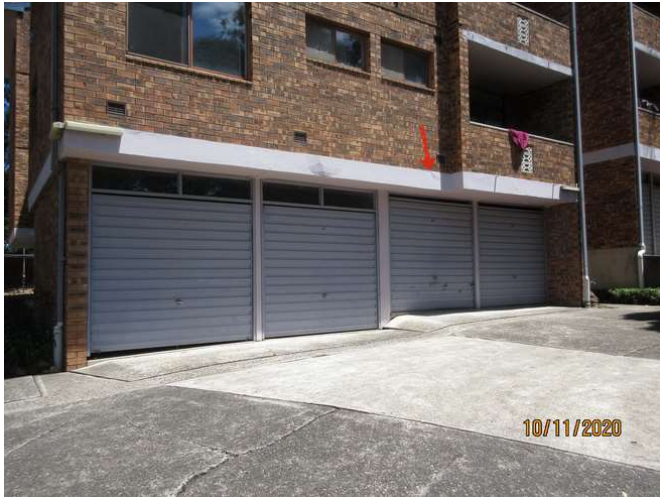
No1_012_Note slight concrete spalling

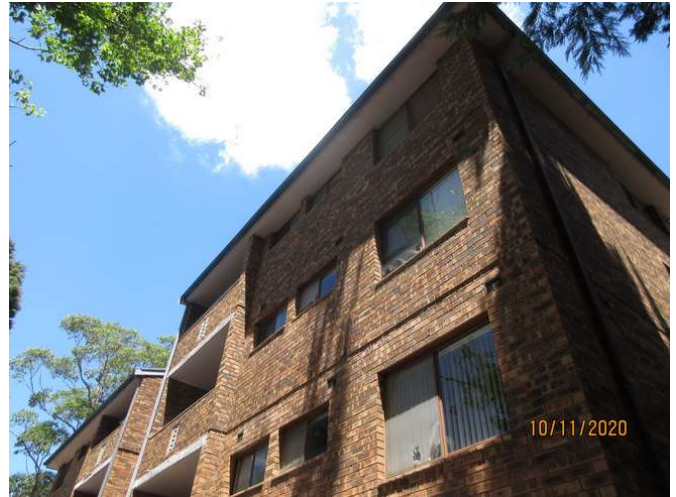
No1_013_Note slight concrete spalling

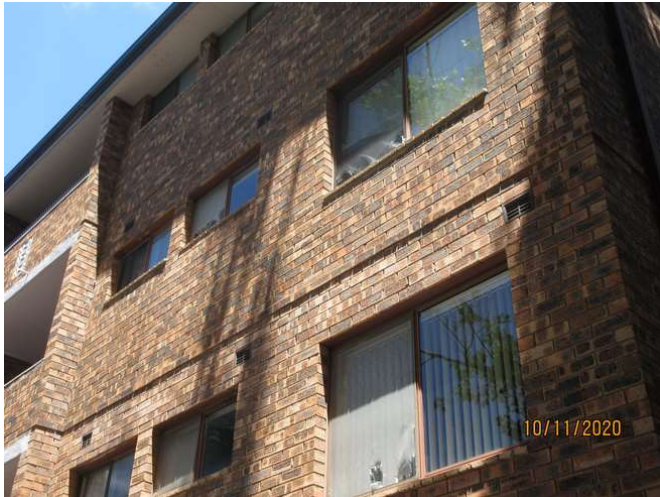
No1_018_Note slight concrete spalling

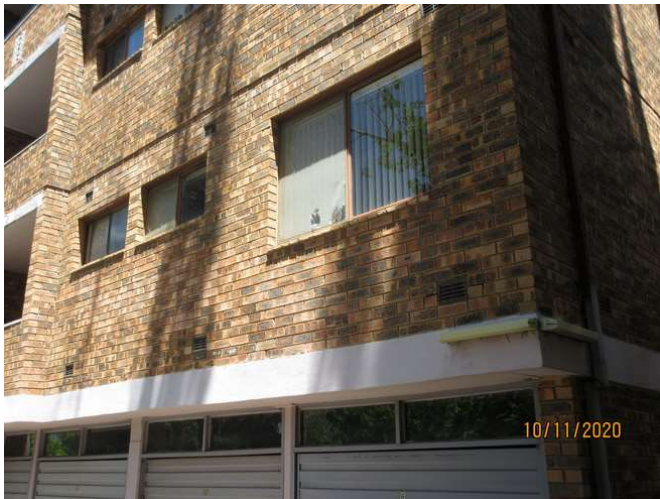
No1_020_Note slight concrete spalling

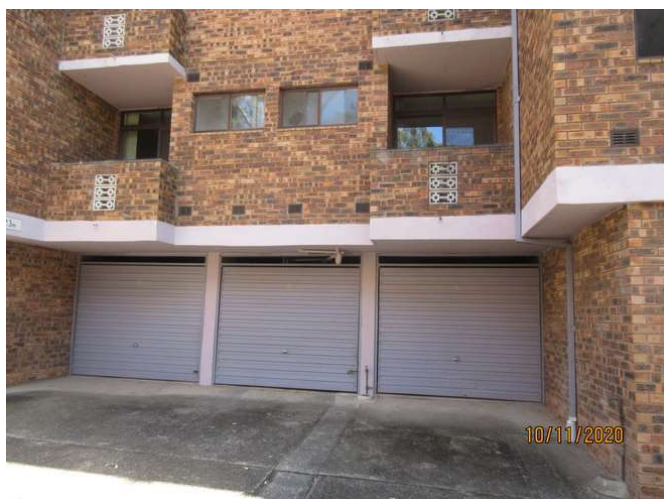
No1_024_Note slight concrete spalling

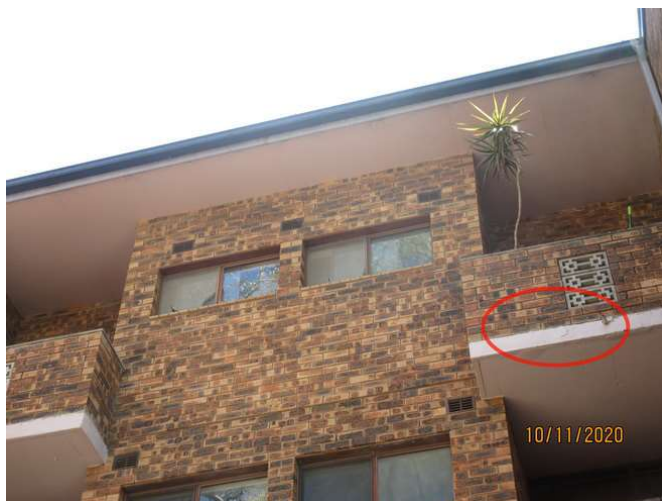
No1_034_Note slight concrete spalling

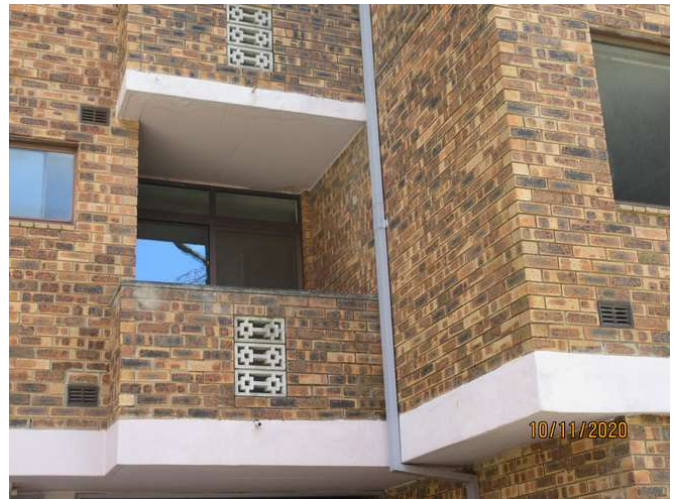
No1_039_Note slight concrete spalling

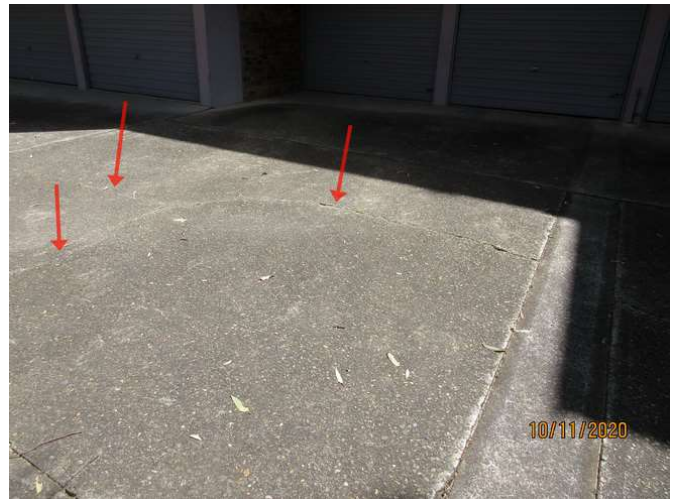
No1_045_Note evident cracking to concrete driveway

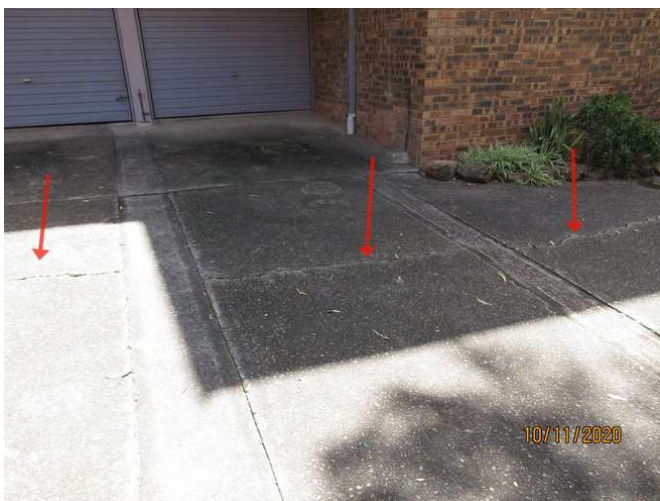
No1_046_Note evident cracking to concrete driveway

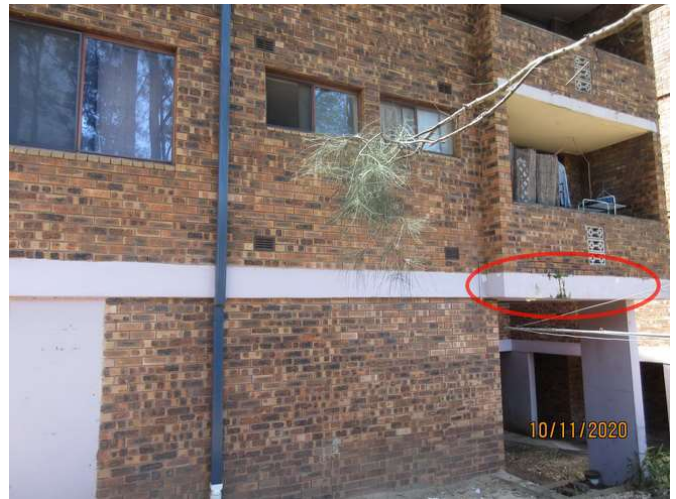
No1_051_Note slight concrete spalling

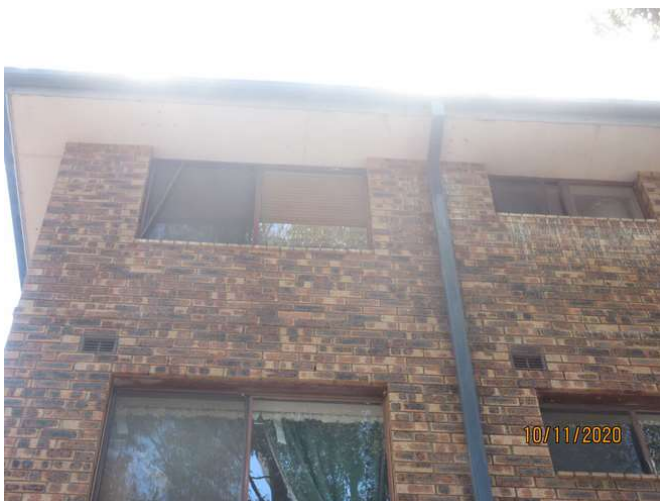
No1_052_Note slight concrete spalling

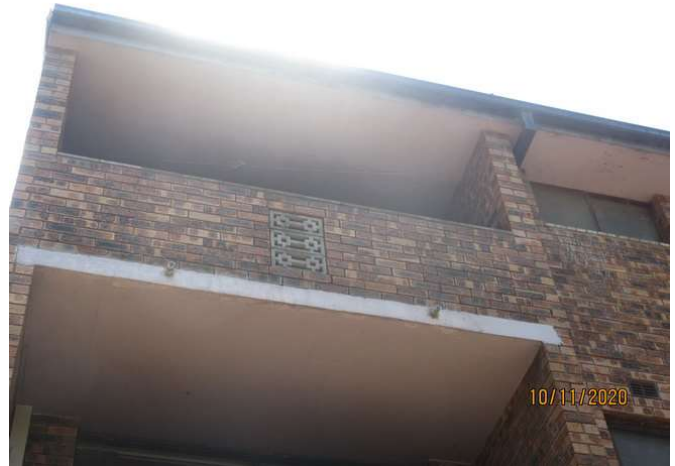
No1_067_Note slight concrete spalling

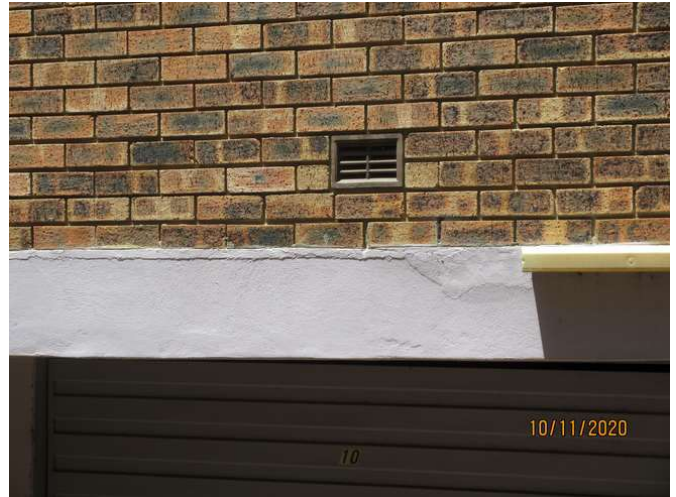
No1_085_Note slight concrete spalling

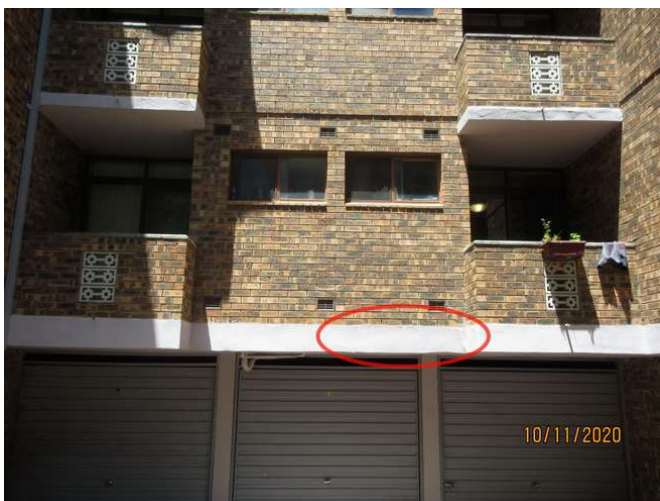
No1_088_Note slight concrete spalling

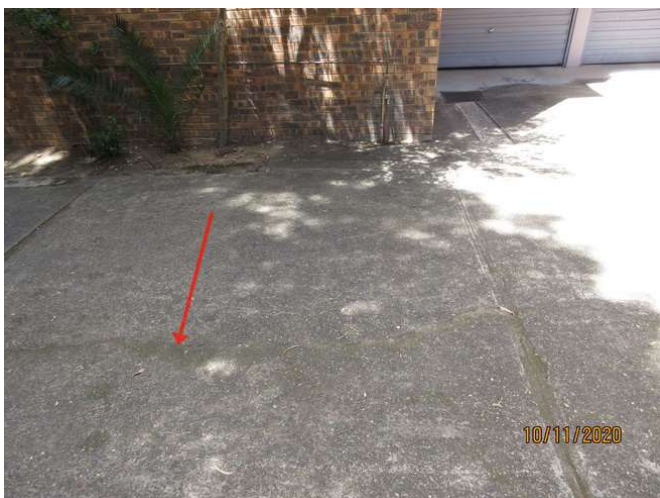
No1_094_Note dropping in levelling to the eastern driveway

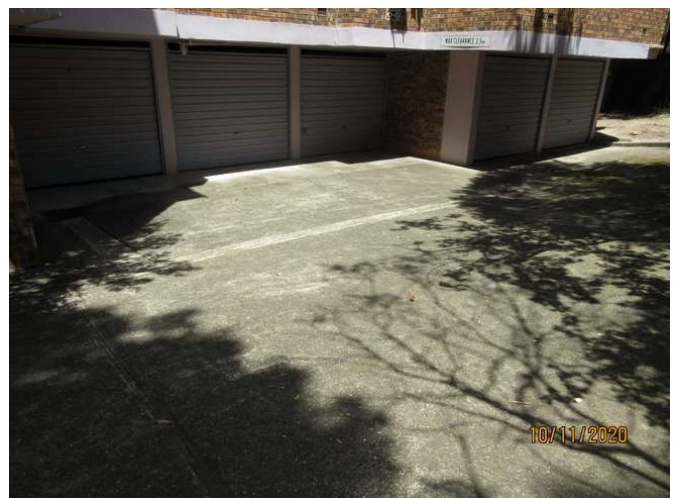
No1_095_Note evident cracking to concrete driveway

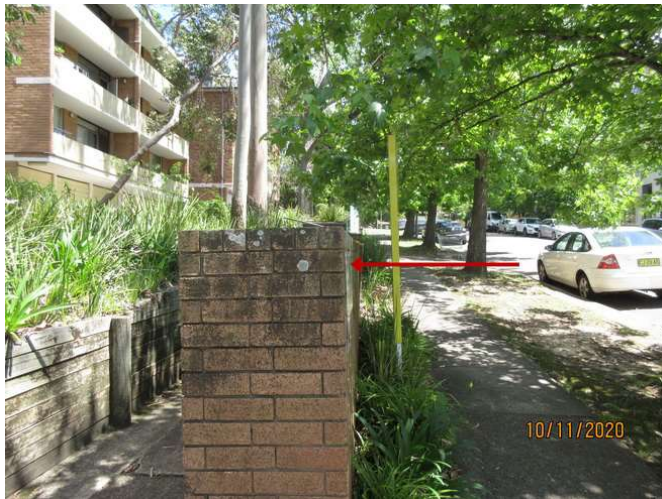
No 3_003_Note distressed wall

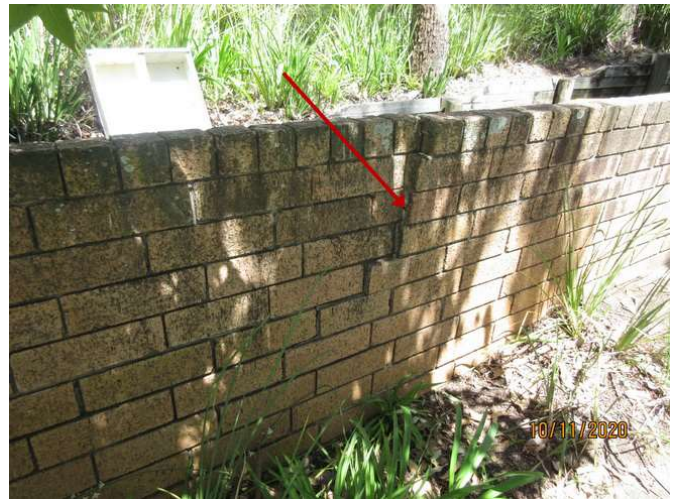
No 3_004_Note distressed wall

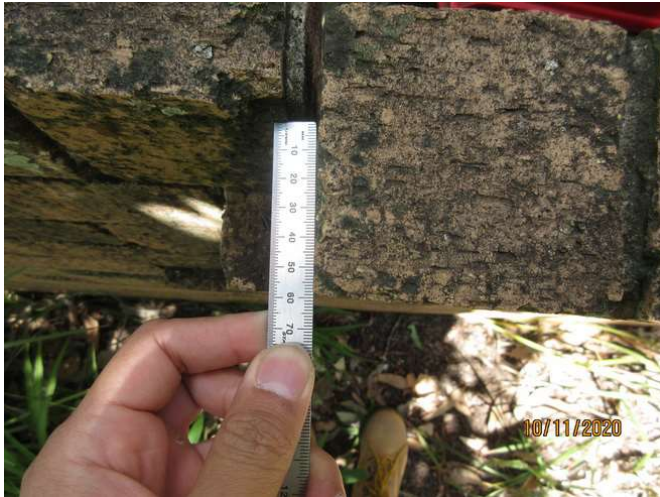
No 3_007_Note an estimated 59.0mm displacement on top

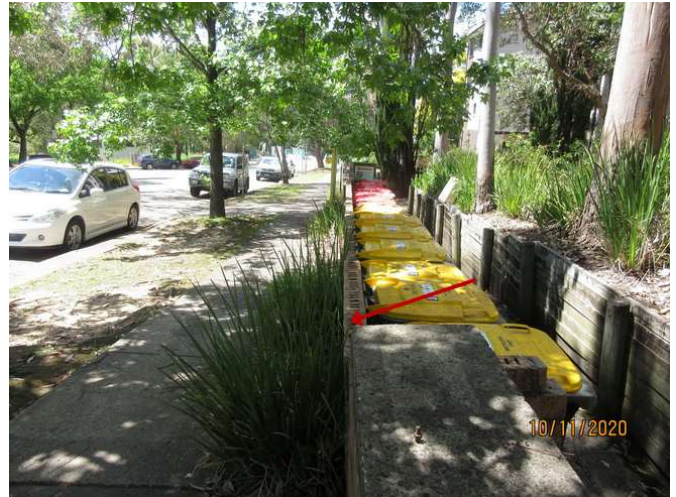
No 3_008_Note distressed wall

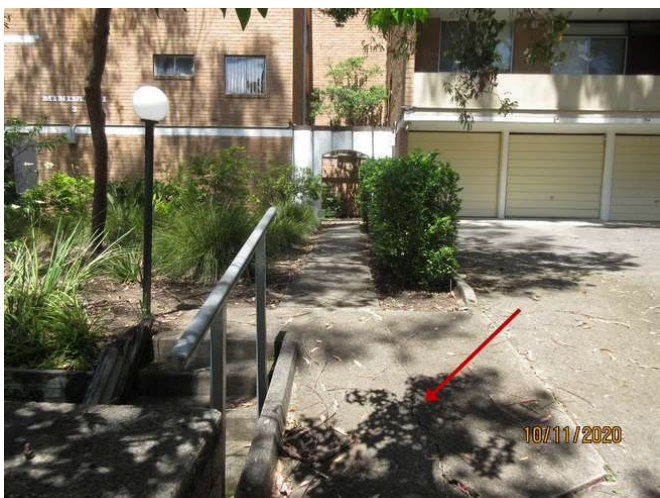
No 3_011_Note distressed wall

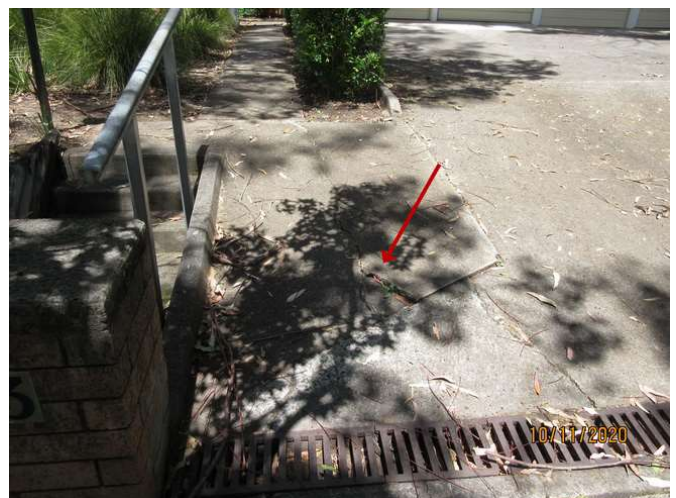
No 3_012_Note distressed wall

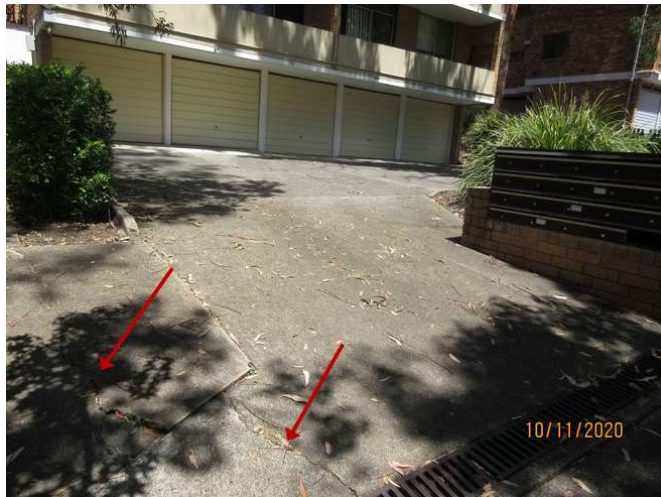
No 3_013_Note distressed wall

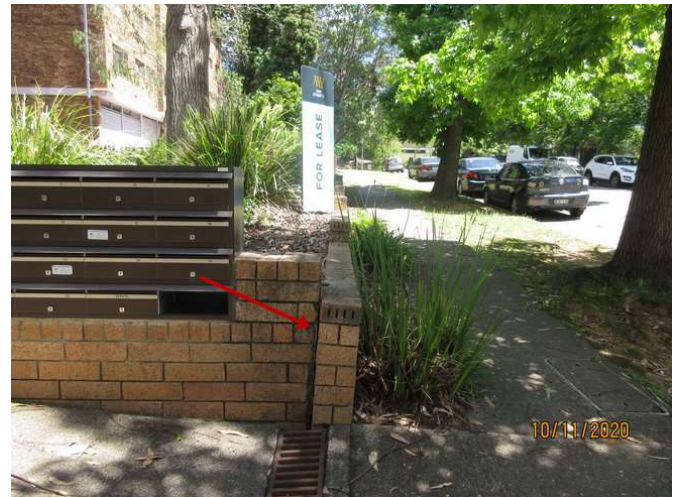
No 3_014_Note the gap

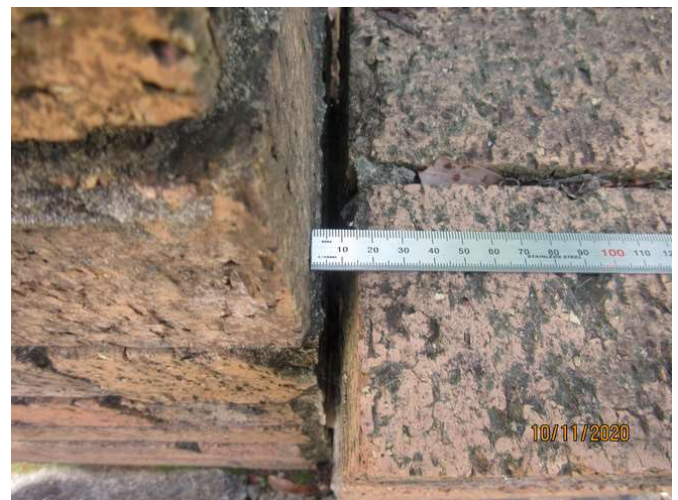
No 3_016_Note an estimated 15mm width of opening

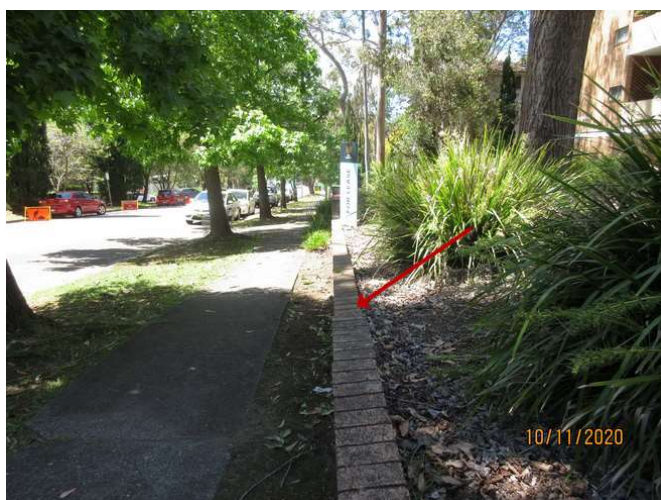
No 3_017_Note distressed wall

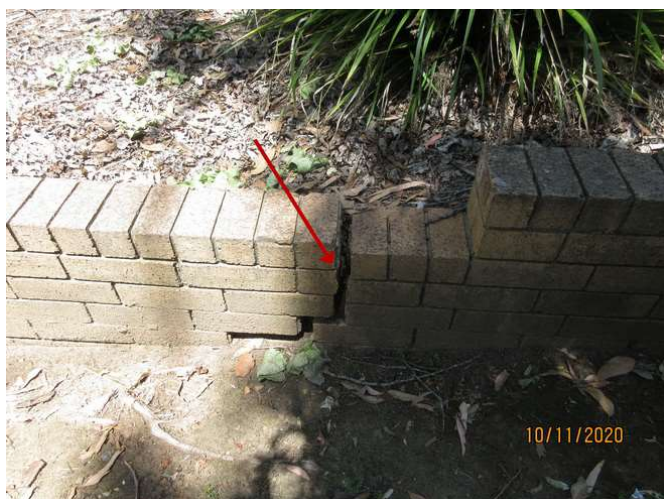
No 3_019_Note distressed wall

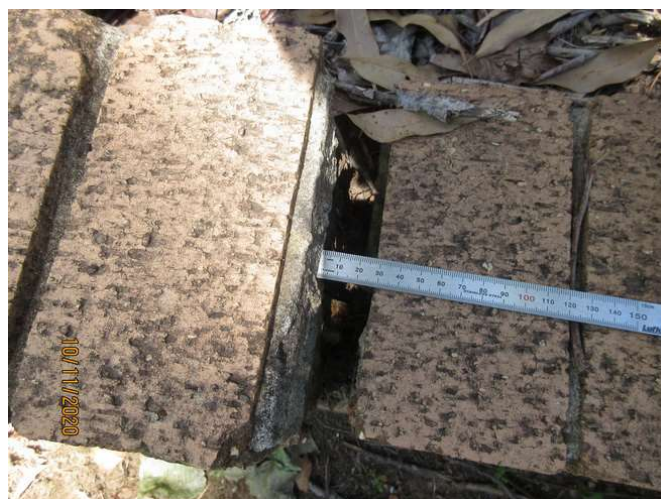
No 3_020_Note an estimated 28.0mm width of opening

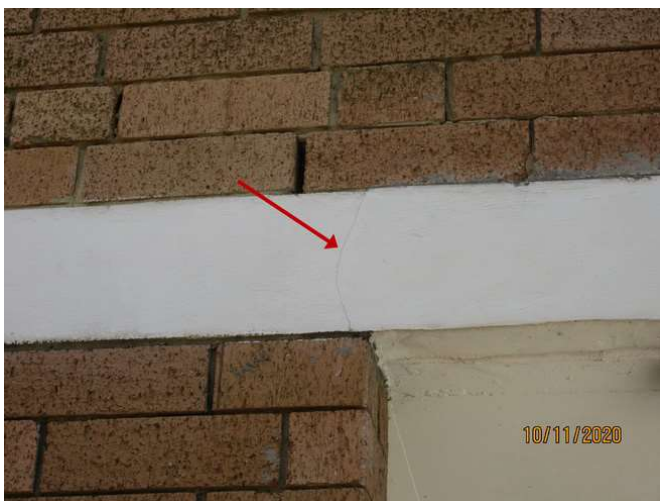
No 3_064_Note the cracking damage

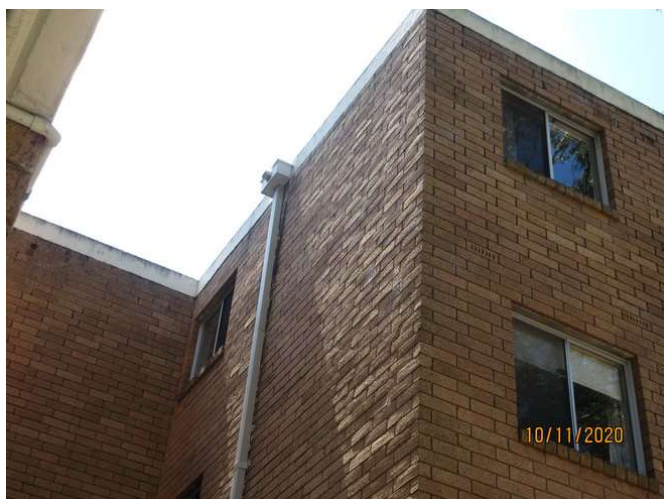
No 3_068_ Note the cracking damage

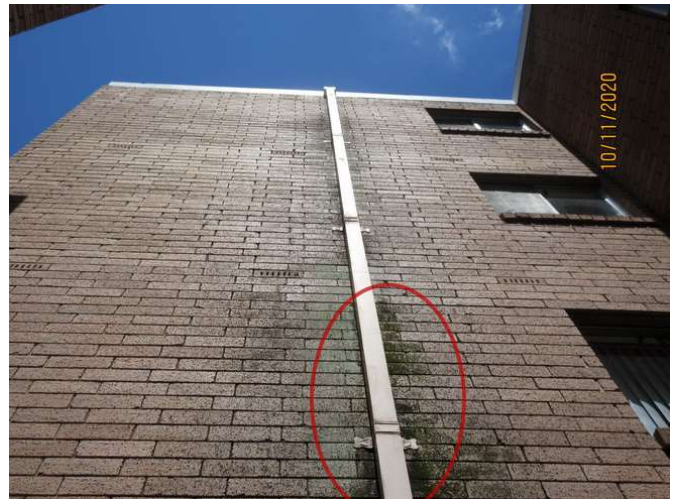
No 3_087_Note the sign of overflow roof water

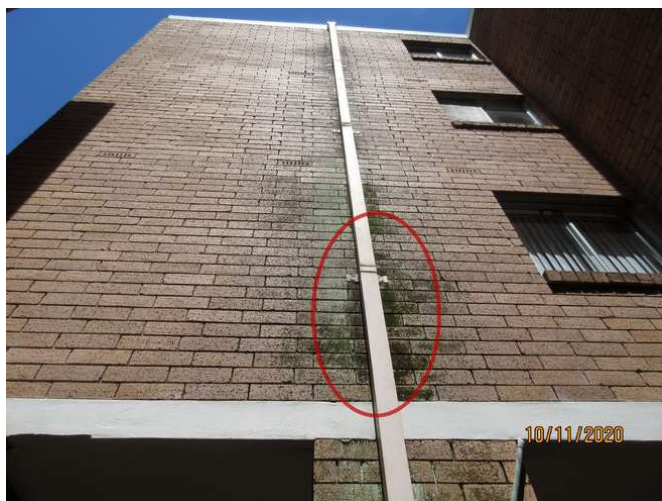
No 3_088_Note the sign of overflow roof water

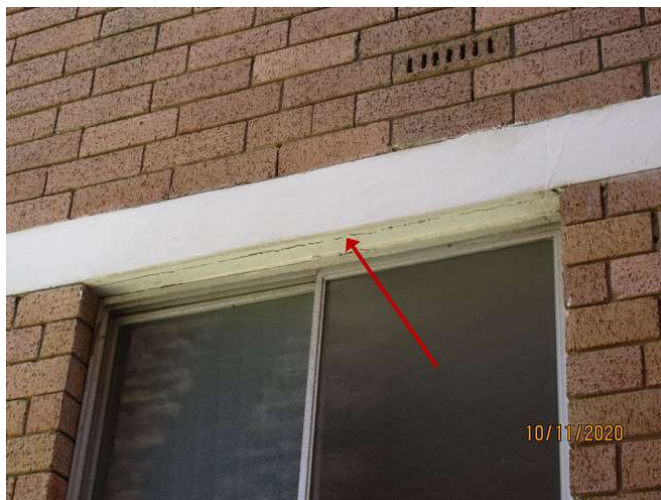
No 3_098_Note the cracking damage

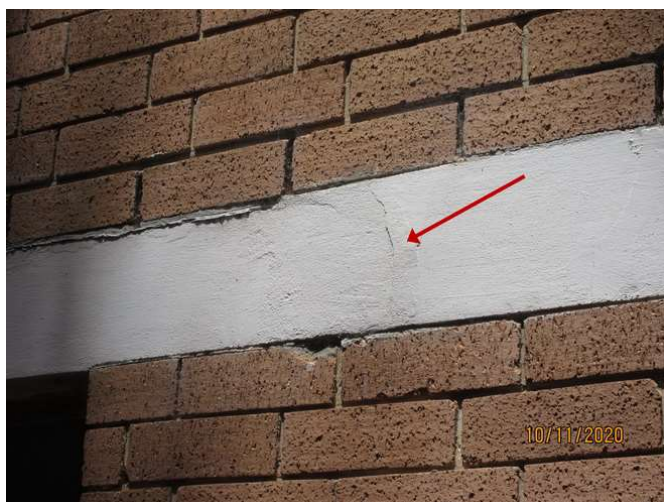
No 3_122_Note the cracking damage

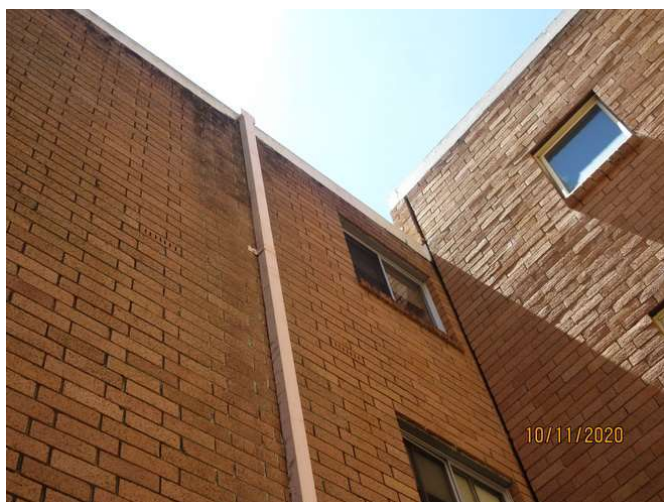
No 3_128_ Note the sign of overflow roof water

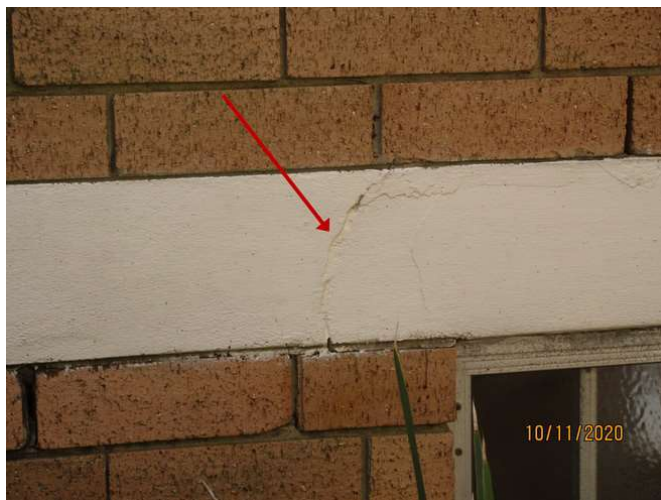
No 3_134_Note the cracking damage

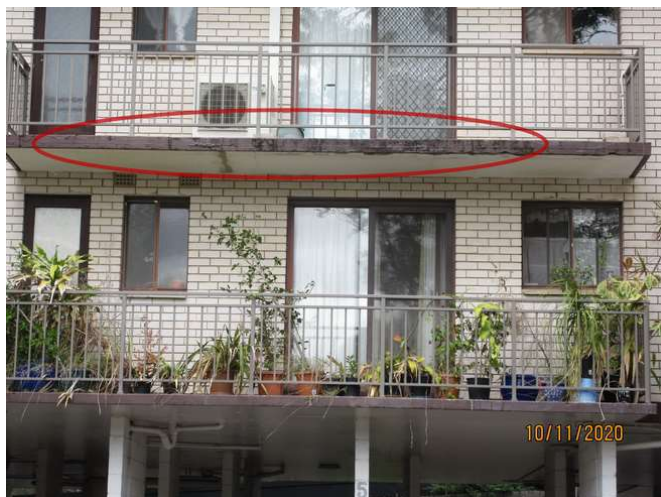
No 5_020_Note mould build up and dampness damage

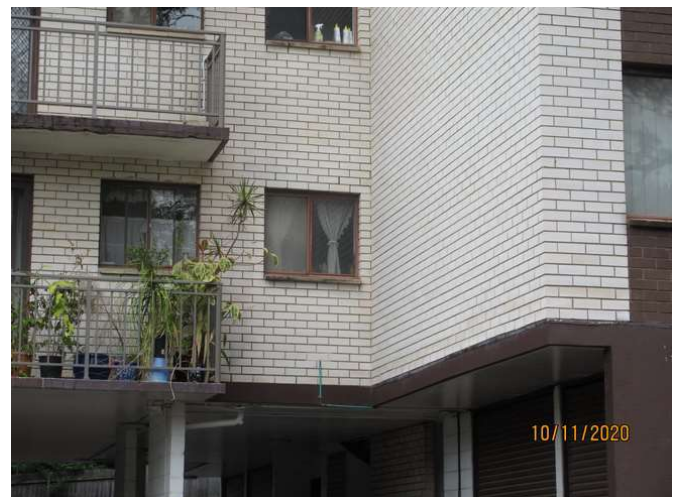
No 5_021_Note mould build up and dampness damage

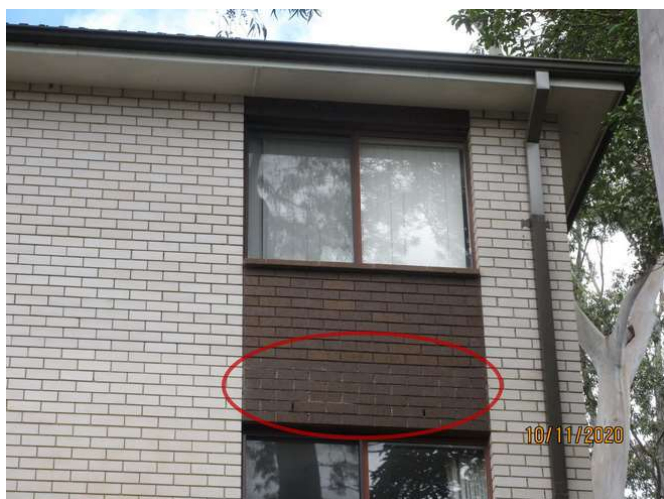
No 5_024_Note re-addressing to course joints

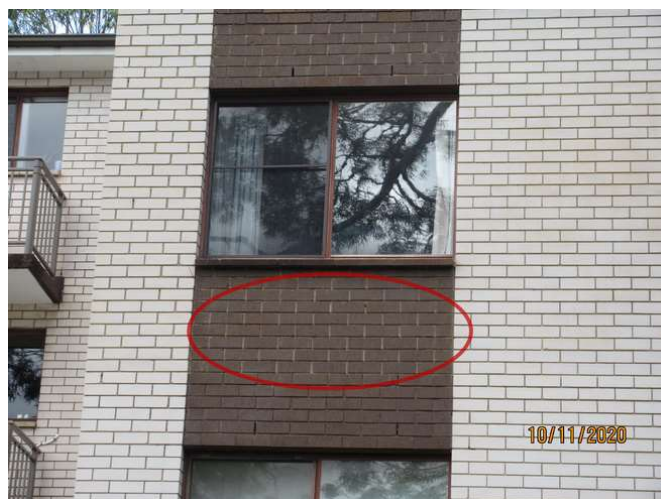
No 5_025_Note re-addressing to course joints

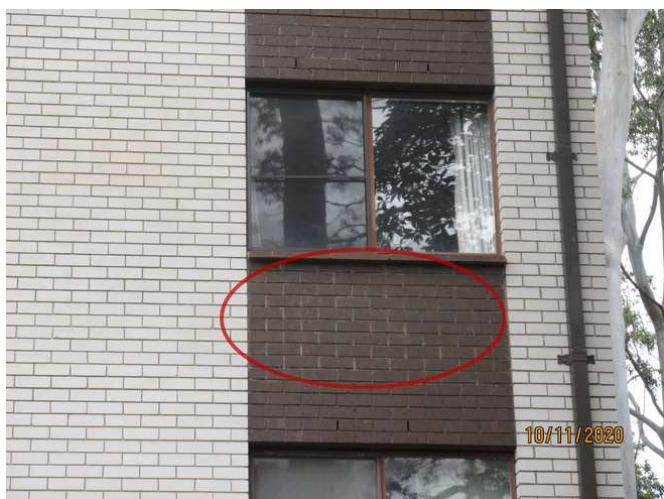
No 5_026_Note re-addressing to course joints

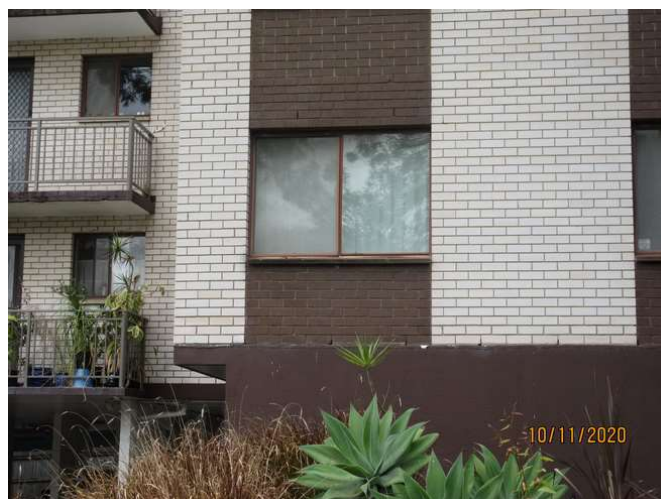
No 5_027_Note re-addressing to course joints

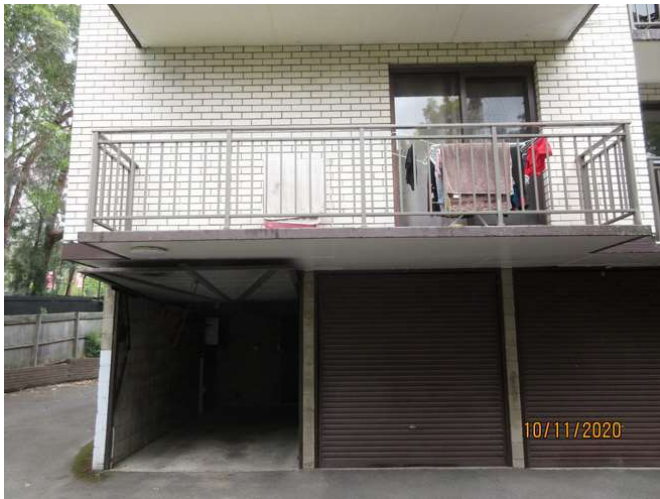
No 5_032_Note mould build up and dampness damage

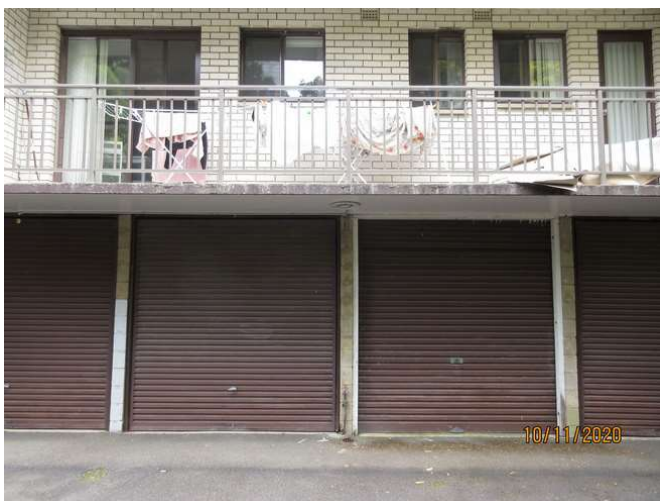
No 5_040_Note water damage

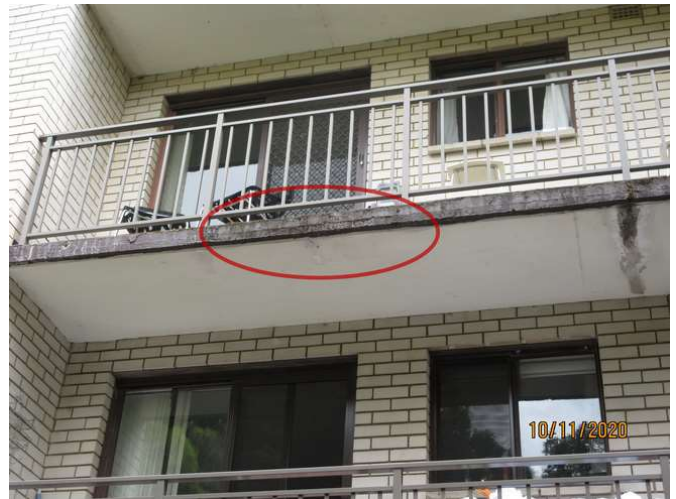
No 5_043_Note water damage
