CONSTRUCTION CERTIFICATE No. J/74556/01

Issued under the Environmental Planning and Assessment Act 1979 Sections 6.4 and 6.7

Address: Ivanhoe Estate comprising Ivanhoe Place, Wilcannia Way, Nyngan Way, Narromine Way and Cobar Way, part of 2-4 Lyonpark Road and portions of Shrimptons Creek adjacent to the centre line of the creek, Macquarie Park

Description: Stage 1 development application for the redevelopment of the Ivanhoe Estate, including:

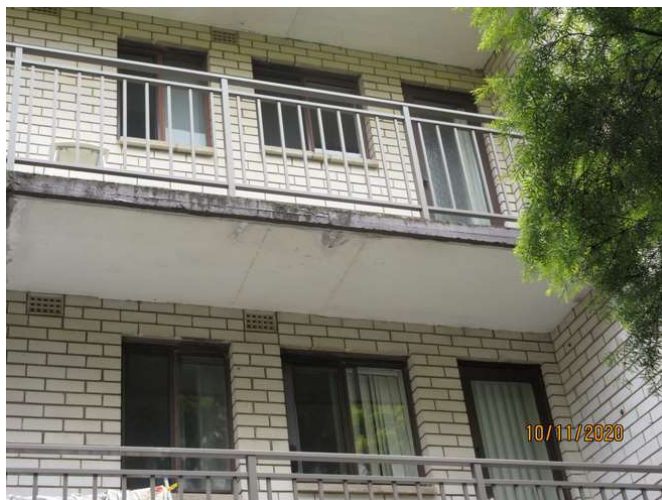
No 5_044_Note water damage

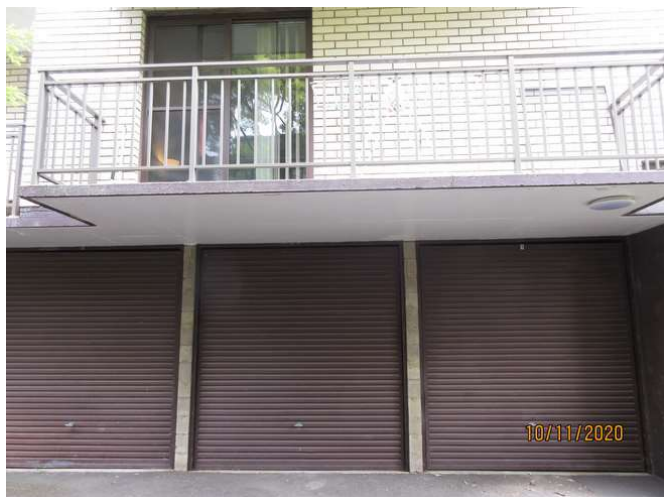
No 5_048_Note water damage

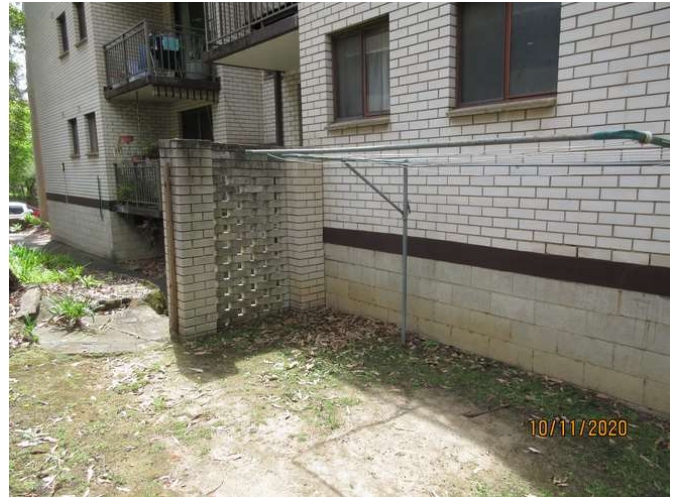
No 5_085_Note distressed wall

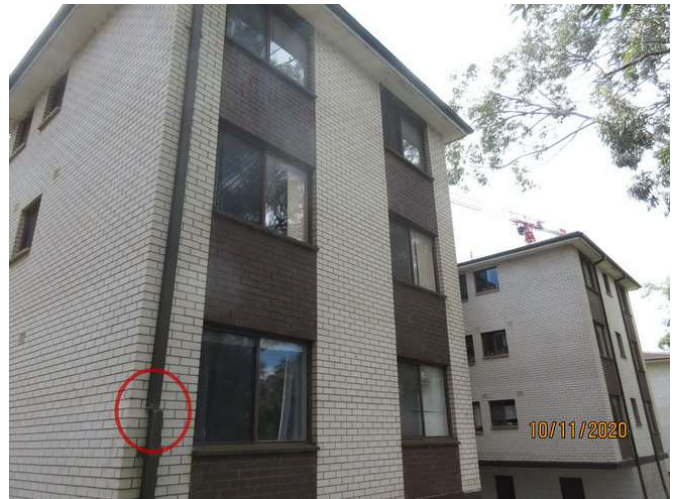
No 5_088_Note dislodged downpipe

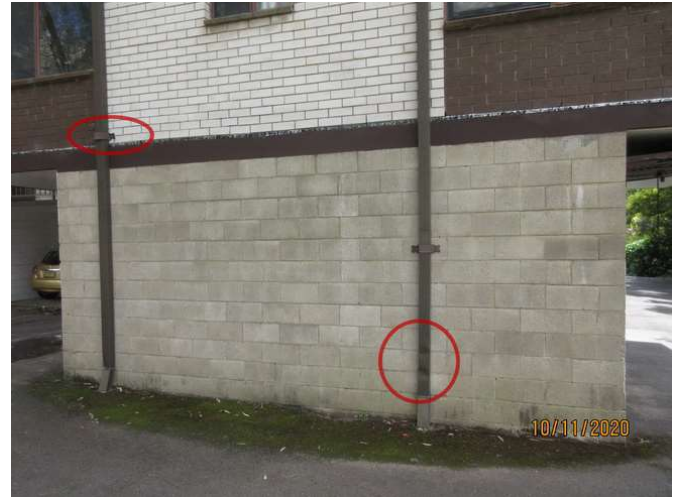
No 5_092_Note loose bracket and impact damage

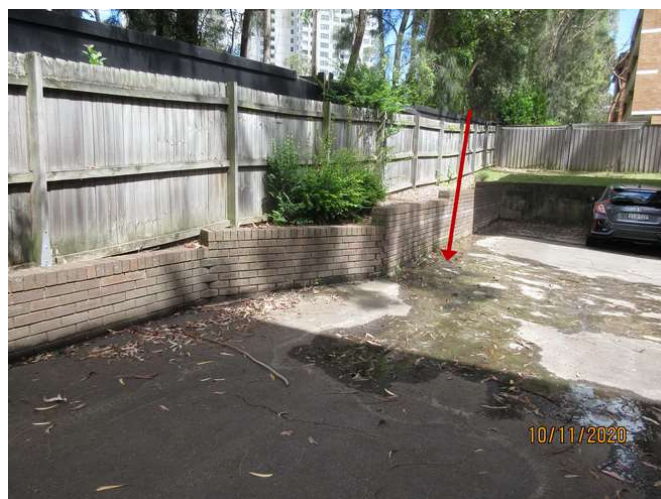
No 5_098_Note groud n water leakage

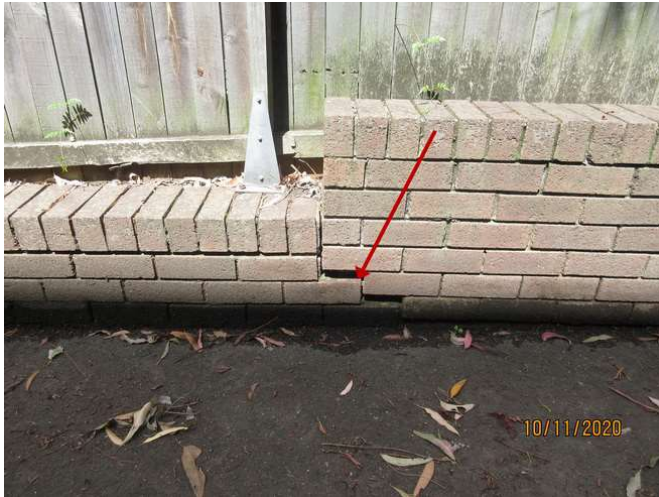
No 5_103_Note distressed retaining boundary wall

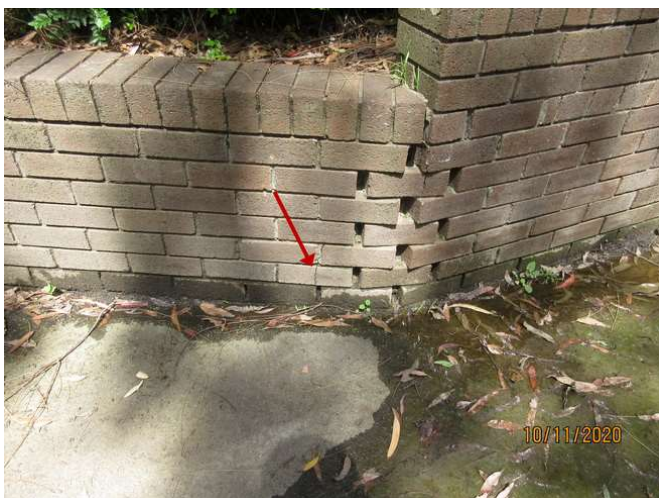
No 5_107_Note the cracking damage

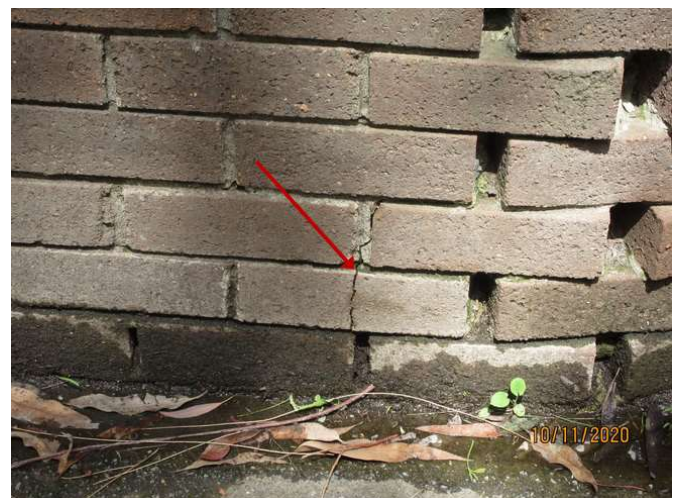
No 5_108_Note the cracking damage

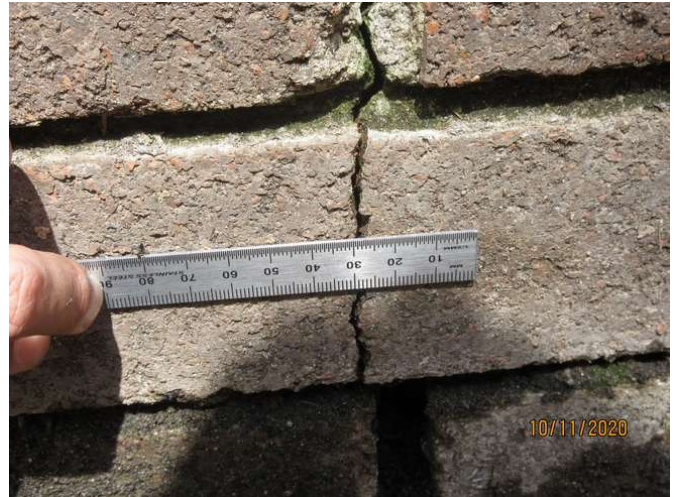
No 5_110_Note an estimated 3.0mm cracking width at representative location

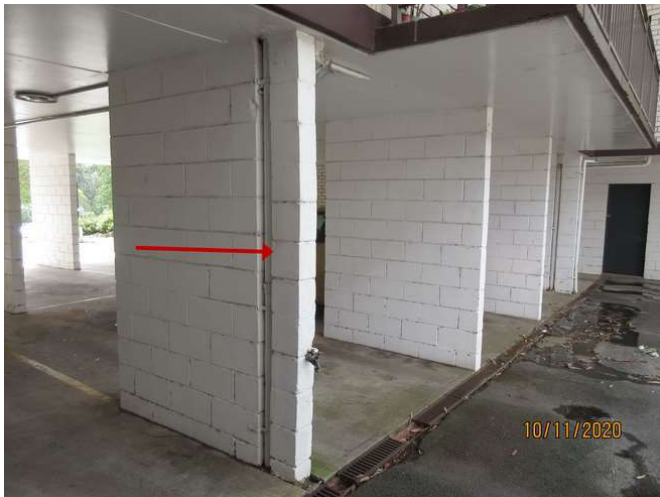
No 5_111_Note distressed wall

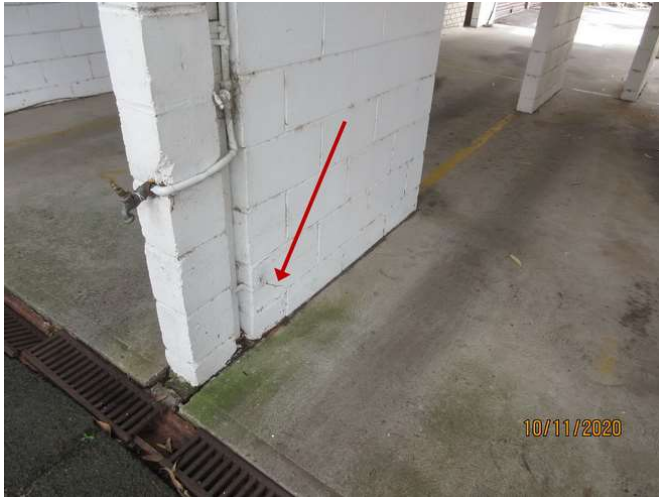
No 5_115_Note the cracking damage

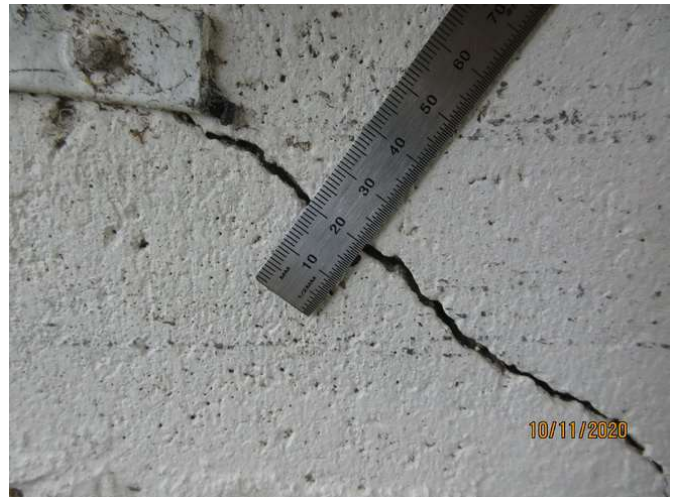
No 5_118_Note an estimated 2.0mm cracking width at representative location

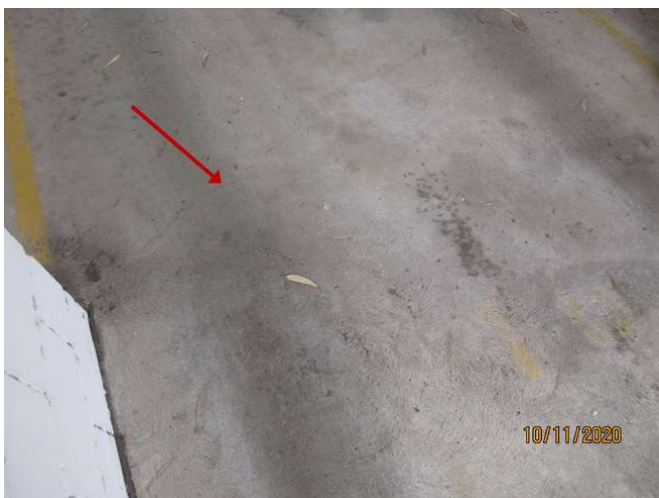
No 5_119_Note cracking generally noted to concrete slab

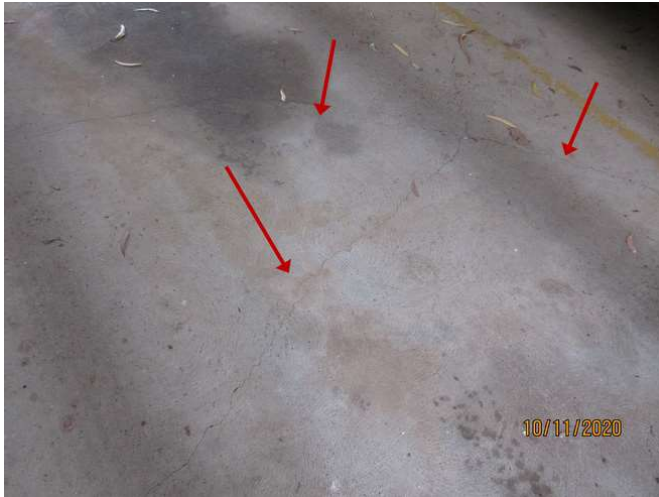
No 5_121_Note cracking generally noted to concrete slab

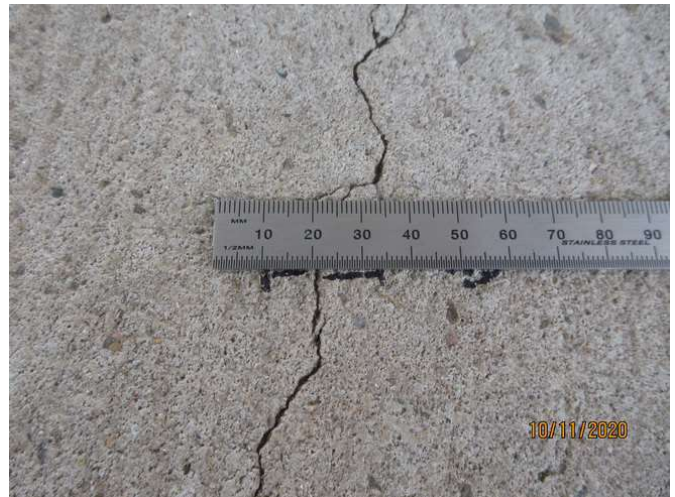
No 5_124_Note an estimated 1.0mm cracking width at representative location

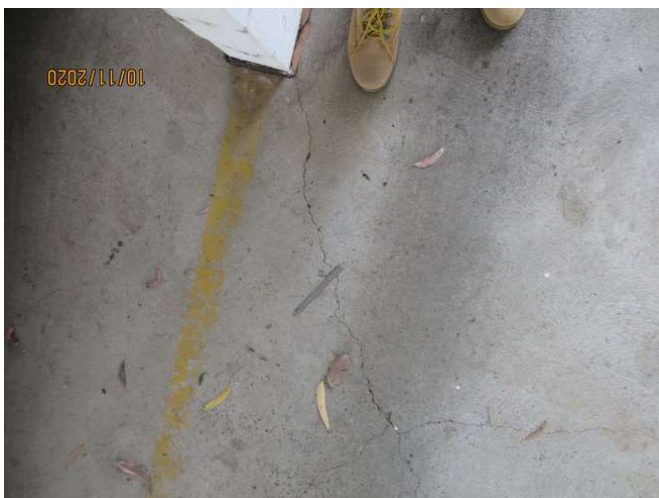
No 5_125_Note cracking generally noted to concrete slab

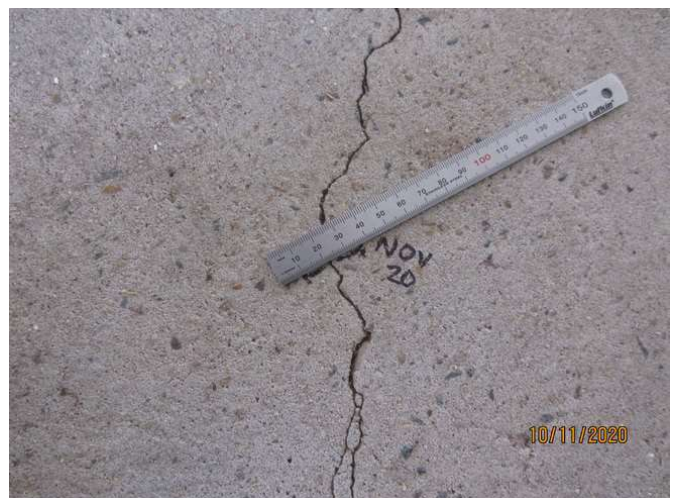
No 5_126_Note an estimated 2.0mm cracking width at representative location

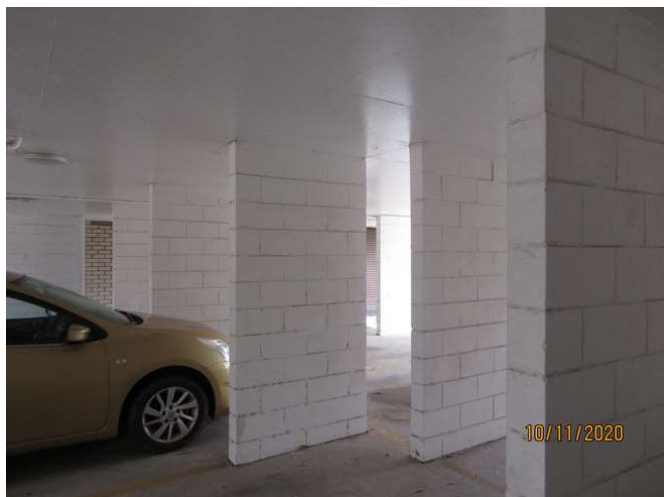
No 5_144_Note an estimated 2.0mm cracking width at representative location

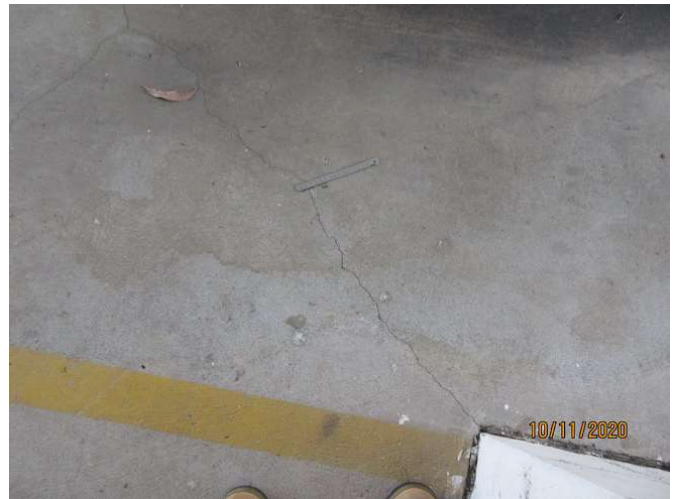
No 5_151_Note an estimated 1.5mm cracking width at representative location

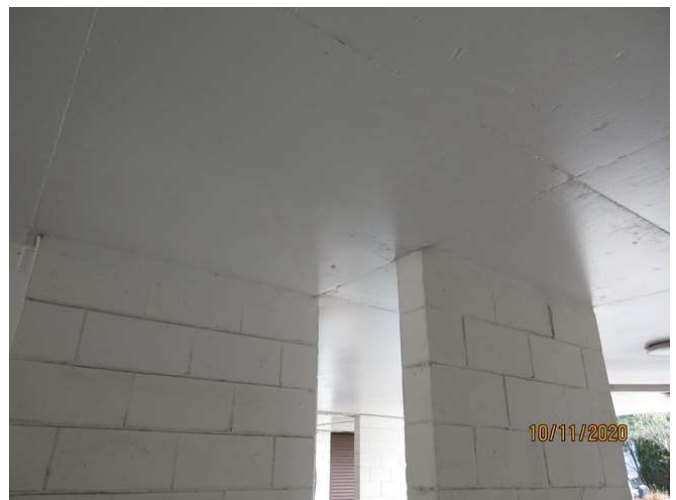
No 5_153_Note an estimated 1.0mm cracking width at representative location

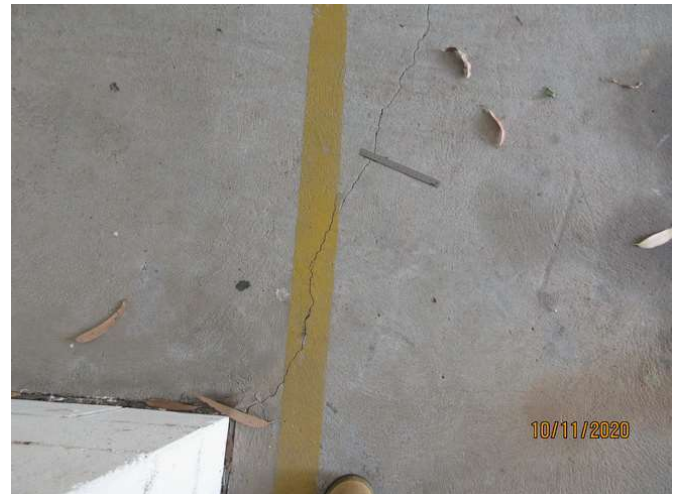
No 5_159_Note an estimated 2.0mm cracking width at representative location

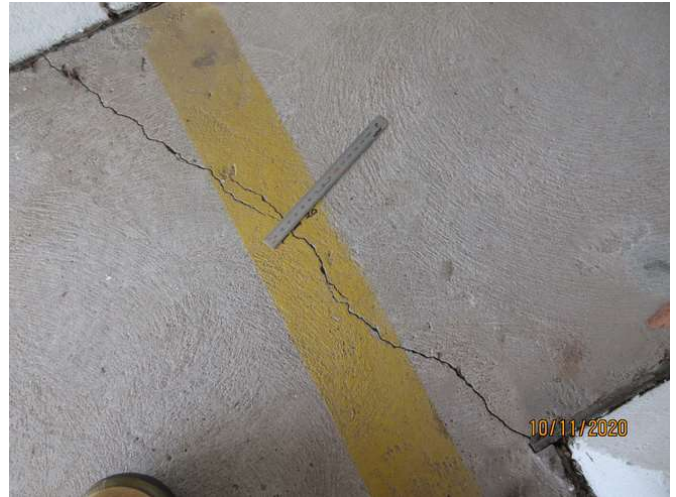
No 5_163_Note an estimated 1.0mm cracking width at representative location

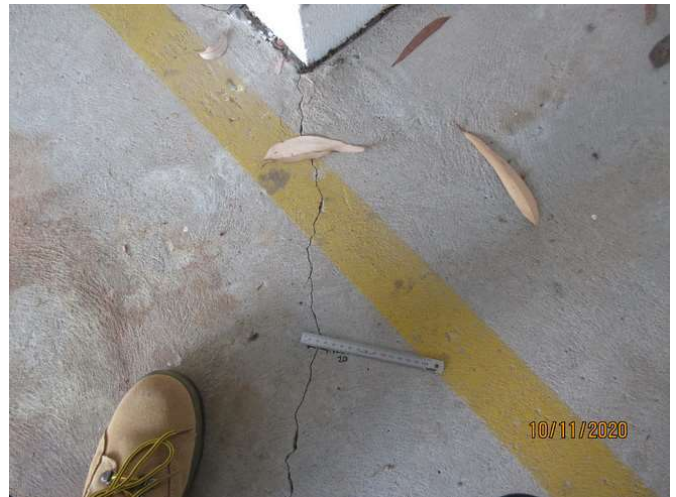
No 5_165_Note an estimated 1.0mm cracking width at representative location

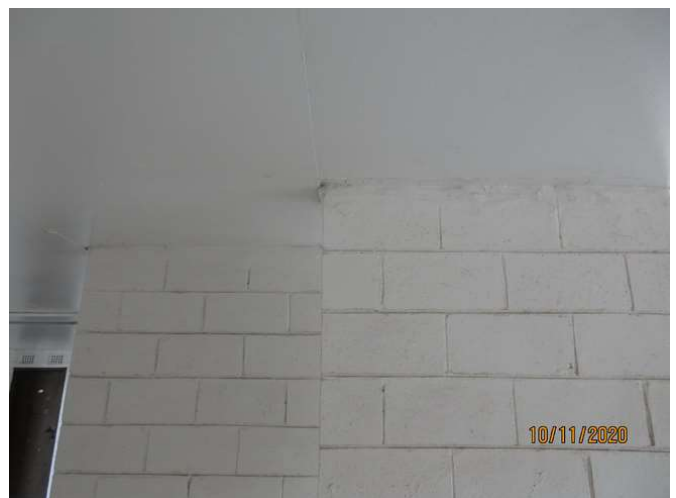
No 5_167_Note an estimated 1.5mm cracking width at representative location

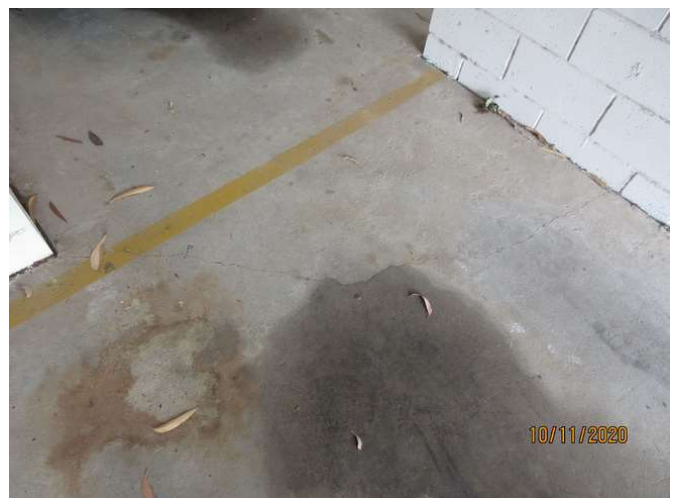
No 5_173_Note an estimated 1.0mm cracking width at representative location

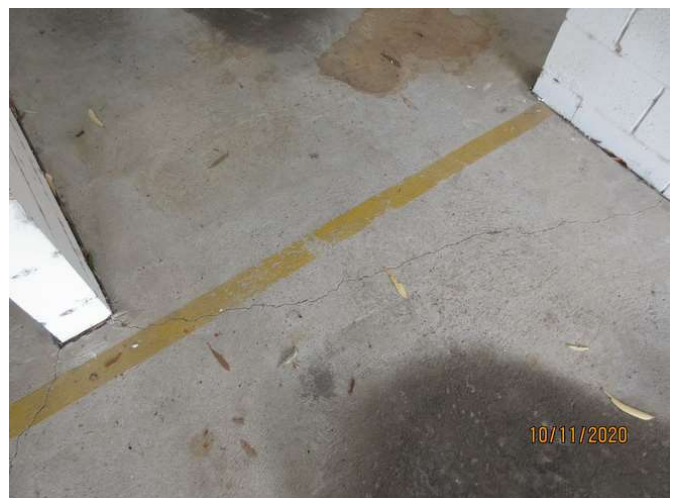
No 5_179_Note an estimated 1.5mm cracking width at representative location

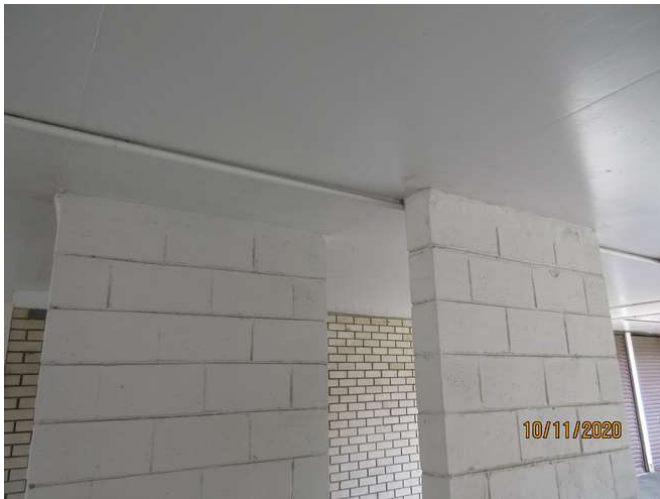
No 5_182_Note an estimated 1.5mm cracking width at representative location

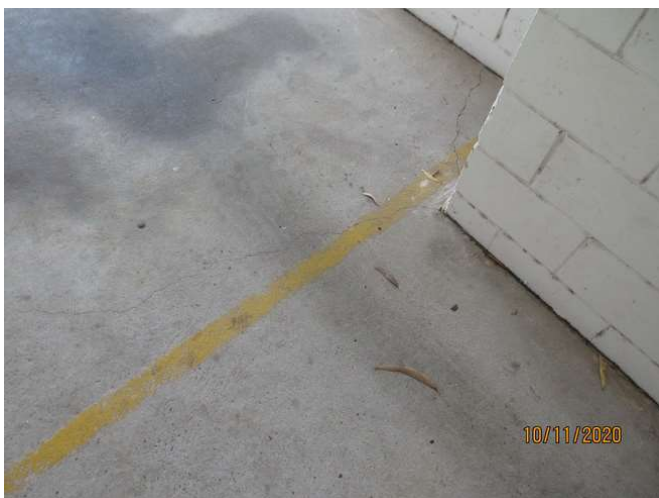
No 5_190_Note an estimated 1.0mm cracking width at representative location

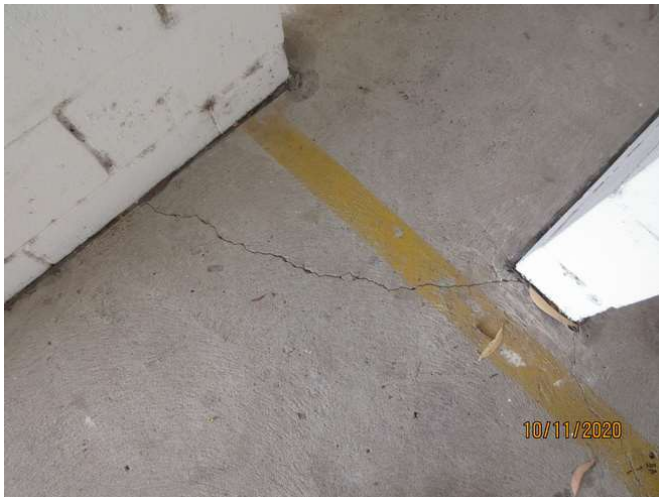
No 5_194_Note an estimated 2.0mm cracking width at representative location

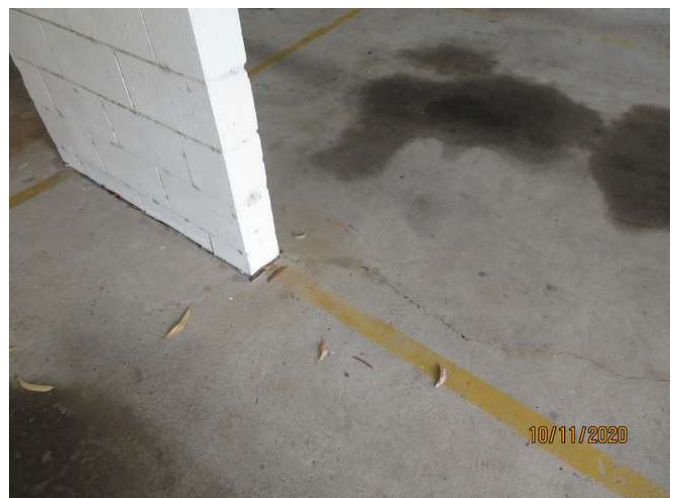
No 5_197_Note an estimated 1.5mm cracking width at representative location

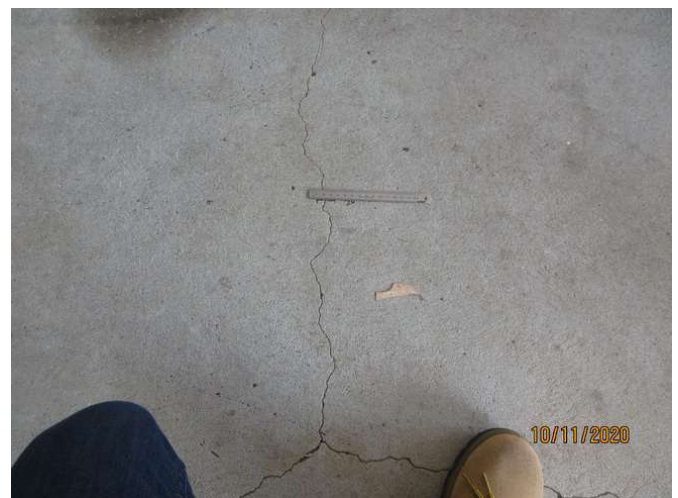
No 5_203_Note an estimated 2.0mm cracking width at representative location

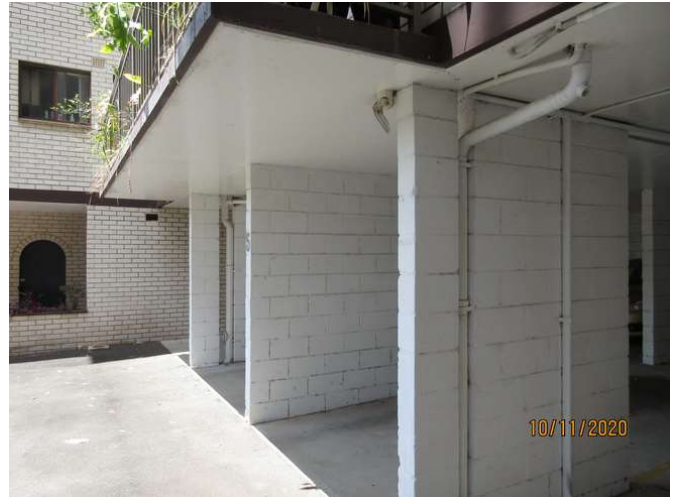
No 5_205_Note an estimated 1.5mm cracking width at representative location

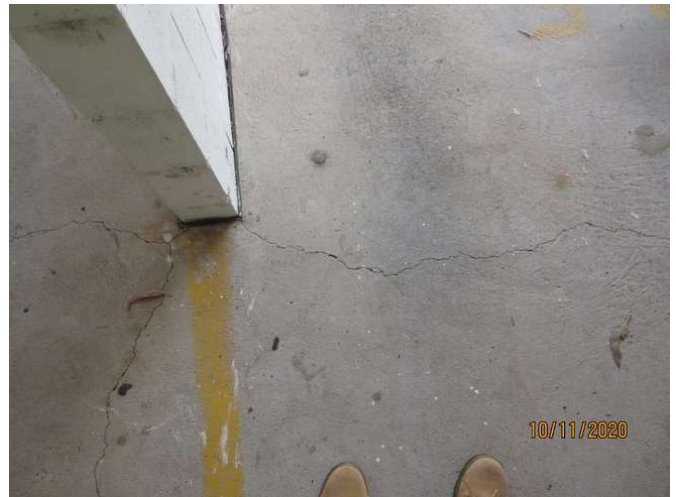
No 5_213_Note an estimated 2.0mm cracking width at representative location

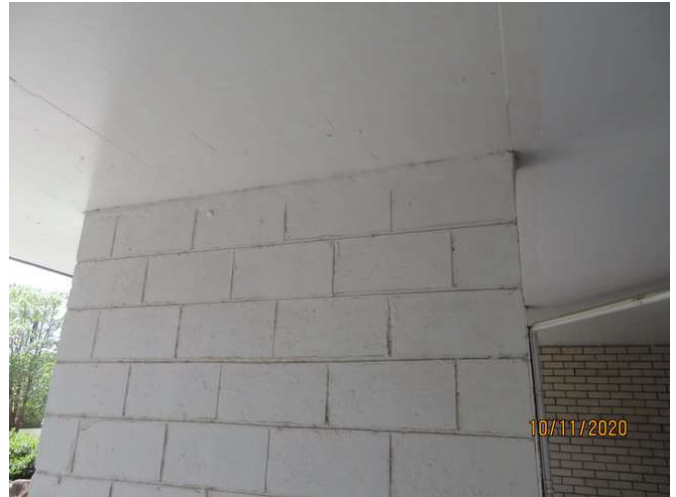
No 5_217_Note an estimated 1.5mm cracking width at representative location

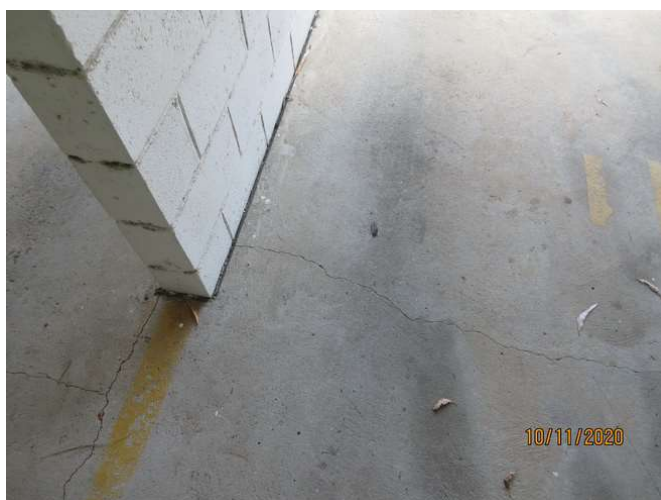
No 5_226_Note an estimated 1.0mm cracking width at representative location

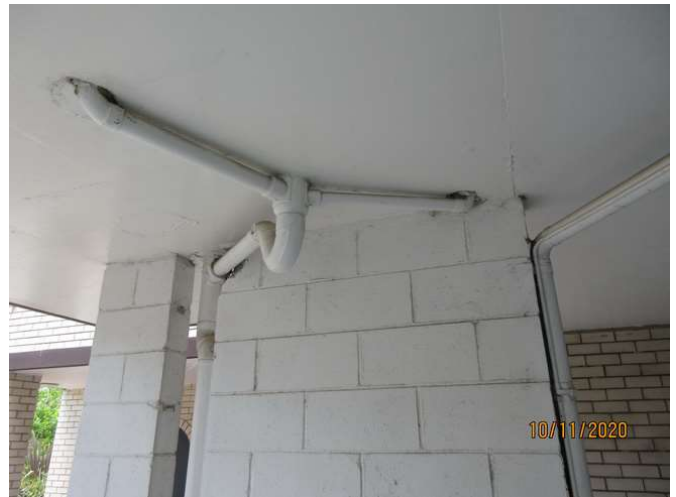
No 5_231_Note an estimated 1.5mm cracking width at representative location

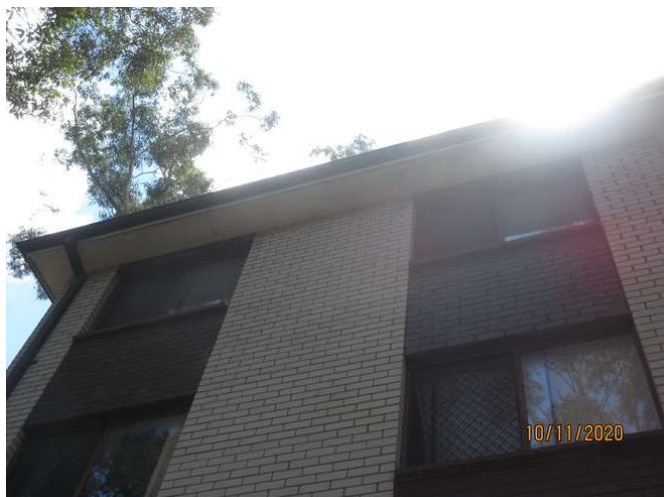
No 5_240_Note an estimated 1.5mm cracking width at representative location

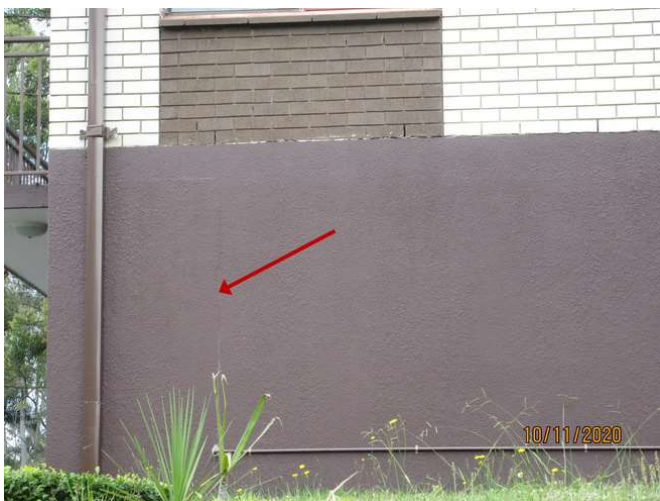
No 7_011_Note cracking damage

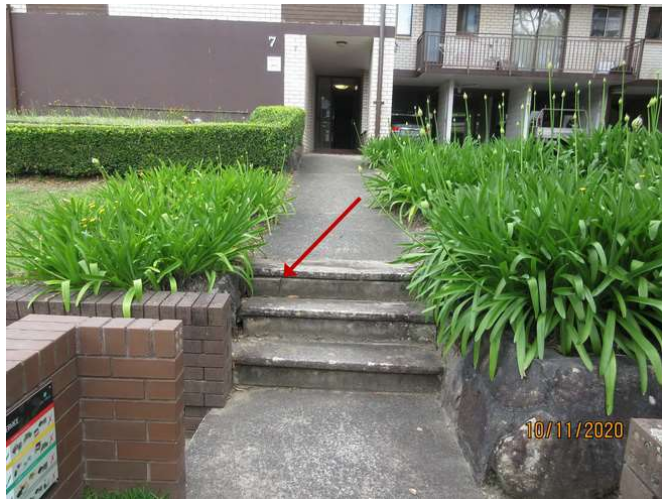
No 7_013_Note cracking damage

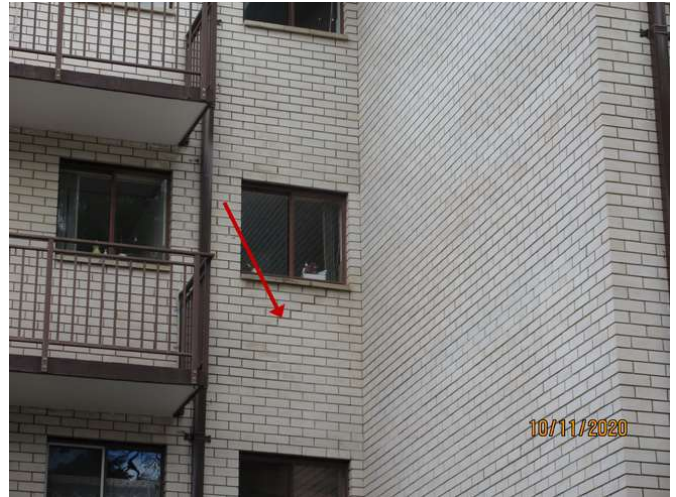
No 7_020_Note stepped cracking to wall

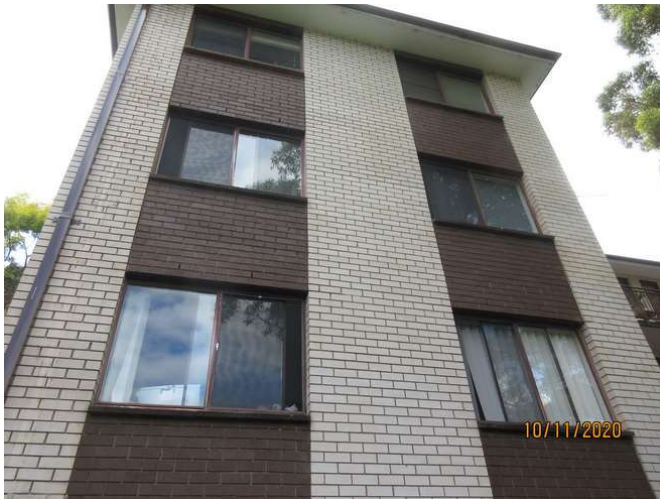
No 7_056_Note elevation dropping next to deep excavation

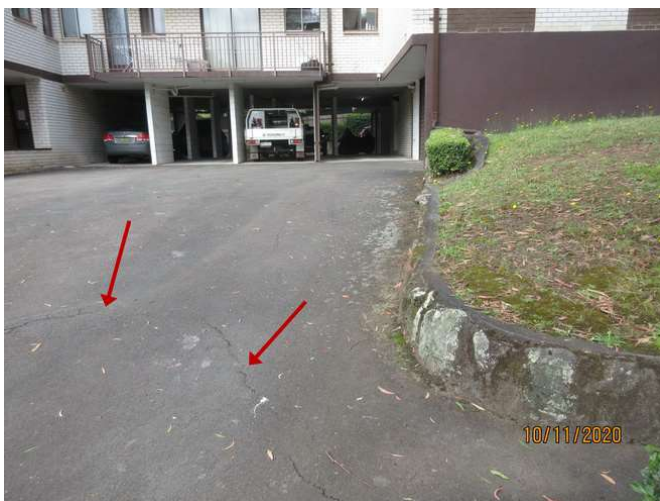
No 7_148_Note distressed road surface

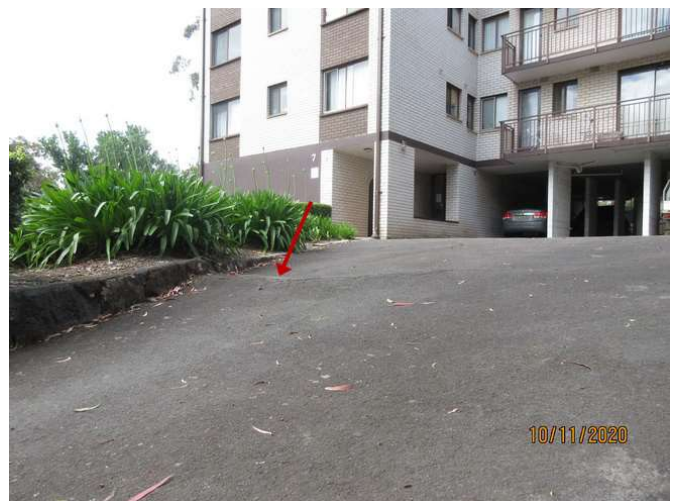
No 7_149_Note distressed road surface

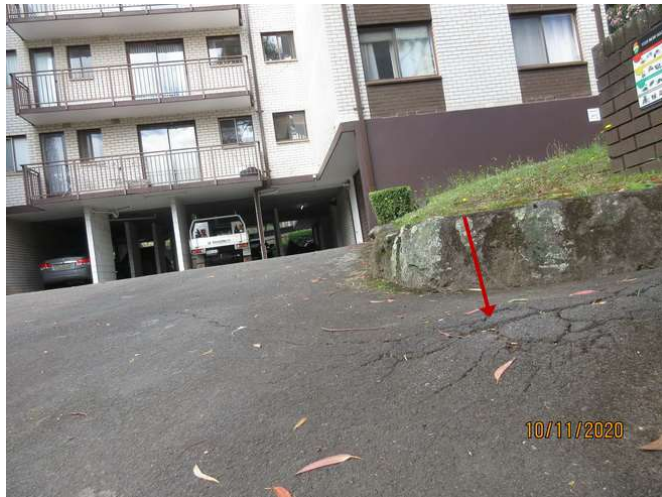
No 7_150_Note distressed road surface

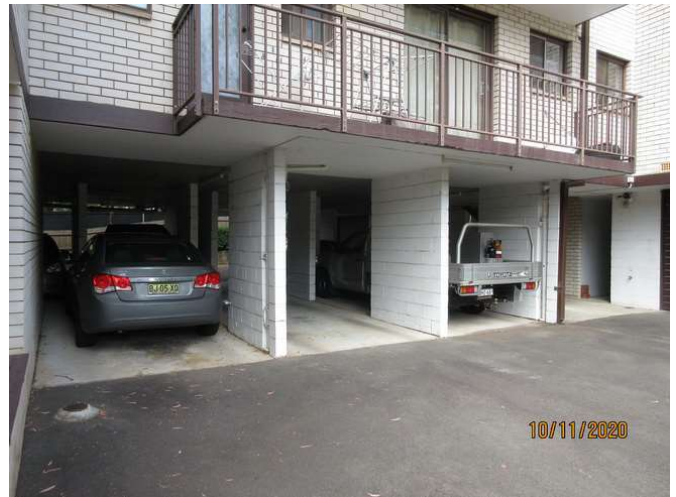
No 7_151_Note distressed road surface

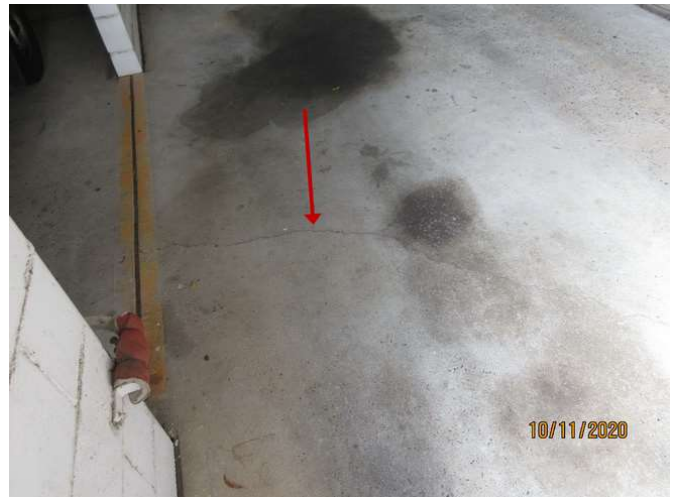
No 7_165_Cracking generally noted to concrete slab

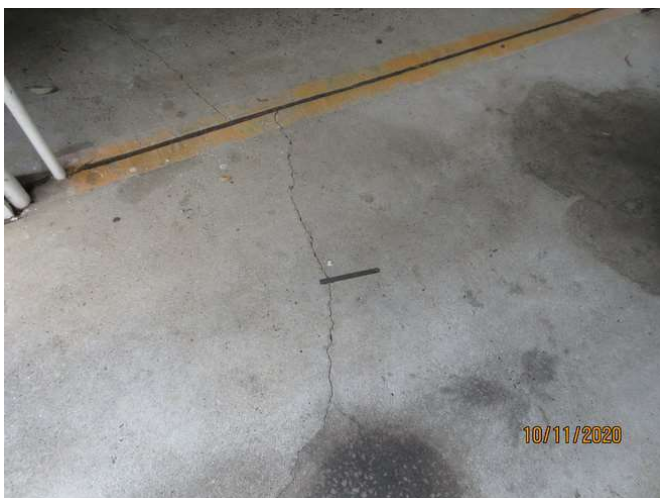
No 7_166_Cracking generally noted to concrete slab

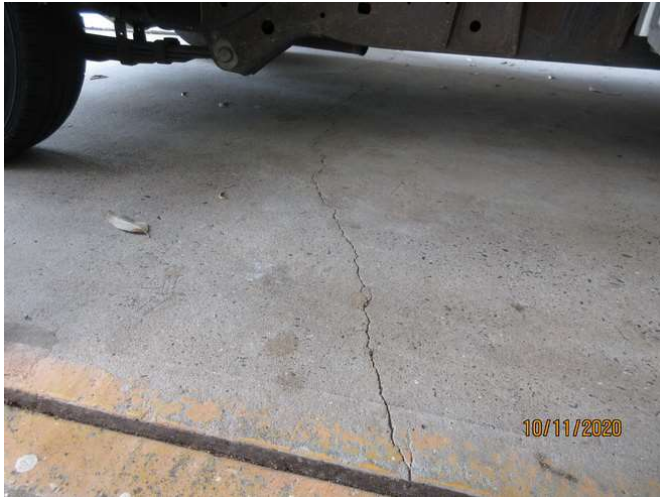
No 7_168_Note an estimated 1.5mm cracking width at representative location

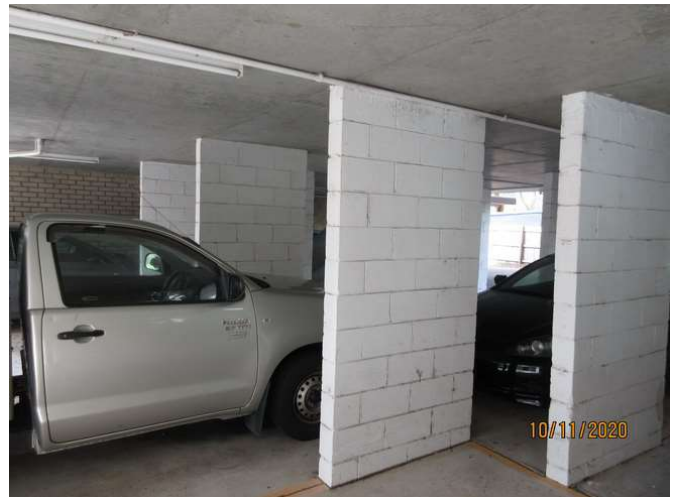
No 7_171_Note an estimated 1.5mm cracking width at representative location

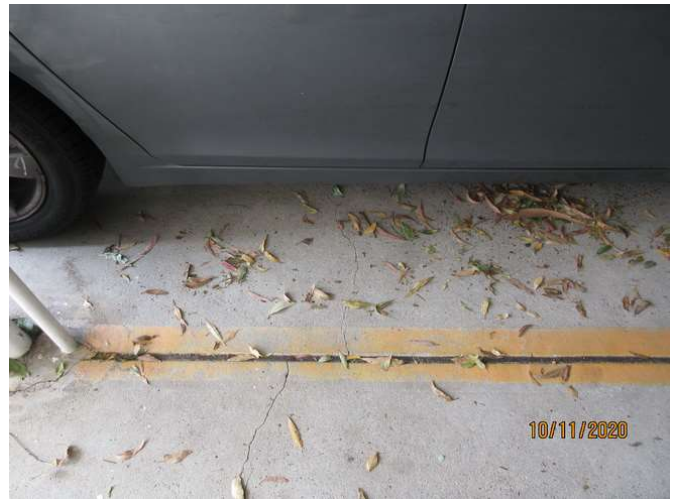
No 7_205_Note an estimated 2.0mm cracking width at representative location

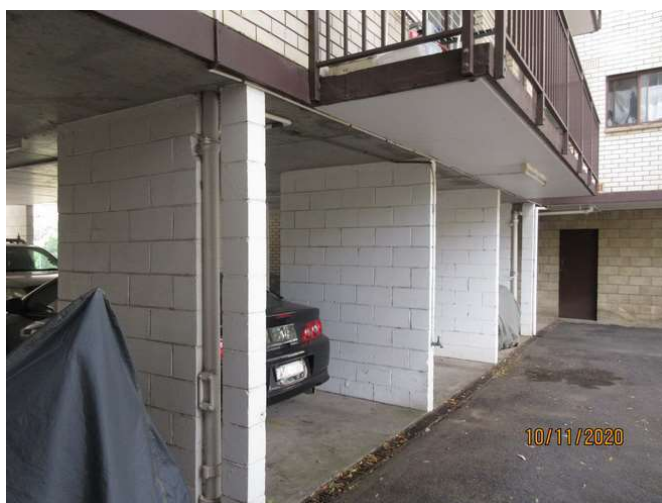
No 7_208_Note an estimated 1.5mm cracking width at representative location

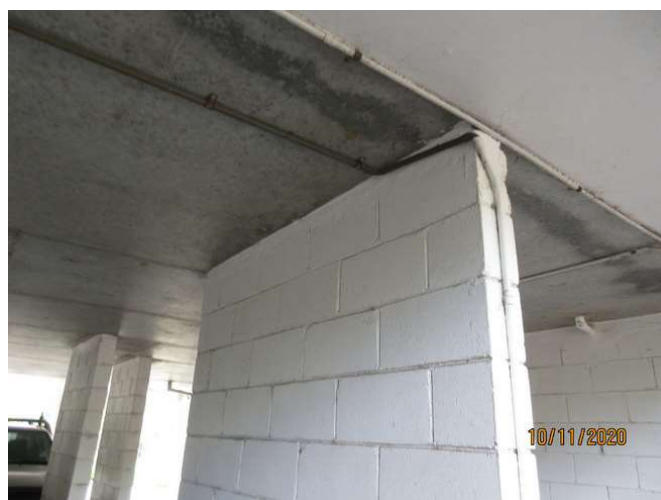
No 7_221_Note an estimated 0.5mm cracking width at representative location

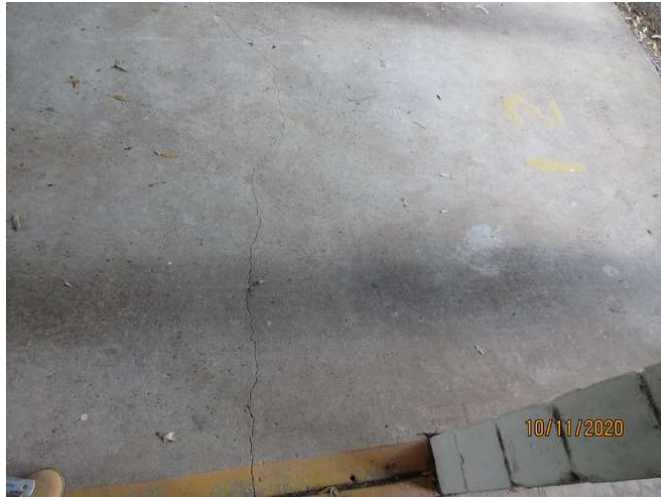
No 7_228_Note an estimated 1.0mm cracking width at representative location

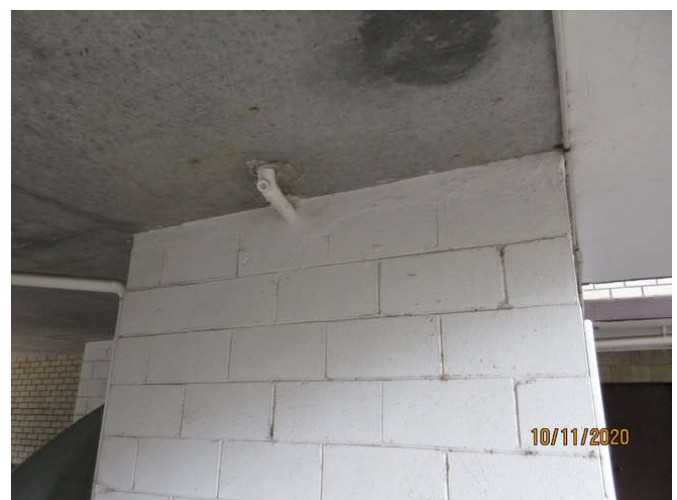
No 7_233_Note an estimated 1.0mm cracking width at representative location

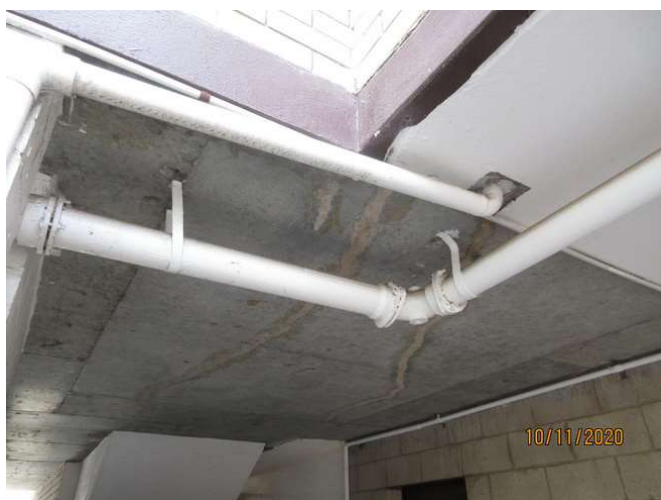
No 7_244_Note an estimated 1.0mm cracking width at representative location
